# Bridge Inspection Report

**A5096**  
**I 540-SEC 1, SB LN**  
**over**  
**Boston Street-Sebastian**

Facility Carried: I 540-SEC 1, SB LN

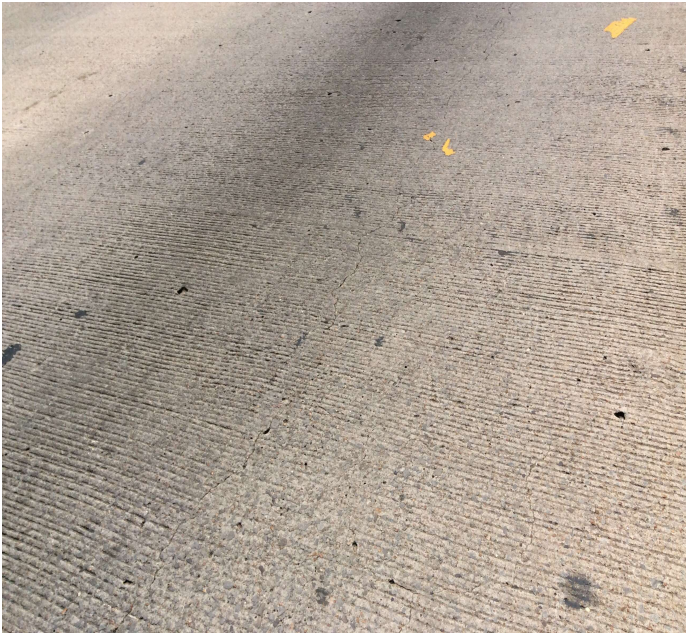
The deck has sealable longitudinal, transverse, and map cracking on the driving surface of the deck. Transverse cracks with light efflorescence are visible from the undersurface of the deck. Transverse cracks appear to correspond with the joints in the parapet walls. There are isolated areas of light abrasion on the driving surface of the deck.

PHOTO 1      Description      Longitudinal crack in Span 3.

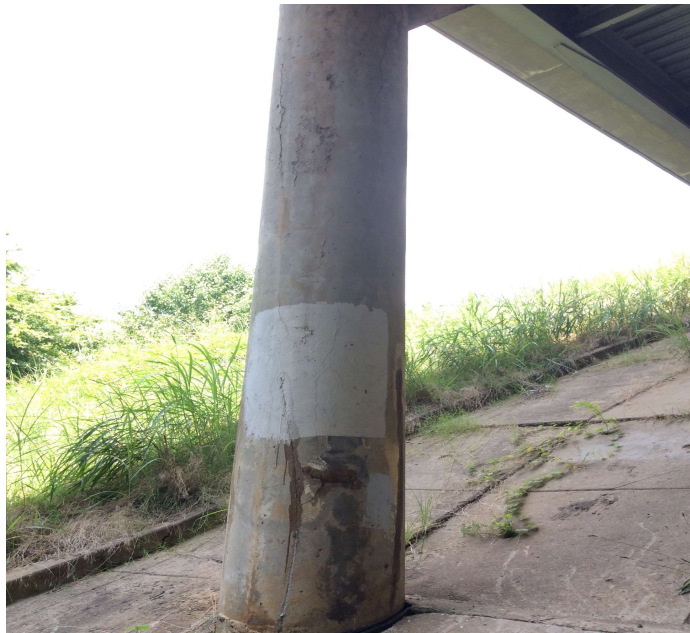
Bent # 2 columns have numerous grouted and epoxy repairs. Bent # 2, Column # 1 has medium scale visible on the exterior face of column. Bent # 2, Column # 2 has a 2' X 3" spall with exposed reinforcing steel on the Span # 2 side of column located approximately 10' above the ground. Exposed reinforcing steel appears to have active corrosion with up to approximately 1/8" section loss at this inspection. Bent # 3 columns have numerous grouted and epoxy repairs. Bent # 3, Column # 1 has heavy scale on the exterior face of column. Bent # 3, Column # 1 has two vertical cracks approximately 3' long located below the cap in the Span # 3 side of column and one full height crack in the Span # 2 side of column.

PHOTO 1      Description      Bent 3, Column1 patched area

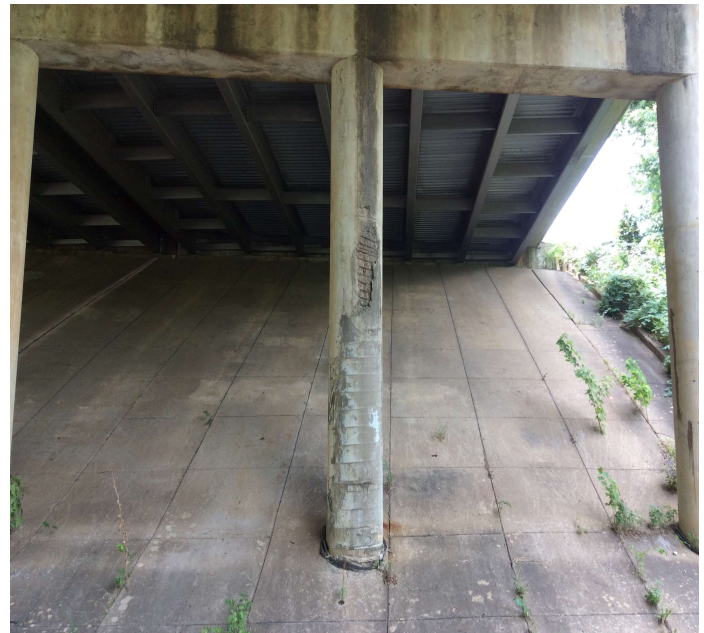
PHOTO 2      Description      Bent 2, Column 2.

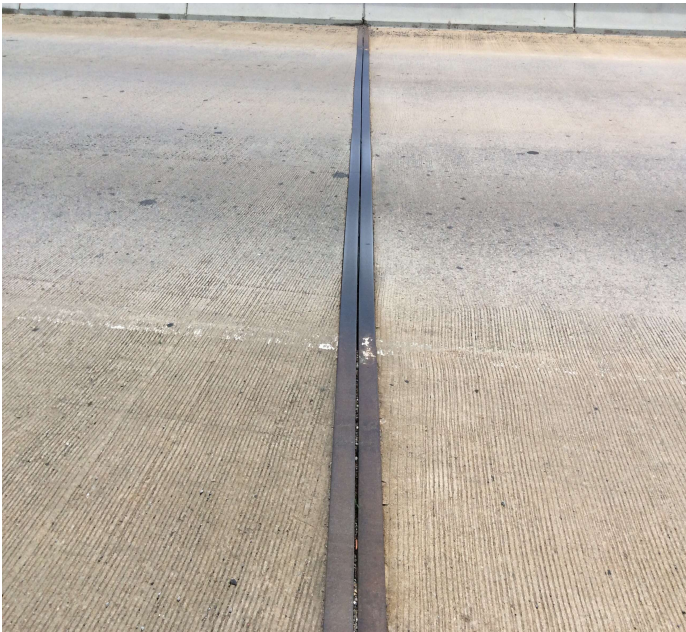
Deck joint seals are deteriorated and partially missing over the intermediate bent caps. Deck joint seals over the abutments are torn and deteriorated.

PHOTO 1      Description      Expansion joint seal over Bent 2.

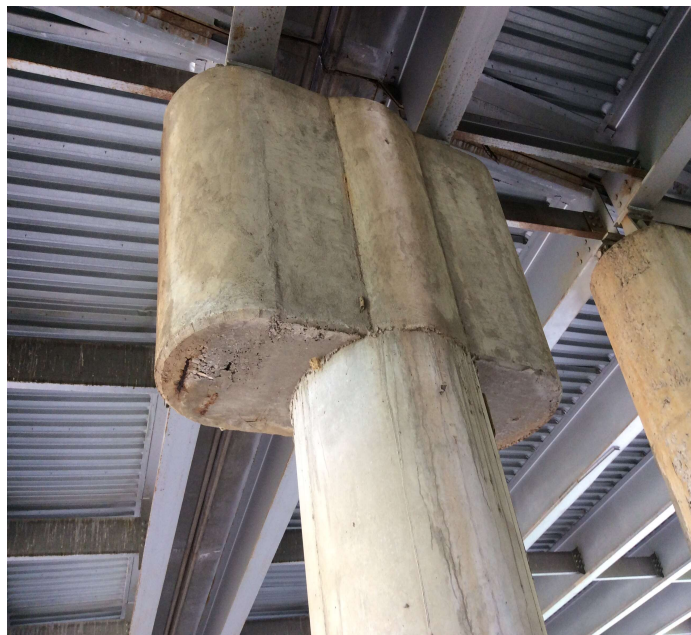
Bent caps have up to medium scale with areas of concrete deterioration where water leaks through the deck joint seals onto the bent caps. Bent # 2 cap, Span # 1 side has a 15' long horizontal crack located approximately 4" below the top of cap. Bent # 2 cap, Span # 2 side has a 25' long crack located approximately 6" below the top of cap. Bent # 3 cap, Span # 2 side of cap has a 3' long horizontal crack under Bay # 2 located approximately 4" below the top of cap. Bent # 3 cap, Span # 3 side has a 4' horizontal crack under Bay # 2 located approximately 4" below the top of cap. Bent # 3 cap has two 6" spalls with exposed reinforcing steel located 3' from the Left end of cap. Bent # 3 center cap located over Column # 4 has one 6" spall with exposed reinforcing steel and one 12" spall with exposed reinforcing steel. Exposed reinforcing steel has active corrosion with initial section loss at this inspection.

PHOTO 1 Description Bent 3, center cap under centerline median of highway.

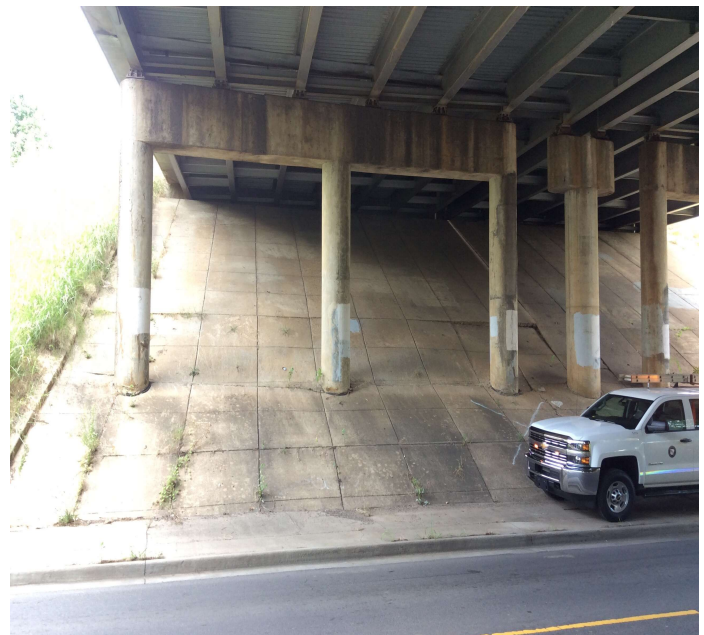
PHOTO 2 Description Bent 3. Typical

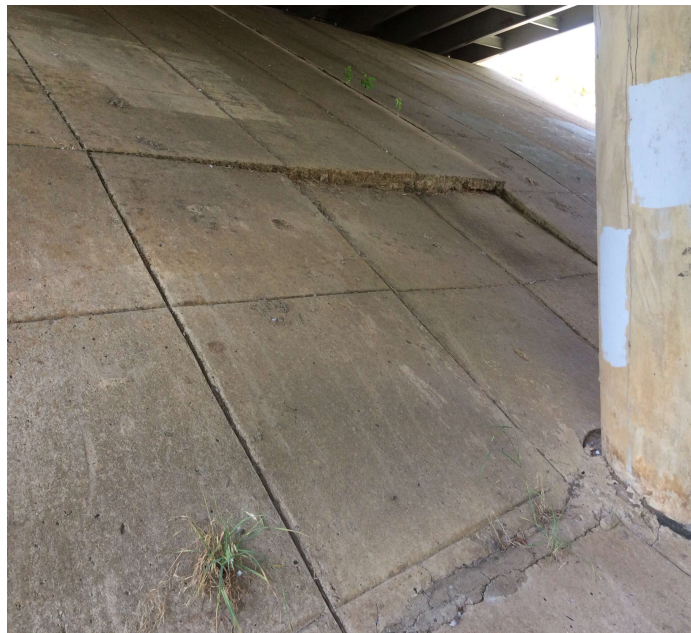
Concrete riprap has settlement under Spans # 1 & 3.

PHOTO 1      Description      Concrete riprap under Span 3.

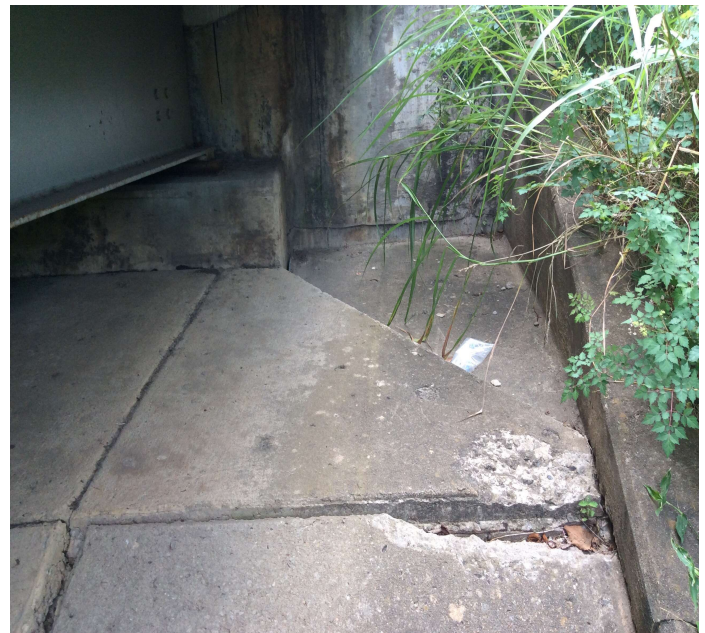
PHOTO 2      Description      Concrete riprap adjacent to Bent 1.
