# Bridge Inspection Report

**A6879**  
**I-540 SB Lanes**  
**over**  
**Clayton Branch-Sebastian**

## Bridge Inspection Report

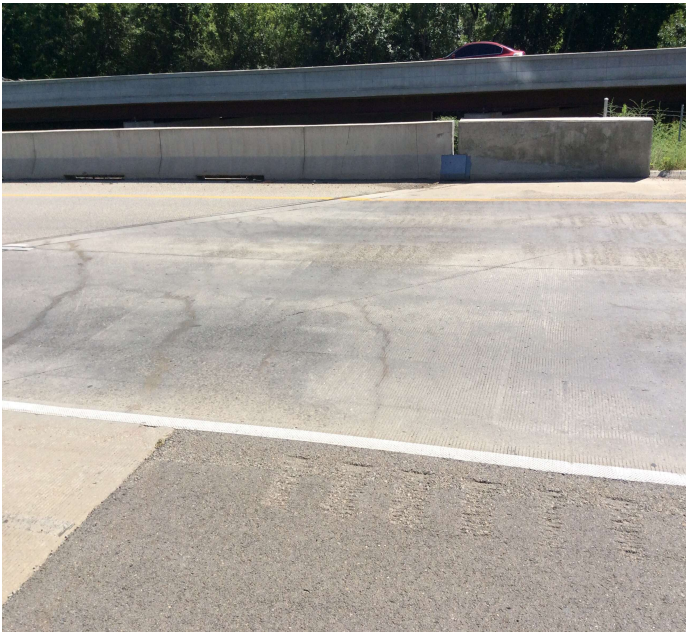
The approach slabs have numerous transverse and diagonal cracks that have been sealed in the past. There are additional cracks that are sealable.

PHOTO 1    Description    South approach slab.

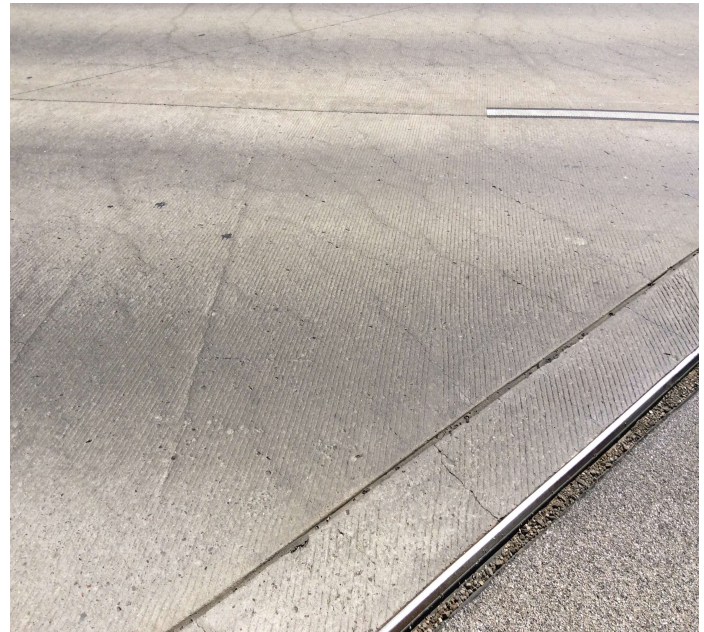
PHOTO 2    Description    North approach slab.
