Bridge Inspection Report

A6881
I 540 SB-Crawford
over
Union Pacific Rail Road

Structure Number: A6881

03/06/2018 - EJW - Routine Inspection conducted on this date. Underclearance verified with no change since the last inspection.

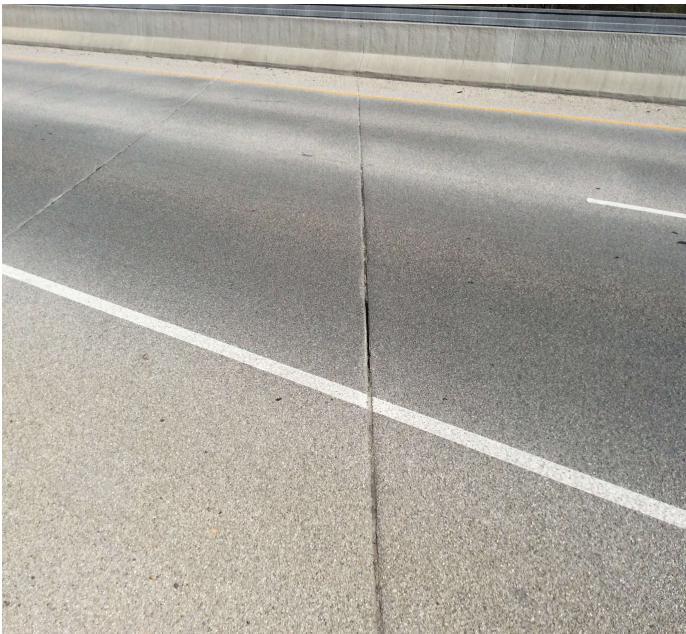
The poured joint material in the sawn joints over the intermediate bents is missing in locations.

PHOTO 1 Description Saw joint sealant deterioration.
