Bridge Inspection Report

B5096
I 540-SEC 1, NB LN
over
Boston St. Seb. Co.

Structure Number: B5096

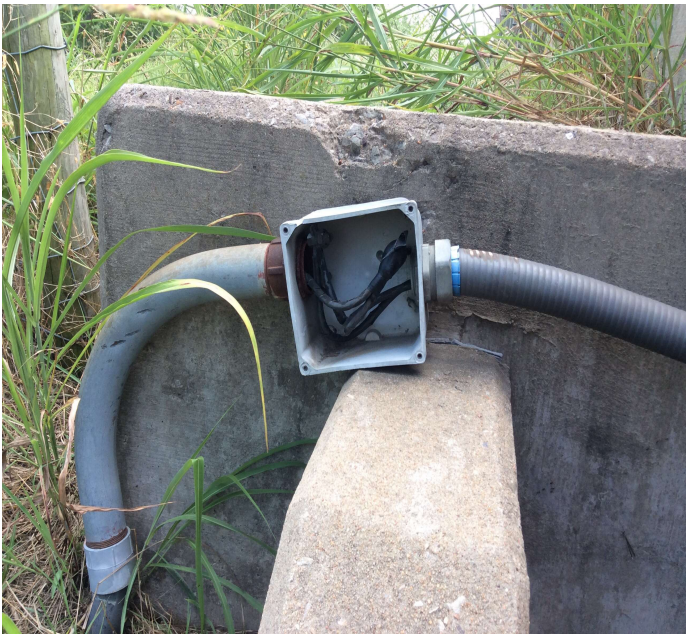
Utility junction boxes on the right side of structure at the north and south bridge ends -

The covers to the utility junction boxes on the right side of structure at the north and south bridge ends are not in place exposing the electrical wire.

PHOTO 1 Description Bent 1 Right, utility box cover missing.

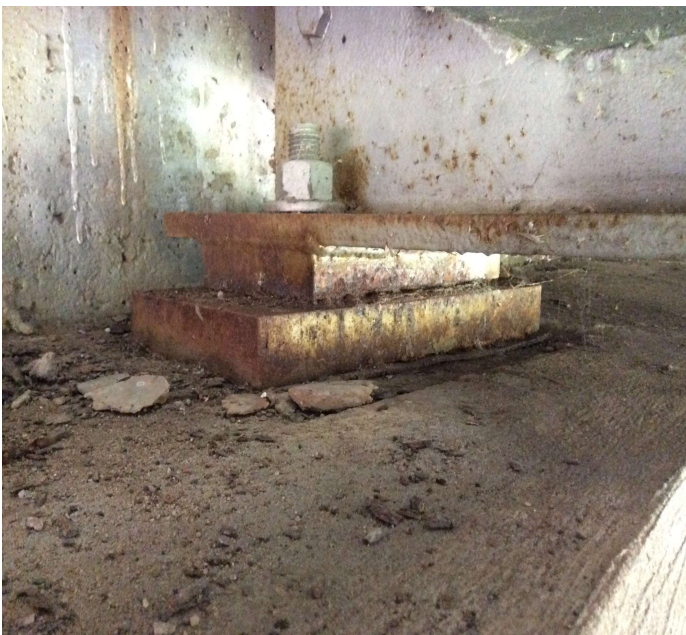
The bearings have a failing paint system with areas of active corrosion.

PHOTO 1 Description Bent 1 beam 6Active corrosion with flaking rust in bearing device.

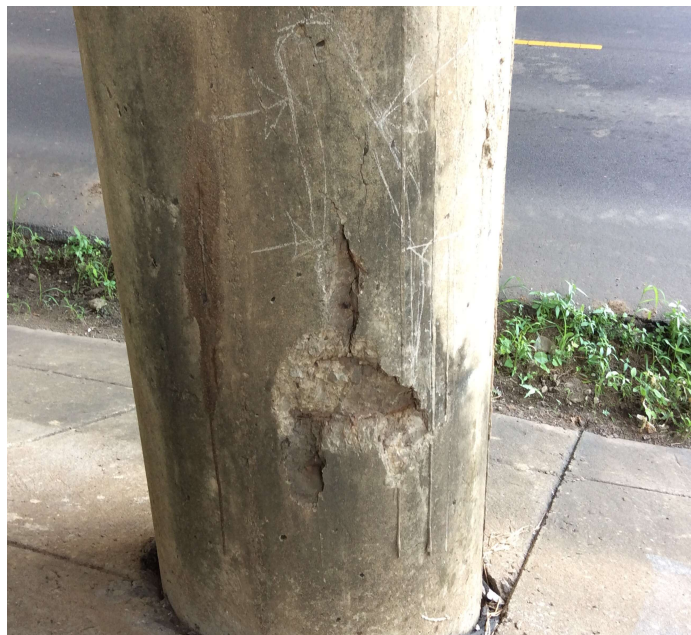
The caps and columns have delaminated areas and areas of shallow spalling that expose reinforcing steel.

PHOTO 1 Description Bent 2 column 3, spalling with exposed reinforcing steel and delaminated areas.

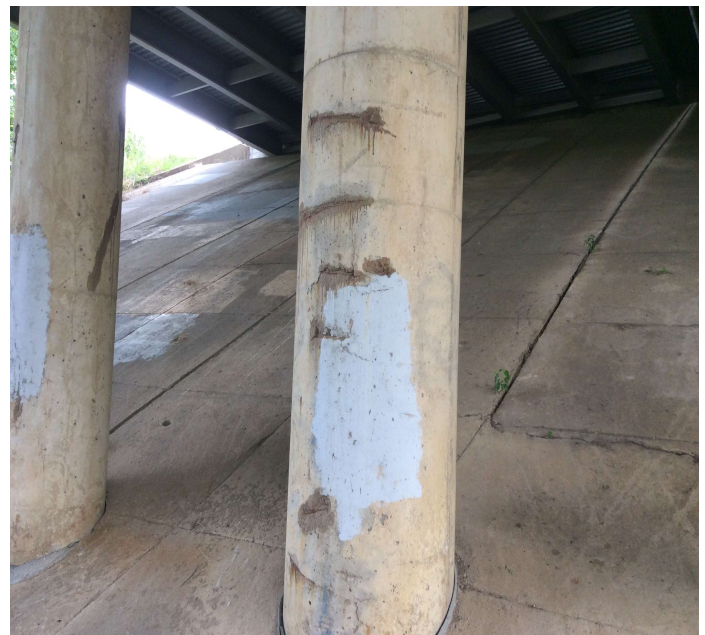
PHOTO 2 Description Bent 2 center column, spalling with exposed reinforcing steel.

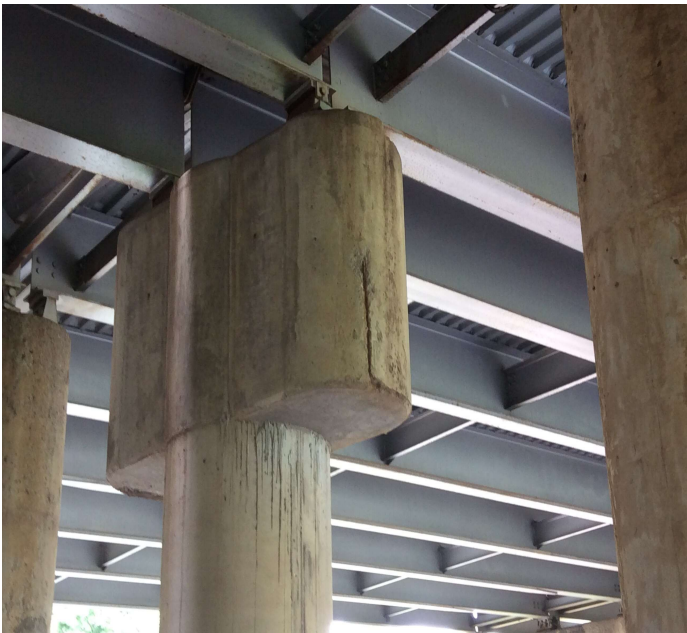
PHOTO 3	Description	Bent 2 center cap under beam 1 has an area of spalling with exposed reinforcing steel.
---------	-------------	----------------------------------------------------------------------------------------

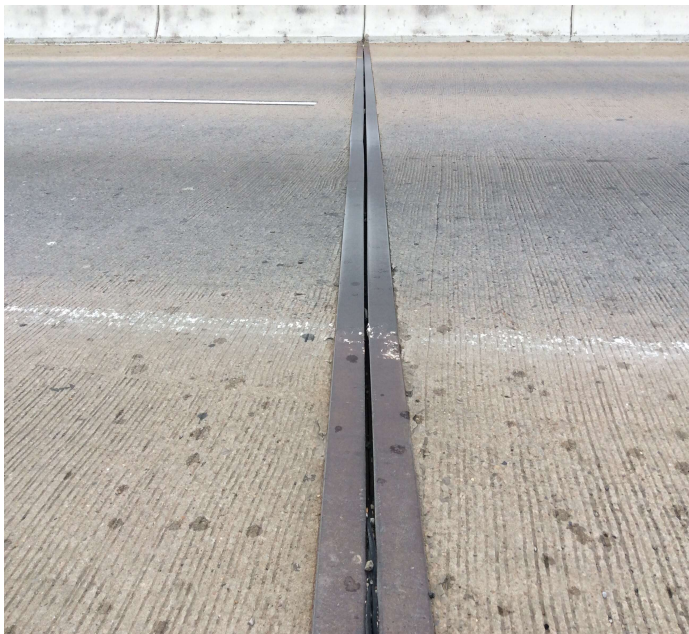
The expansion joint compression seals have deteriorated at all expansion joints and are beginning to come apart in locations. The failing expansion joint seals are allowing water, dirt and debris to leak onto the substructure. The most extreme case is at bent #2 where the majority of the compression seal is no longer in place.

PHOTO 1 Description Bent 2 compression seal deteriorated.

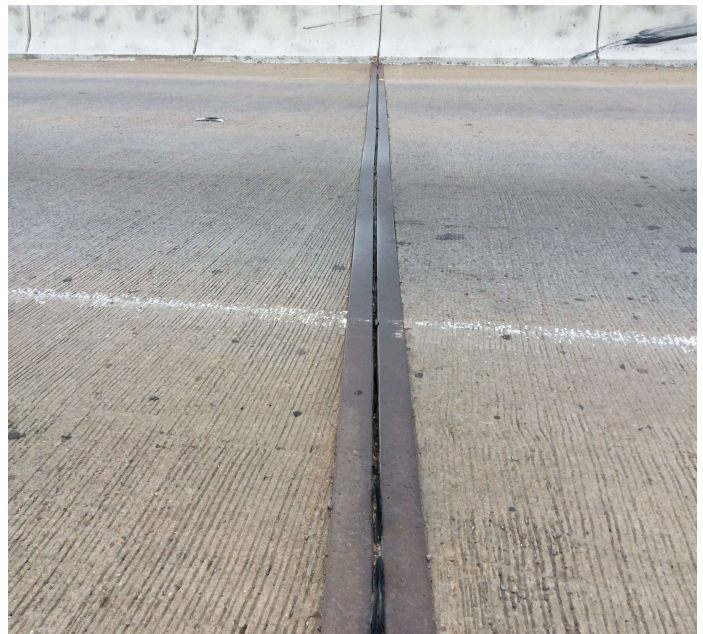
PHOTO 2 Description Bent 3 compression seal deteriorated.

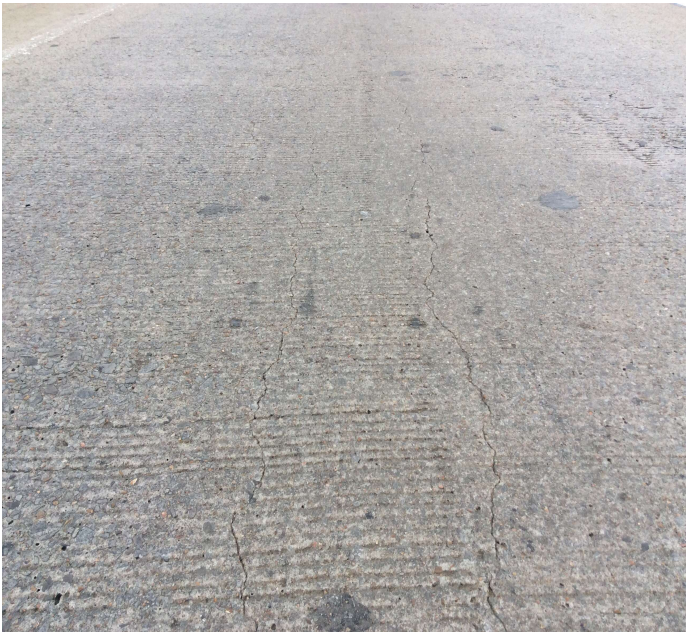
The driving surfaces of the deck and the approach slabs have sealable cracks.

PHOTO 1 Description Full length longitudinal cracking in Right lane of span 3.

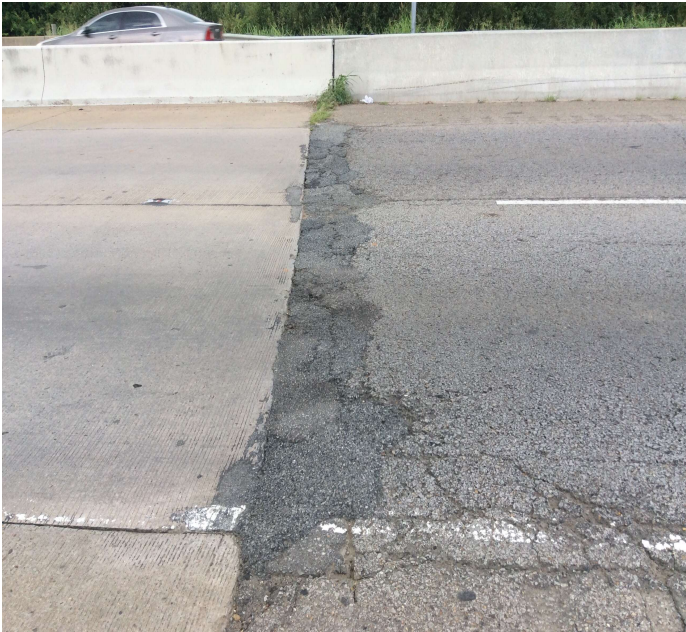
PHOTO 1 Description North approach roadway.

Repairs made to the asphalt driving surface of the north approach roadway have failed allowing large potholes to form at the juncture of the north approach slab and the approach roadway.
