Bridge Inspection Report

B6881
I-540 NB-Crawford
over
Union Pacific Rail Road

03/06/2018 - EJW - Routine Inspection conducted on this date. Underclearances verified on this date, no change since the last inspection.

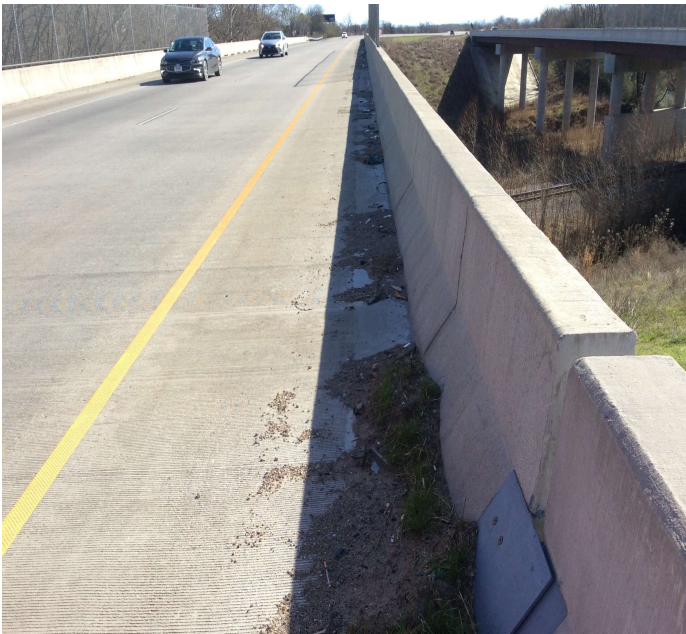
The deck gutters have sand and debris accumulation.

PHOTO 1 Description Gutters with debris accumulation.
