# Bridge Inspection Report

**05016**  
**SH 352-SEC 3**  
**over**  
**I 40-SEC 21**

IDENTIFICATION		INSPECTIONS	
(1) STATE CODE	056 - Arkansas	(90) INSPECTION DATE	02/08/2018
(8) STRUCTURE NUMBER	05016	(91) DESIGNATED INSPECTION FREQUENCY	24

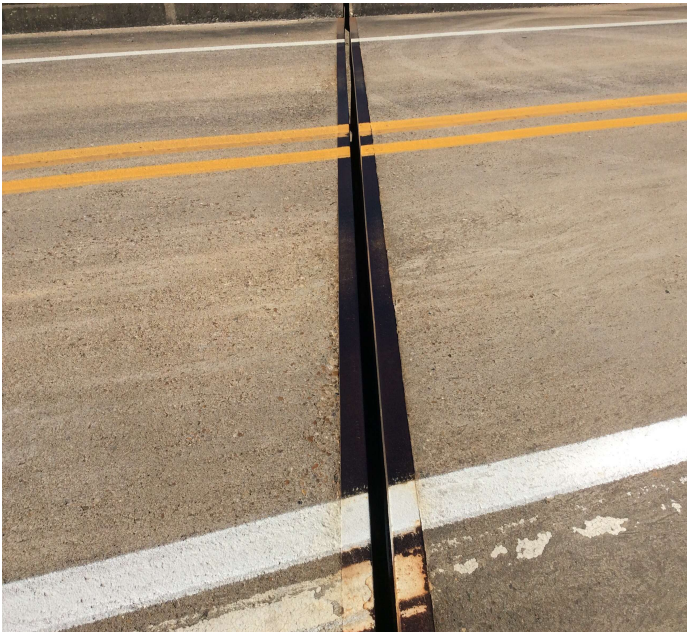
Deck, expansion joint #'s 1 & 3

Joint material is completely missing at joint # 3 and approximately 3 feet is missing from the left side of joint # 1.

PHOTO 1      Description      Joint Seal missing at Pier 3.

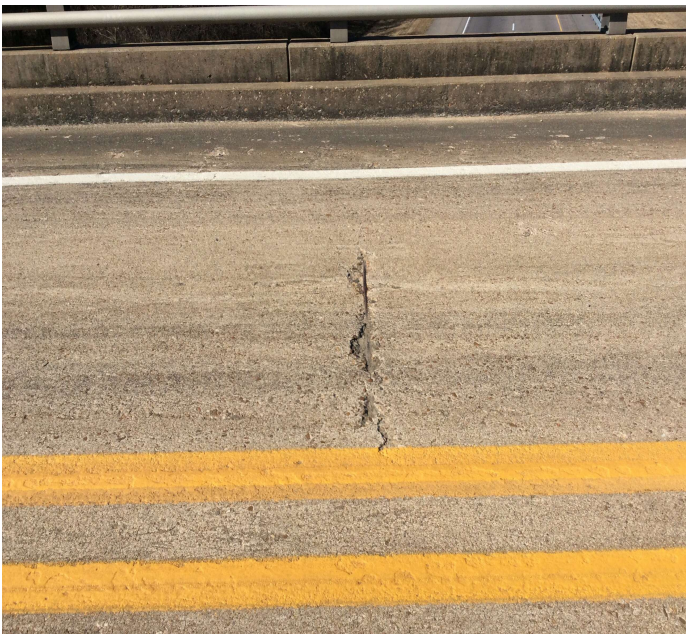
Deck, span # 3, SB lane.

Two minor spalls with rebar exposed.

PHOTO 1      Description      Typ. Delam, Cracking & Spalling W /  
Rebar Exposed in Spans 2 & 3. Rebar  
too close to Surface.

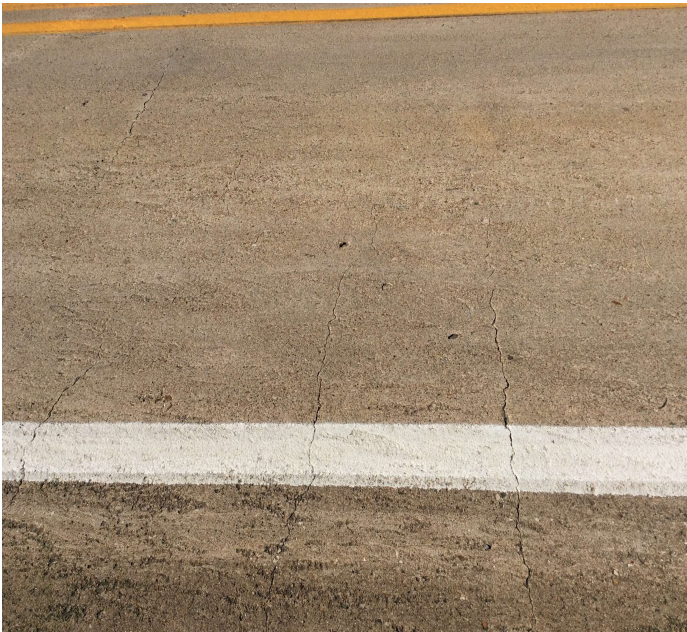
Deck, all spans  
Minor and moderate unsealed cracks.

PHOTO 1    Description    Typ. Cracking in Deck.
