Bridge Inspection Report

05017
SH 352-SEC 3
over
I 40-SEC 21

Structure Number: 05017

Facility Carried: SH 352-SEC 3

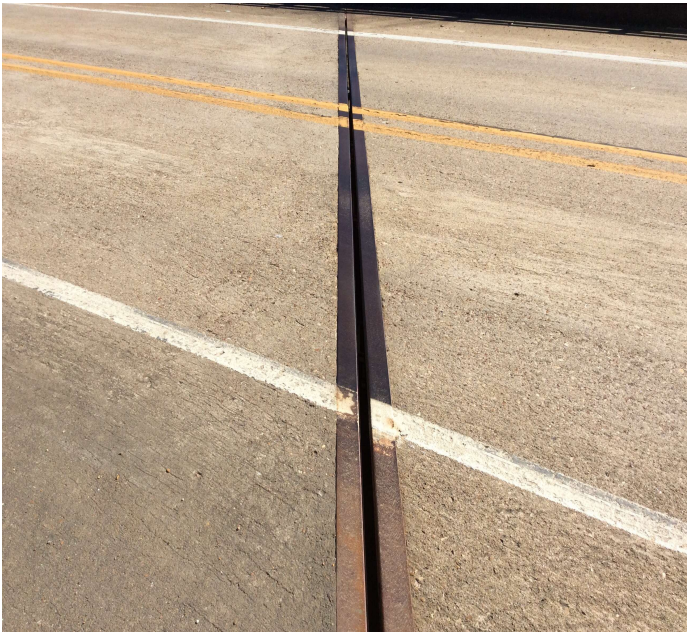
Deck joints #'s 2 & 4.
Joint material is missing.

PHOTO 1 Description Seal Failed at Joints.

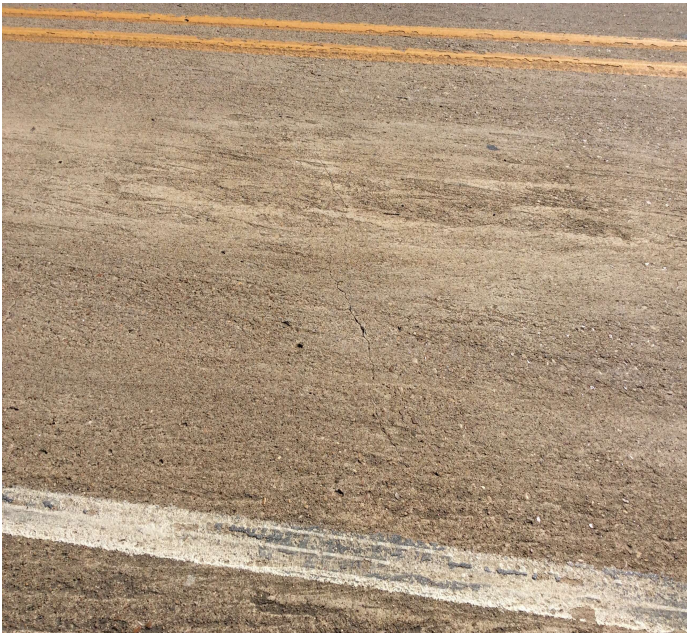
MINOR CRACKING THROUGHOUT DECK.

PHOTO 1 Description Typ. Cracking in Deck.

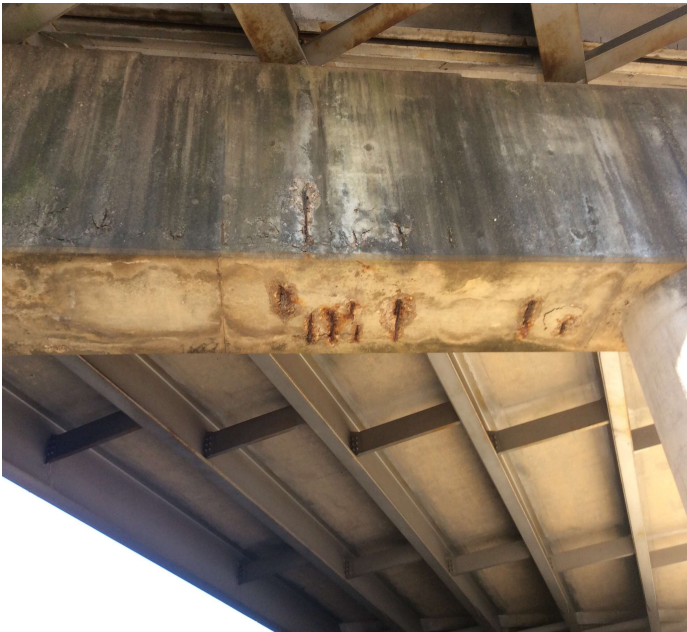
MINOR DELAM, CRACKING & SPALLING W / REBAR EXPOSED IN BK. & BT. FACES OF CAP 4. SPALLING DUE TO REBAR TOO CLOSE TO SURFACE.

PHOTO 1 Description Delam, Cracking & Spalling W / Rebar Exposed in Bk. & Bt. Faces of Cap 4. Spalling due to Rebar too close to Surface.
