# Bridge Inspection Report

**05037**  
**SH 164-SEC 0**  
**over**  
**I 40-SEC 21**

Structure Number: 05037

Facility Carried: SH 164-SEC 0

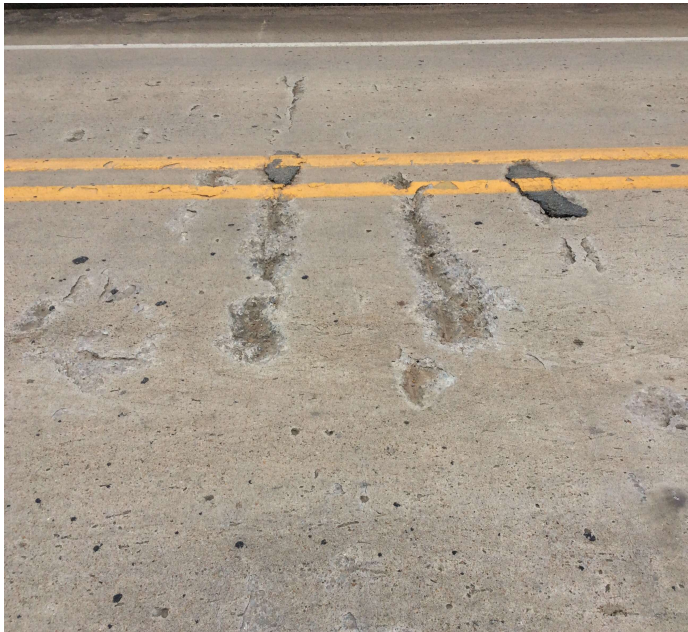
Environment	Total Quantity	Units	Condition State 1	Condition State 2	Condition State 3	Condition State 4
<b>12 - Reinforced Concrete Deck</b>	1- Ben.	10303	sq. ft.	6000	4303	0	0
	MINOR TO MODERATE DELAM, CRACKING & SCALE THROUGHOUT. MINOR SPALLING W / REBAR EXPOSED IN SPAN 3. MINOR CRACKING IN SOFFIT & OVERHANGS.						
1080 - Delamination/Spall/Patched Area		200			200		
1090 - Exposed Rebar		100			100		
1130 - Cracking (RC and Other)		3000			3000		
1190 - Abrasion/Wear (PSC/RC)		1003			1003		
<b>107 - Steel Open Girder/Beam</b>	1- Ben.	1644	ft.	1632	12	0	0
	COND. 1 - 1632 LF - GOOD. COND. 2 - 12 LF - MINOR RUST IN HAUNCHED AREAS OF BEAMS AT PIERS 2 & 4						
1000 - Corrosion		12			12		
515 - Steel Protective Coating		13354	sq. ft.	13342	12	0	0
3440 - Effectiveness (Steel Protective Coatings)		12			12		
<b>161 - Steel Pin and Pin &amp; Hanger Assembly or both</b>	1- Ben.	6	each	5	1	0	0
	COND. 1 - 5 EA - SOME MINOR RUST ON ALL PINS, BEAMS & HANGER BARS COND. 2 - 1 EA - MINOR TO MODERATE RUST & PACK RUST BETWEEN PLATES & BEAM ON BEAM 6 BOTTOM PIN. ALL PINS ULTRA SOUNDED.

MINOR DELAM, CRACKING, SCALING & SPALLING THROUGHOUT DECK. SPALLING W / REBAR EXPOSED IN SPAN 3.

PHOTO 1      Description      Typ. Delam, Cracking, Scaling & Spalling W / Rebar Exposed in Deck. Mainly in Span 3.

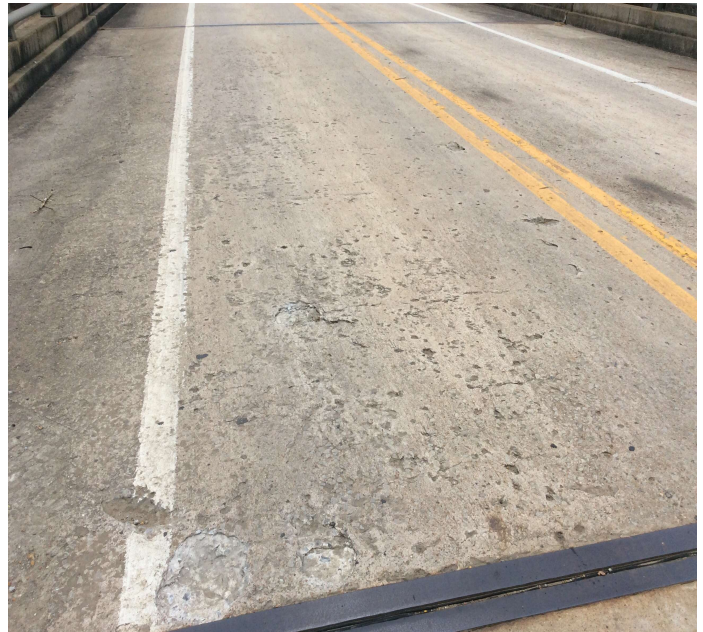
PHOTO 2      Description      Typ. Delam, Cracking, Scaling & Spalling in Deck.

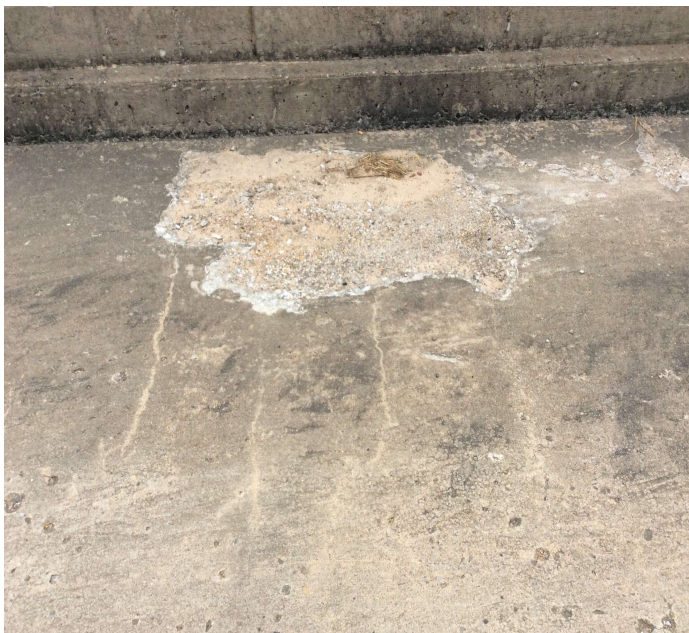
PHOTO 3    Description    Cracking & Scaling in Gutters.

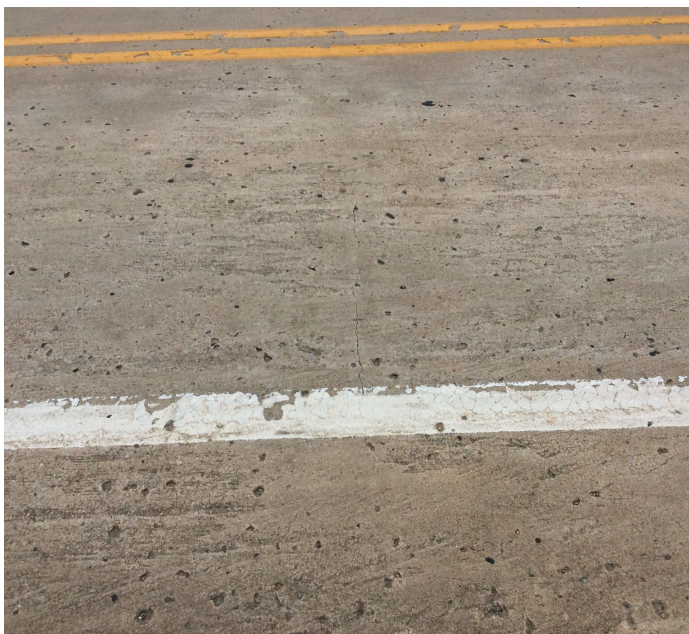
PHOTO 4    Description    Typ. Cracking in Deck.

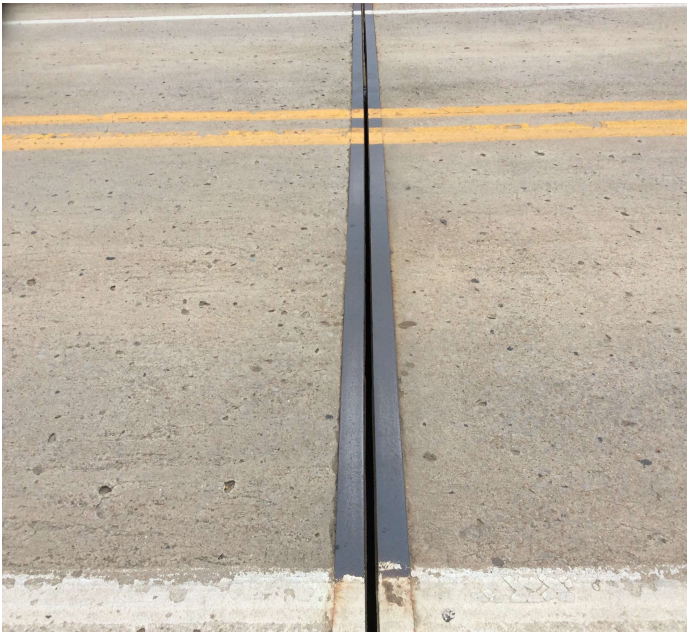
1130 - Cracking (RC and Other)		20			20		
<b>302 - Compression Joint Seal</b>	1- Ben.	170	ft.	0	92	10	68
	COND. 2 - 92 LF - MINOR TO MODERATE DELAM & CRACKING IN SEALS AT JOINTS 1 & 5 COND. 3 - 10 LF - MINOR TO MODERATE DELAM, CRACKING & TEARING IN SEAL AT JOINT 3. COND. 4 - 68 LF - SEALS MISSING AT JOINTS 2 & 4						
2330 - Seal Damage		170			92	10	68
<b>311 - Movable Bearing</b>	1- Ben.	18	each	8	6	4	0
	COND. 1 - 8 EA - GOOD COND. 2 - 6 EA - MINOR RUST ON BEARINGS AT PIER 2. COND. 3 - 4 EA - MINOR TO MODERATE RUST & PACK RUST ON BEARINGS AT PIER 4. BEARING 3 BK. SIDE, BEARINGS 2, 3 & 5 AHD. SIDE.						
1000 - Corrosion		10			6	4	
515 - Steel Protective Coating		72	sq. ft.	32		24	16
<b>313 - Fixed Bearing</b>	1- Ben.	24	each	14	10	0	0
	COND. 1 - 14 EA - GOOD. COND. 2 - 10 EA - MINOR TO MODERATE RUST ON SOME BEARINGS AT ABUTMENTS 1 & 5 AND PIER 2.						
1000 - Corrosion		10			10		
515 - Steel Protective Coating		96	sq. ft.	56		40

Deck joints at joint #s 2 and 4  
Joint material is missing.

PHOTO 1    Description    Seals Missing at Joints.

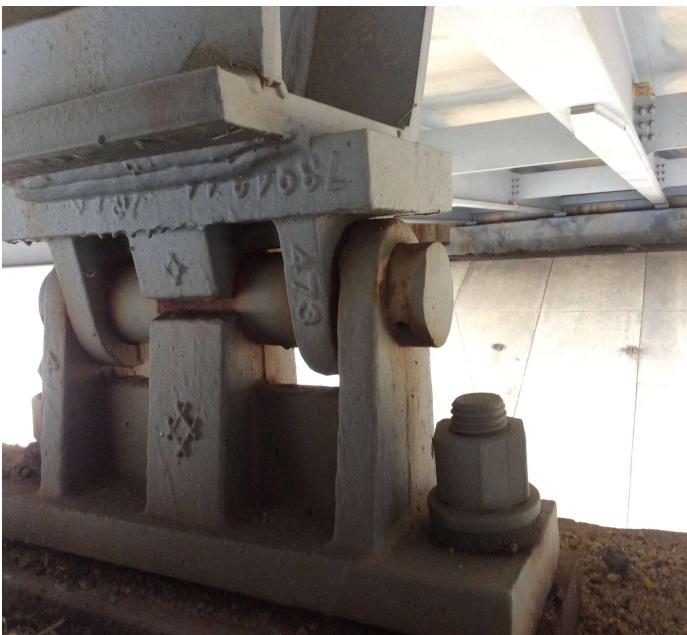
Bearing # 4, aheadside of pier # 4.  
Shear key is missing from right side of bearing pin,

PHOTO 1      Description      Shear key missing from Rt. Side of bearing pin at bearing 4 Ahd. Side pier 4.

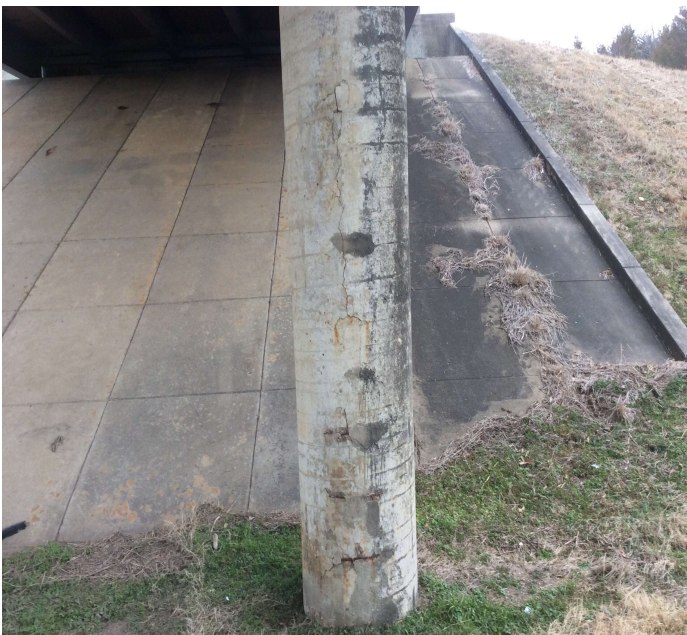
1000 - Corrosion		1			1		
515 - Steel Protective Coating		24	sq. ft.	23		1	
<b>205 - Reinforced Concrete Column</b>	1- Ben.	6	each	4	2	0	0
	COND. 1 - 4 EA - GOOD COND. 2 - 2 EA - MINOR TO MODERATE DELAM, CRACKING & SPALLING W / REBAR EXPOSED IN COLUMN 1 AT PIER 3 & COLUMN 2 AT PIER 4. SPALLING DUE TO REBAR TOO CLOSE TO SURFACE.						
1090 - Exposed Rebar		2			2		
<b>215 - Reinforced Concrete Abutment</b>	1- Ben.	90	ft.	90			
	MINOR VERTICAL CRACKING IN THE BACK WALLS.						
<b>234 - Reinforced Concrete Pier Cap</b>	1- Ben.	106	ft.	82	24	0	0
	COND. 1 - 90 LF - MINOR VERTICAL CRACKING THROUGHOUT COND. 2 - 24 LF - MINOR TO MODERATE DELAM, HORIZONTAL CRACKING & SCALE IN CAPS 3 & 4. MINOR DELAM, CRACKING, SCALE & SPALLING W / REBAR EXPOSED IN BK. FACES OF CAPS 2 & 4						
1090 - Exposed Rebar		4			4

MINOR DELAM, CRACKING & SPALLING W / REBAR EXPOSED IN COLUMN 1 AT PIER 3 & COLUMN 2 AT PIER 4.  
SPALLING DUE TO REBAR TOO CLOSE TO SURFACE.

PHOTO 1      Description      Delam, Cracking, Scaling & Spalling  
W / Rebar Exposed in Column 2 at Pier  
4.

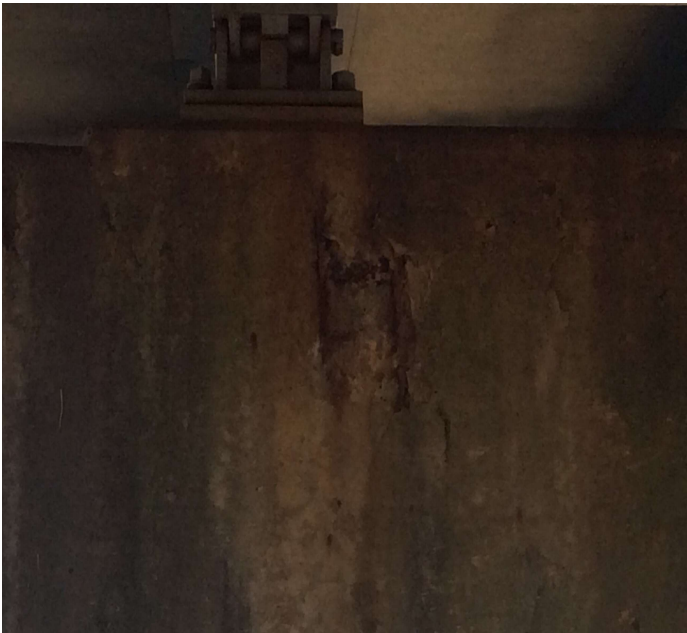
PHOTO 1    Description

MINOR DELAM, CRACKING & SPALLING W / REBAR EXPOSED IN BK. FACE OF CAP 2 & BT FACE OF CAP 4.
