Bridge Inspection Report

A5038
I 40, WB LNS
over
Dirty Creek

Structure Number: A5038

Facility Carried: I 40, WB LNS

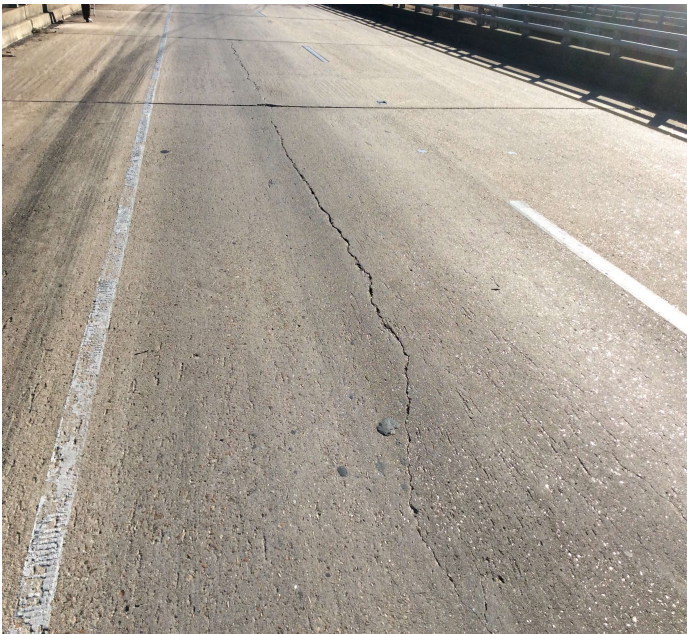
Bridge deck, All spans
Major unsealed longitudinal crack.
Picture included.

PHOTO 1 Description Typ Long Cracking in all .Spans

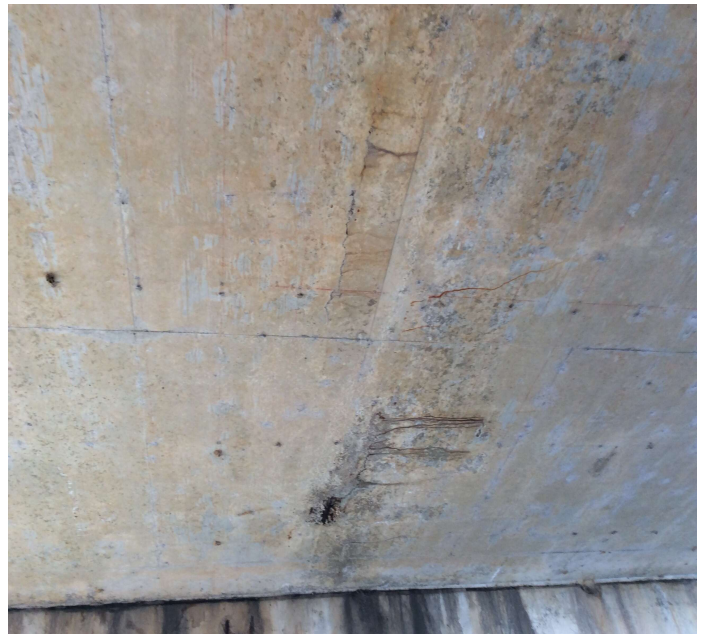
PHOTO 2 Description Cracking & Spalling W / Rebar Exposed
in Soffit unde Long Cracks in Deck.

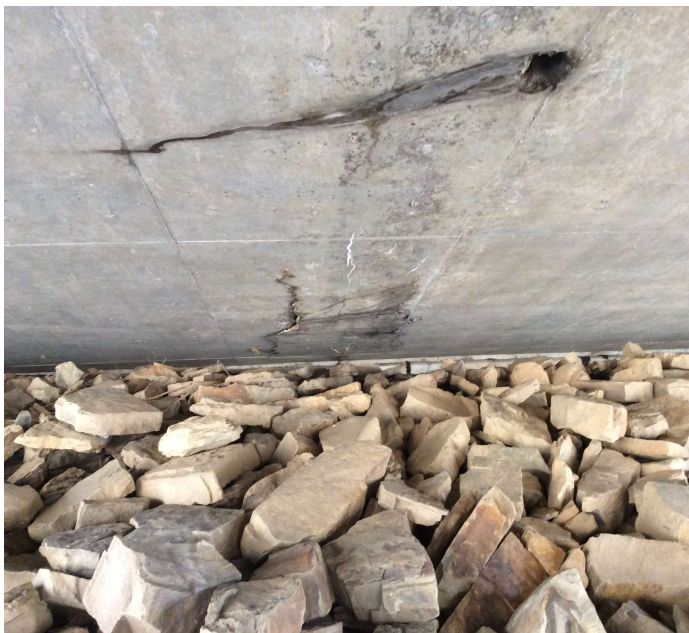
PHOTO 3 Description Typ. Delam & Cracking in Soffit under Long Cracks in Deck.

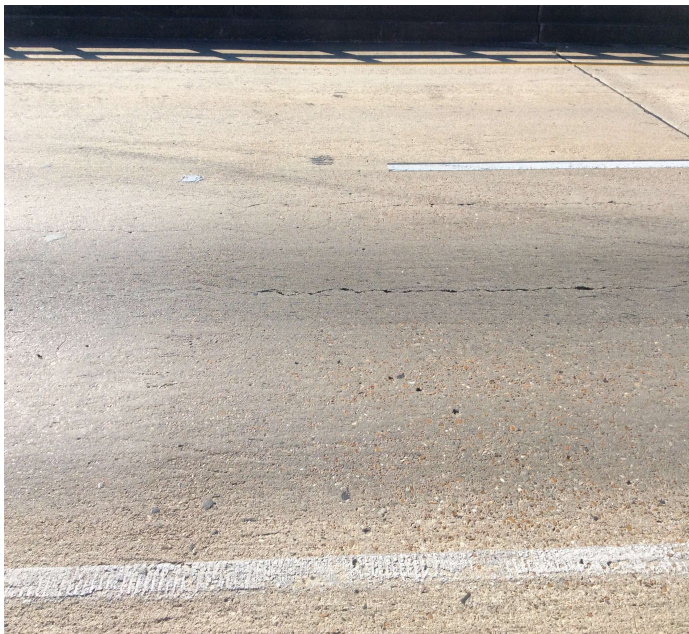
PHOTO 4 Description Typ. Cracking in Deck.

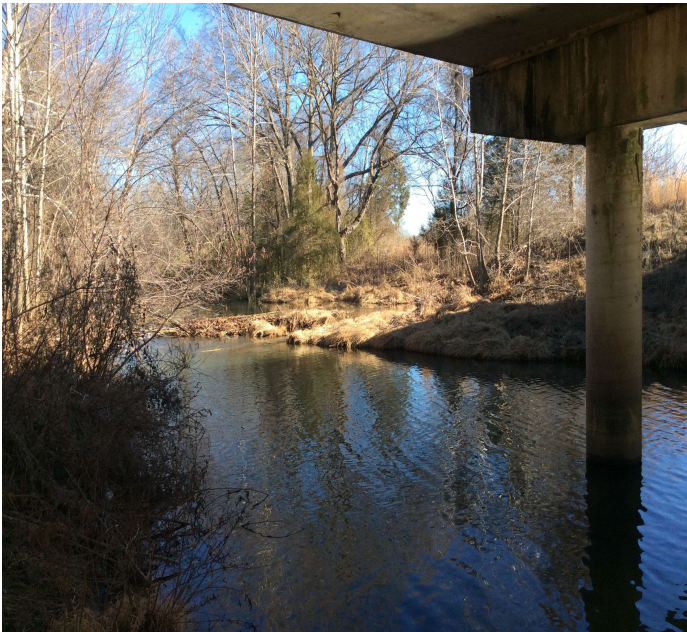
MINOR TO MODERATE BRUSH, VEG, SILT & SMALL BEAVER DAM IN CHANNEL BLOCKING FLOW ON LT. (UP) SIDE.

PHOTO 1 Description Brush, Veg. & Silt in Channel Blocking Flow on Lt. (Up) Side.
