Bridge Inspection Report

B5038
I-40, EB LNS
over
Dirty Creek

Structure Number: B5038

Facility Carried: I-40, EB LNS

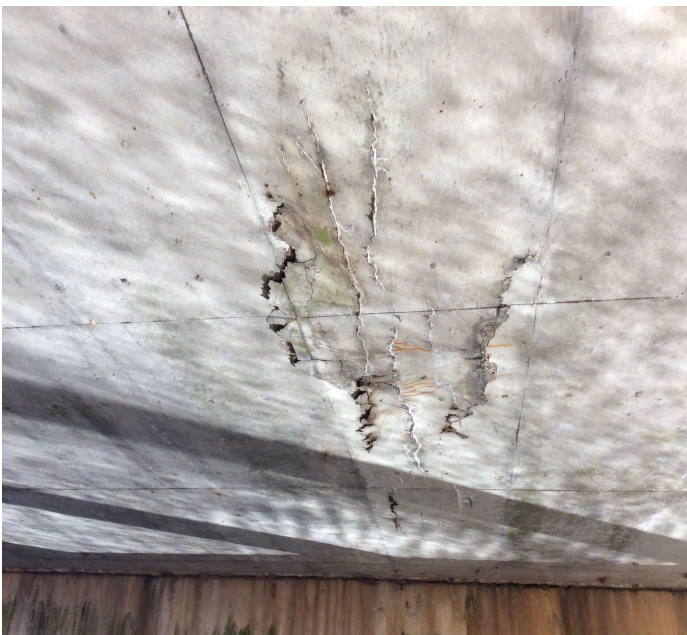
Underside of deck slab, All spans.

Major longitudinal cracking. Also major delamination in span # 1 near abutment # 1.

PHOTO 1 Description Typ. Delam & Cracking in Soffit under
Long Cracks in Deck.

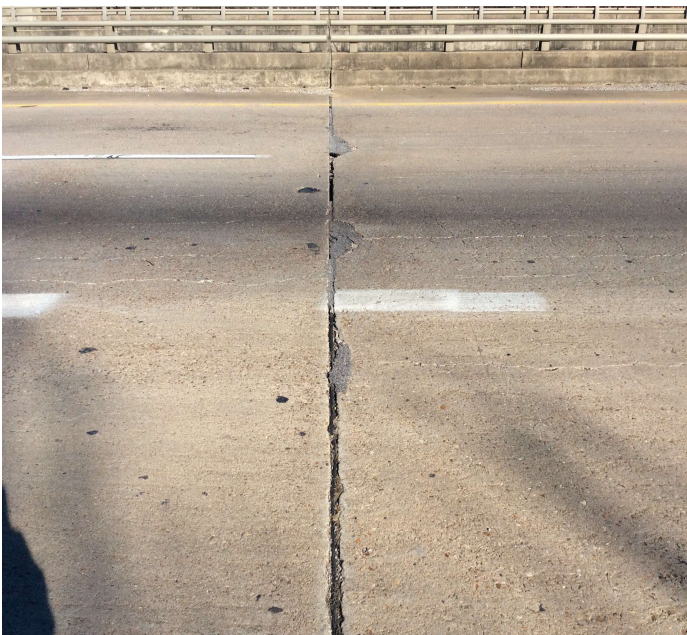
Span # 3, just ahead of joint # 3.
Moderate spalling.

PHOTO 1 Description Typ. Condition of Joints.

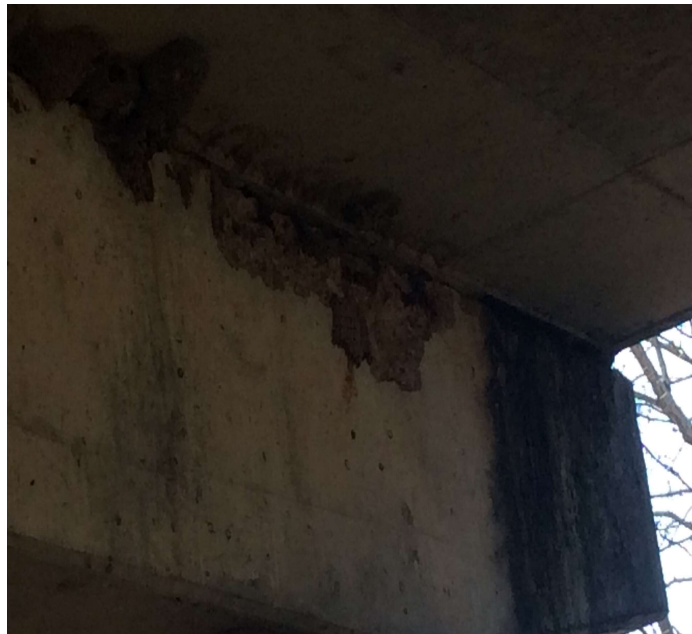
Left end of cap 4
major cracking and delamination.
Minor delam, cracking & spalling in Bk. Face of cap 4 above column 3

PHOTO 1 Description Minor Delam & Spalling in Bk. Face
Cap 4 above Column 3.

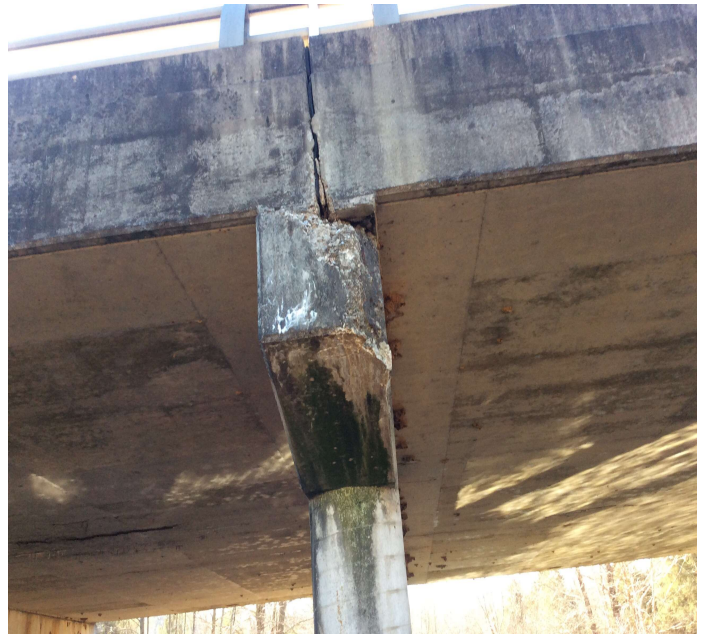
PHOTO 2 Description Delam, Cracking & Spalling in Lt. End
of Cap 4 Bk. Side.

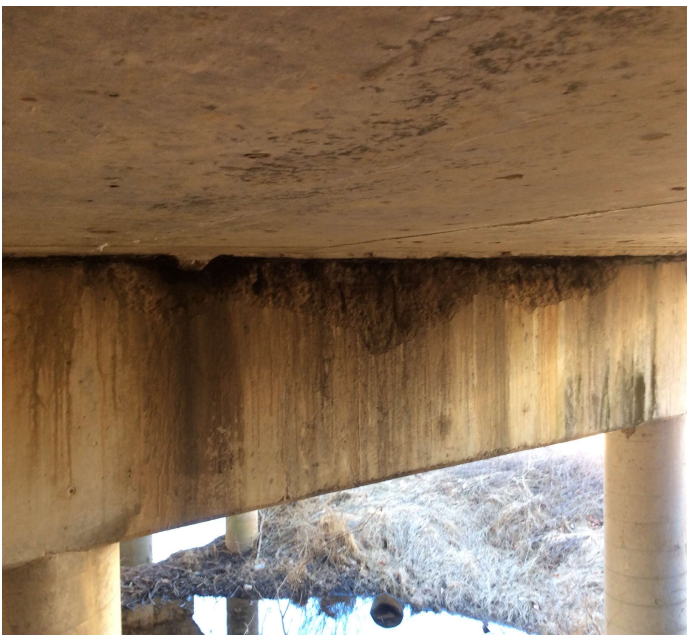
Aheadside of cap at pier # 5.
Spalling with rebar exposed.

PHOTO 1 Description Delam, Cracking & Spalling W / Rebar
Exposed in Ahd. Face of Cap 5.

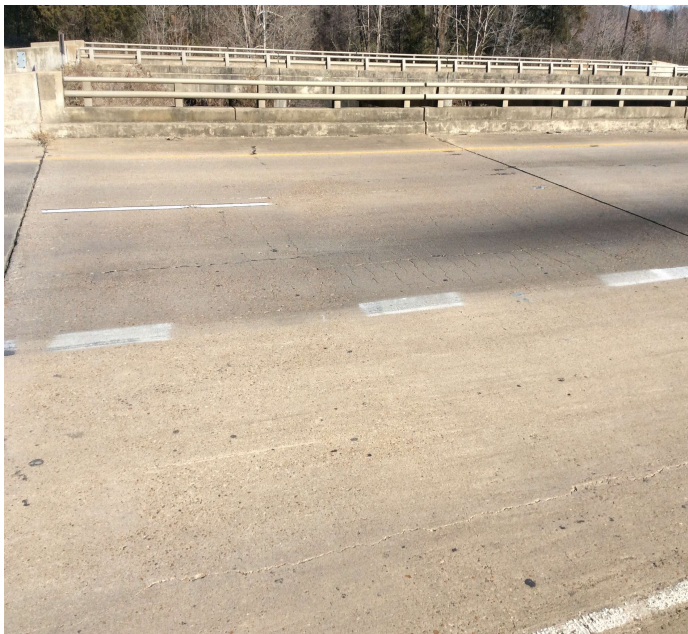
Bridge deck; All spans

Major unsealed longitudinal cracking. Also some transverse cracking,

PHOTO 1 Description Typ. Condition of Deck.

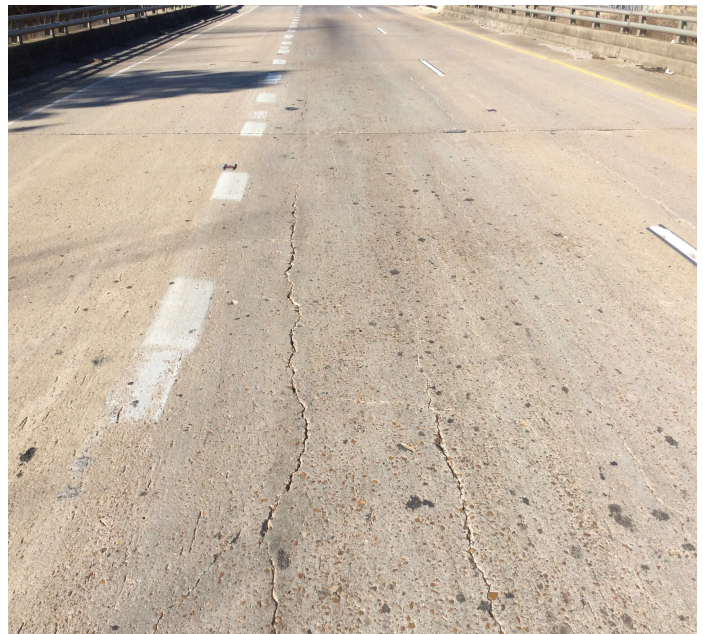
PHOTO 2 Description Typ. Long Cracking in all Spans.

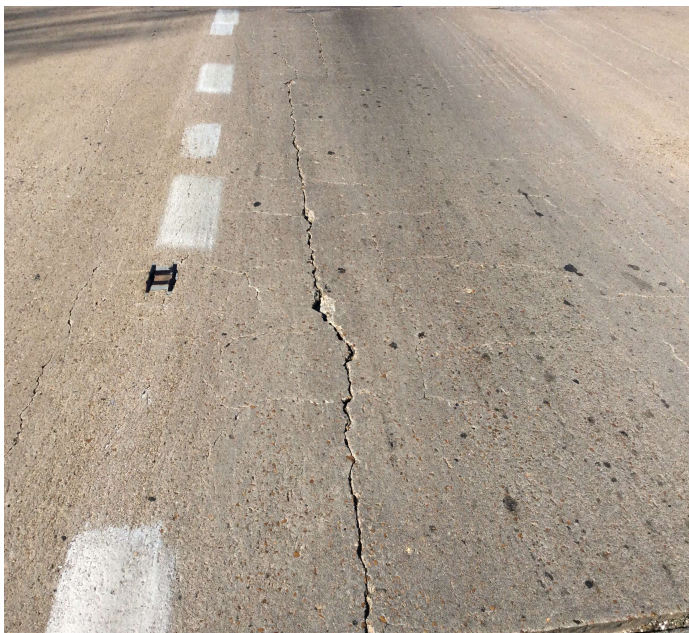
PHOTO 3 Description Typ. Long Cracking in Deck.

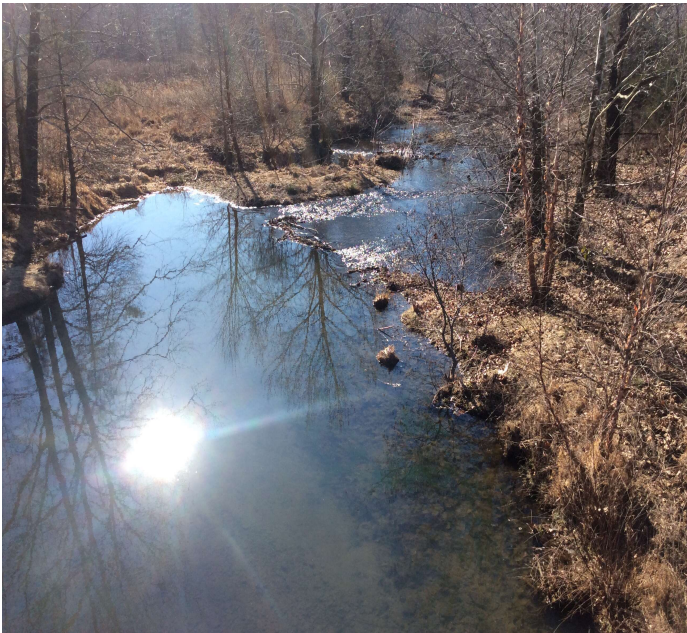
MINOR BRUSH, VEG. SILT & SMALL BEAVER DAM IN CHANNEL BLOCKING FLOW ON RT. (DN) SIDE.

PHOTO 1 Description Brush, Veg, Silt & Small Beaver Dam in Channel Blocking on Rt. (Dn) Side.
