Bridge Inspection Report

A5039

I-40-SEC 21-WB LNS

Middle Fk Horsehead Cr.

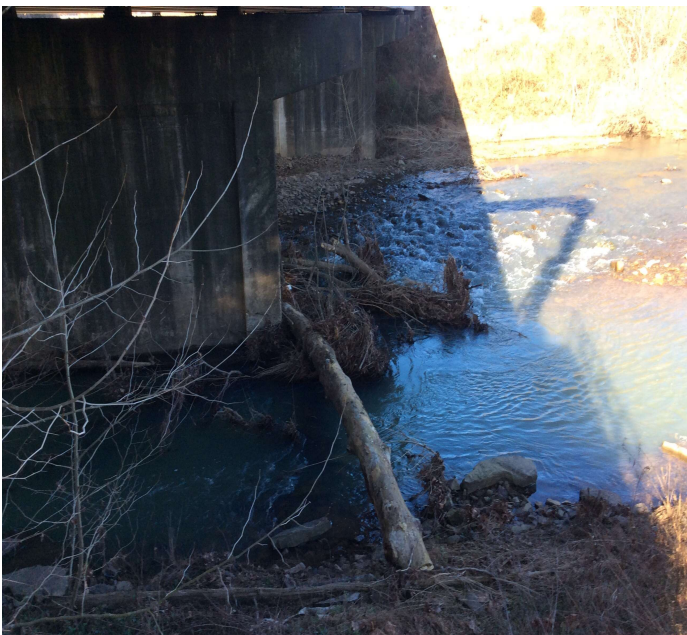
Drift at upstream side of pier # 3.

PHOTO 1 Description Drift at Pier 3.

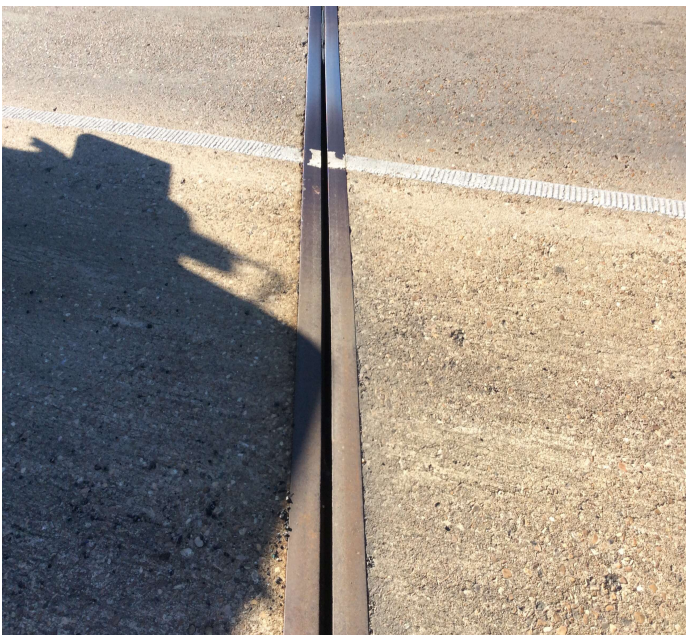
Deck joint #s 1, 2 & 3.
A portion of joint material is missing at these joints.

PHOTO 1 Description Joint Seals missing

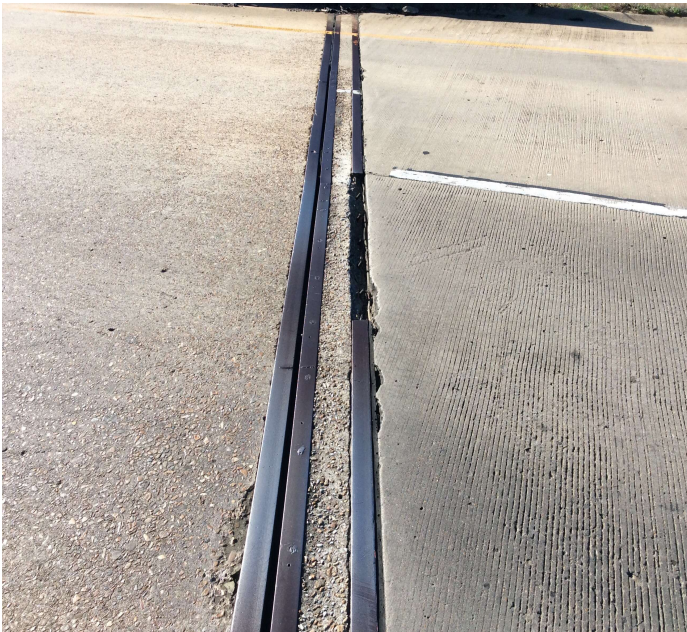
Abutment # 1, joint at headwall.

The right end of the joint armor in the left lane is slightly loose.

PHOTO 1 Description Joint Armor missing at Abutment 1.

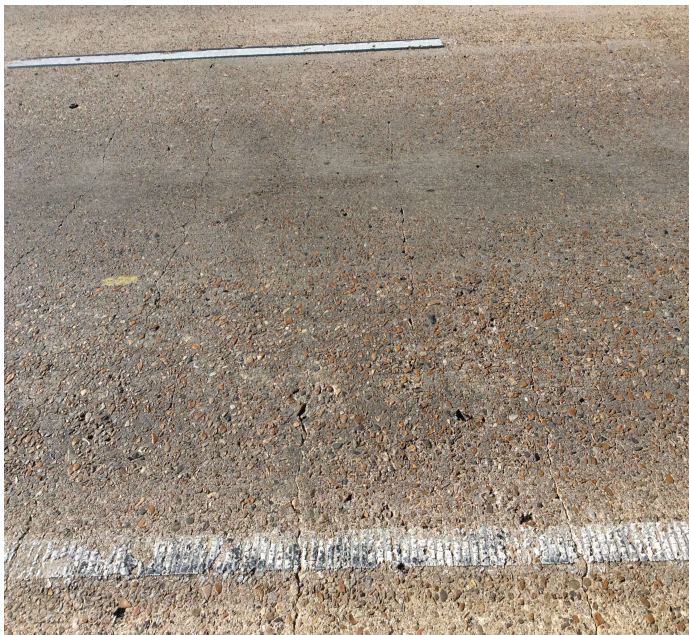
MINOR TO MODERATE CRACKING THROUGHOUT DECK.

PHOTO 1 Description Typ. Cracking in Deck.

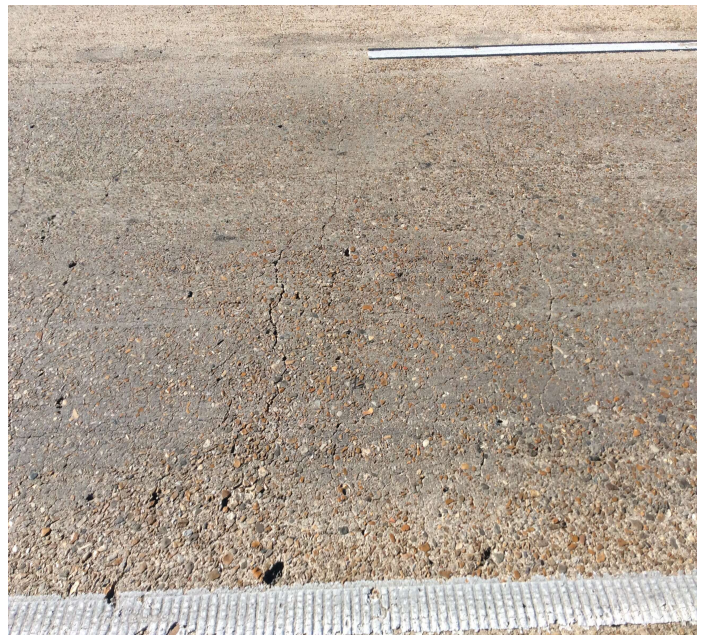
PHOTO 2 Description Typ. Cracking in Deck.
