# Bridge Inspection Report

**B5039**  
**I-40-SEC 21-EB LNS**  
**over**  
**Middle Fk Horsehead Cr.**

Structure Number: B5039

Facility Carried: I-40-SEC 21-EB LNS

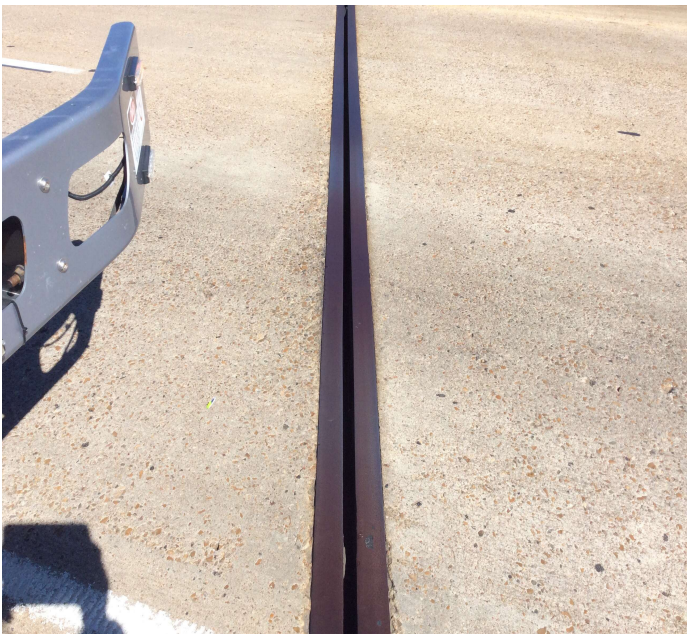
Deck joint #s 1 & 2 & 3

Joint # 1 approx. 90% of joint material is missing.

Joint # 2 all of joint material is missing.

Joint # 3 all of joint material is missing.

PHOTO 1      Description      Seals Failed at Joints.

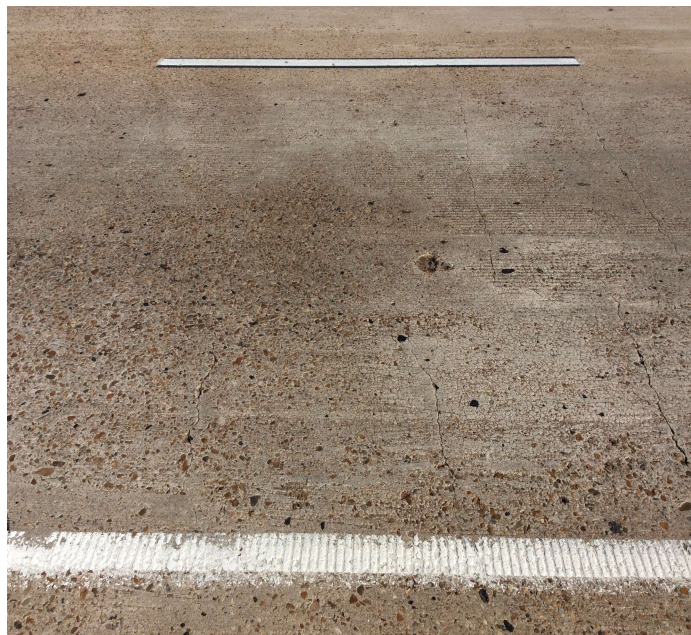
Moderate unsealed cracks. Most of cracks are transverse. Minor Spalling at Joints.

PHOTO 1      Description      Typ. Cracking in Deck.

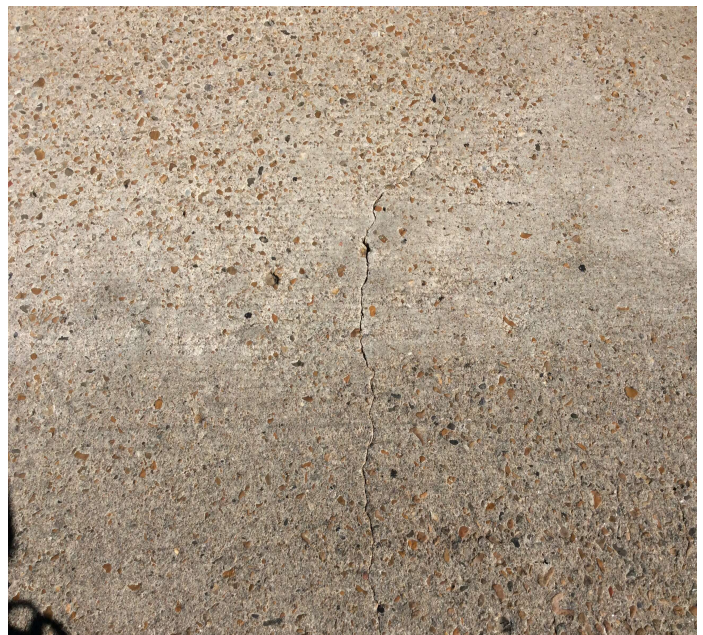
PHOTO 2      Description      Typ. Cracking in Deck.

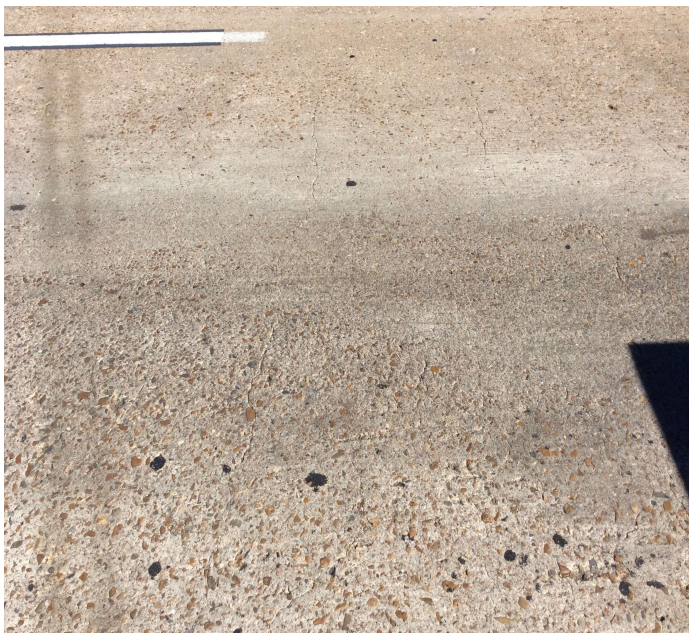
PHOTO 3      Description      Typ. Cracking in Deck.

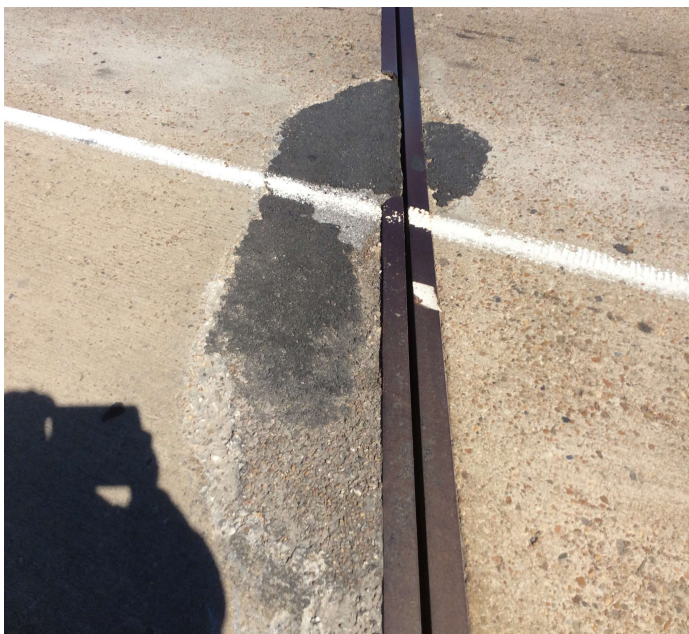
PHOTO 4      Description      Patched & Spalled Areas at Joints.

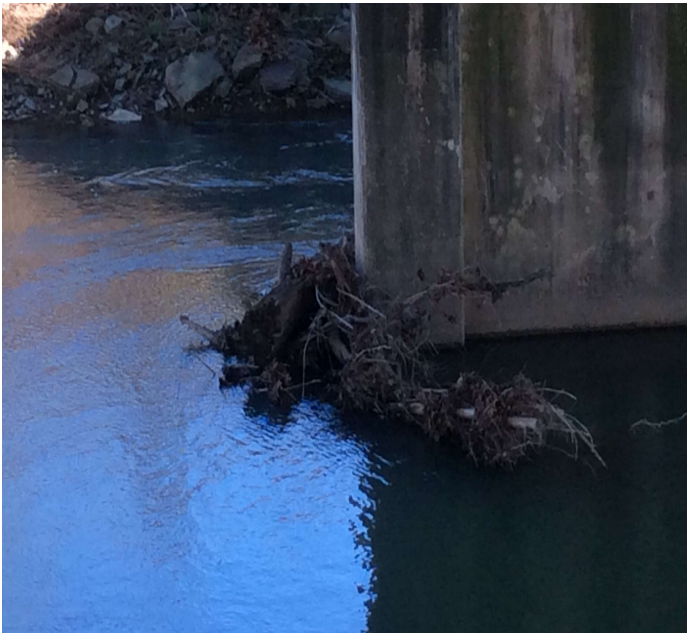
MINOR DRIFT IN CHANNEL BLOCKING FLOW AT PIER 3 ON LT. (UP) SIDE.

PHOTO 1    Description    Drift at Pier 3.
