Bridge Inspection Report

A5040
I 40-SEC 21-WB LN
over
CR 440, Horsehead Creek

Structure Number: A5040

Facility Carried: I 40-SEC 21-WB LN

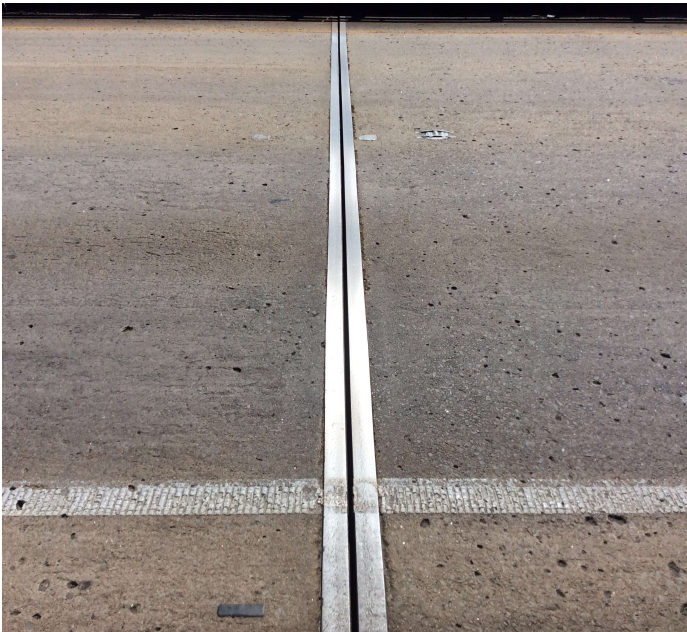
302 - Compression Joint Seal	1- Ben.	312	ft.	0	0	204	108
COND. 3 - 208 LF - MODERATE TO MAJOR DELAM & CRACKING IN ALL SEALS. MINOR POPPING AT JOINTS ON IMPACT. COND. 4 - 108 LF - SEALS AT PIERS 4 & 6 HAVE FAILED & FALLEN OUT OF JOINTS. SEALS AT ABUTMENTS 1 & 8 & PIER 7 HAVE SOME FAILED AREAS.							
2310 - Leakage		108					108
2330 - Seal Damage		204				204	
311 - Movable Bearing	1- Ben.	49	each	0	19	30	0
MINOR TO MODERATE RUST & PACK RUST ON ALL BEARINGS.							
1000 - Corrosion		49			19	30	
515 - Steel Protective Coating		147	sq. ft.	0	57	90	0
3440 - Effectiveness (Steel Protective Coatings)		147			57	90	
313 - Fixed Bearing	1- Ben.	49	each	0	29	20	0
MINOR TO MODERATE RUST & PACK RUST ON ALL BEARINGS.							
1000 - Corrosion		49			29	20	
515 - Steel Protective Coating		147	sq. ft.	0	87	60	0
3440 - Effectiveness (Steel Protective Coatings)		147			87	60	
321 - Reinforced Concrete Approach Slab	1- Ben.	2886	sq. ft.	1386	1000	500	0

Deck joint #s 1, 4, 6, 7 & 8. Seals at Joints 1, 7 & 8 have several failed Areas. Seals at Joints 4 & 6 have failed & fallen out of Joints.

PHOTO 1 Description Seal missing at Joints.

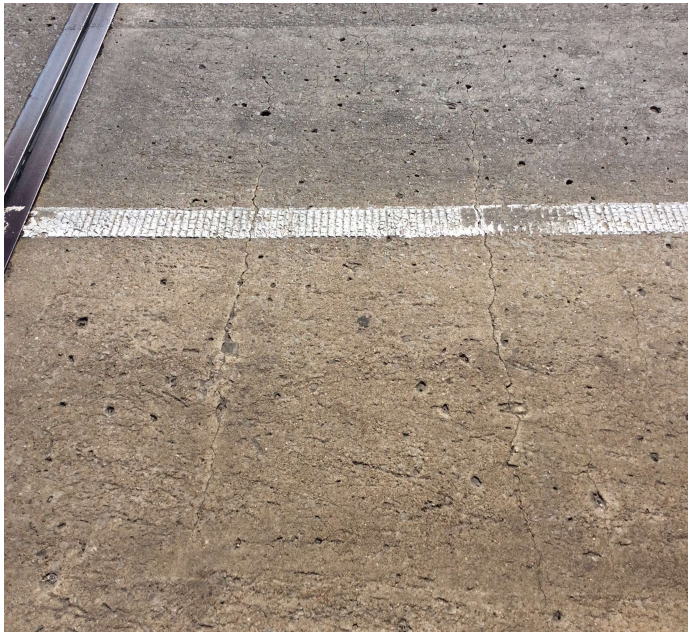
Environment	Total Quantity	Units	Condition State 1	Condition State 2	Condition State 3	Condition State 4
12 - Reinforced Concrete Deck	1- Ben.	13598	sq. ft.	3998	8600	1000	0
	MODERATE CRACKING & SCALE THROUGHOUT DECK. MINOR TO MODERATE DELAM & SPALLING W / REBAR EXPOSED. MAINLY IN SPANS 1, 2, 3 & 7. POPOUTS THROUGHOUT DECK. MINOR DELAM, CRACKING & SPALLING W / REBAR EXPOSED AROUND DECK DRAINS. MINOR CRACKING IN SOFFIT.						
1080 - Delamination/Spall/Patched Area		4000			4000		
1090 - Exposed Rebar		600			600		
1130 - Cracking (RC and Other)		5000			4000	1000	
107 - Steel Open Girder/Beam	1- Ben.	2247	ft.	2195	27	25	0
	MINOR RUST & OLD SECTION LOSS IN HAUNCHED AREAS OF SOME BEAMS. SEVERAL BEAMS IN SPANS 1 - 3 HAVE CRACKS IN WEB AT DIAPHRAGM CONNECTIONS. PLATES ARE WELDED TO WEB FOR DIAPHRAGMS TO BOLT ON. SEE A5040 BEAM NOTES 18 FOR CRACK DETAILS.						
1000 - Corrosion		40			20	20	
1010 - Cracking		12			7	5

Moderate unsealed cracks, most of cracks are transverse.

PHOTO 1 Description Typ. Cracking in Deck.

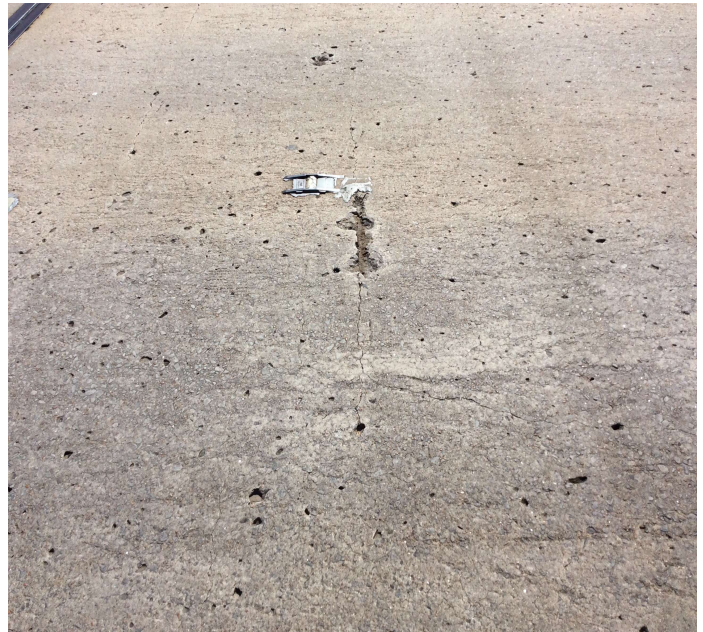
PHOTO 2 Description Minor Spall in Deck.

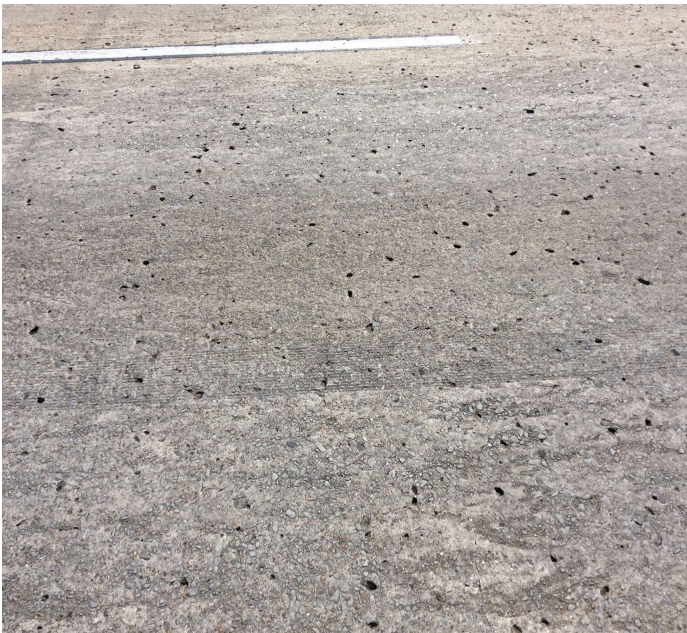
PHOTO 3 Description Typ Popuots in Deck.

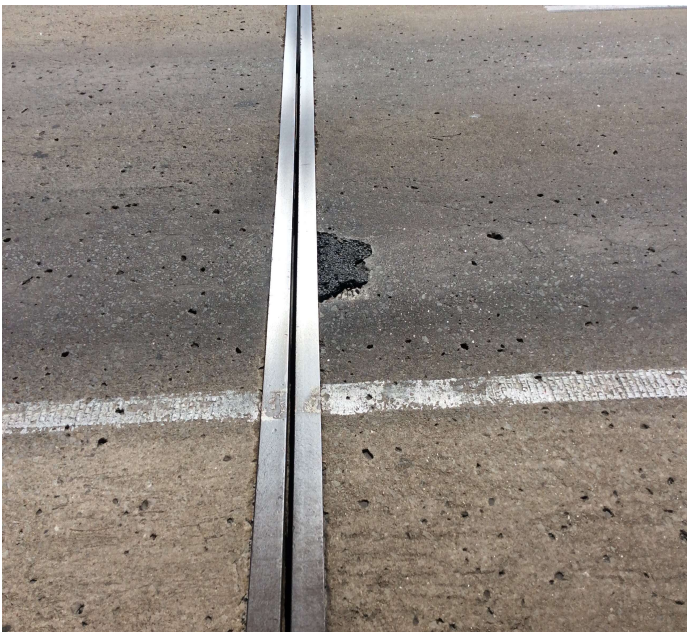
PHOTO 4 Description Typ. Minor Spalling at Joints 6 & 7.

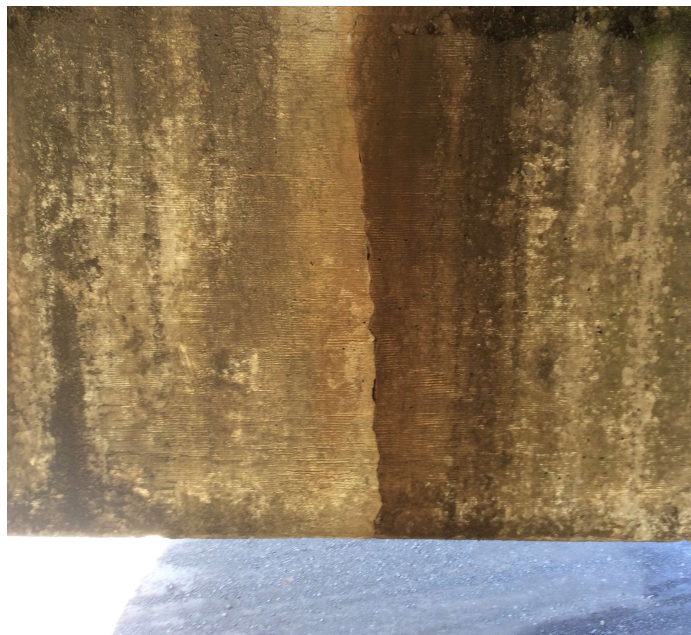
MODERATE TO MAJOR VERTICAL CRACK IN CAP 3 BETWEEN COLUMNS 1 & 2. CRACK STARTS AT BOTTOM CAP & GOES TO TOP.

PHOTO 1 Description Vertical Crack in Cap 3 Ahd. Side.

installed rubber spacers and cleaned pack rust

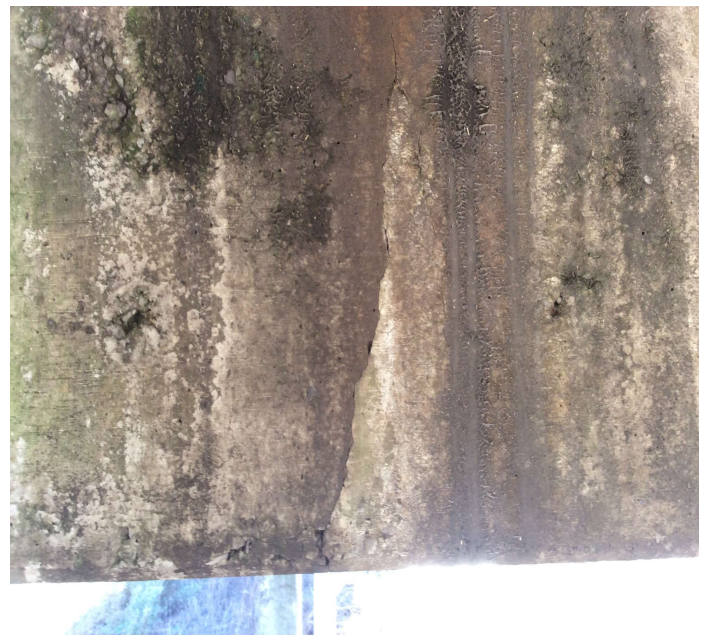
PHOTO 2 Description Vertical Crack in Cap 3 Bk. Side.

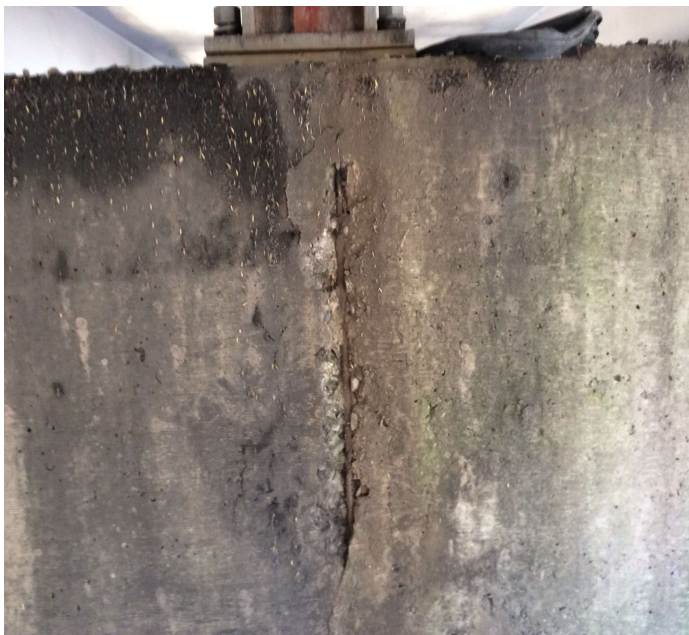
MINOR DELAM, CRACKING & SPALLING W / REBAR EXPOSED IN BK. FACE OF CAP 5 & AHD. FACES OF CAPS 6 & 7.

PHOTO 1 Description Typ. Delam, Cracking & Spalling W / Rebar Exposed in AHD Faces of Caps 6 & 7.

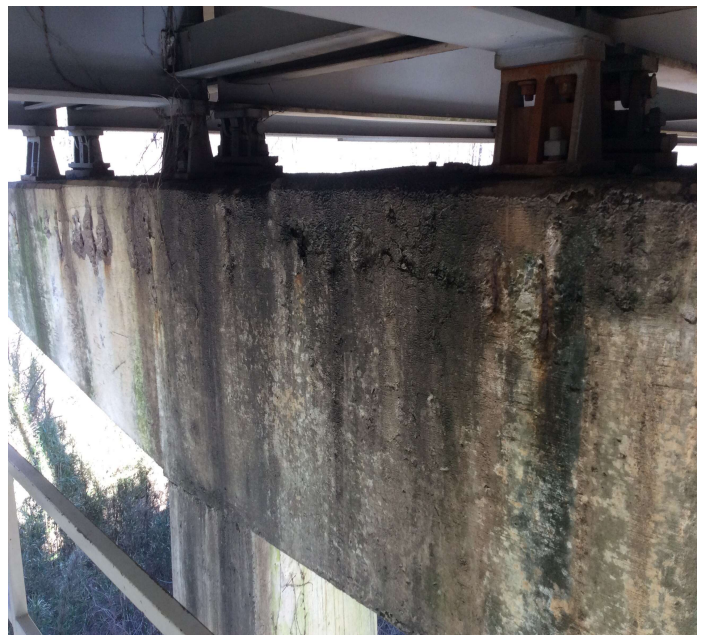
PHOTO 2 Description Delam, Cracking & Spalling W / Rebar Exposed in Bk. Face of Cap 5.
