# Bridge Inspection Report

**B5040**  
**I 40-SEC 21-EB LN**  
**over**  
**CR 440, Horsehead Creek**

Structure Number: B5040

Facility Carried: I 40-SEC 21-EB LN

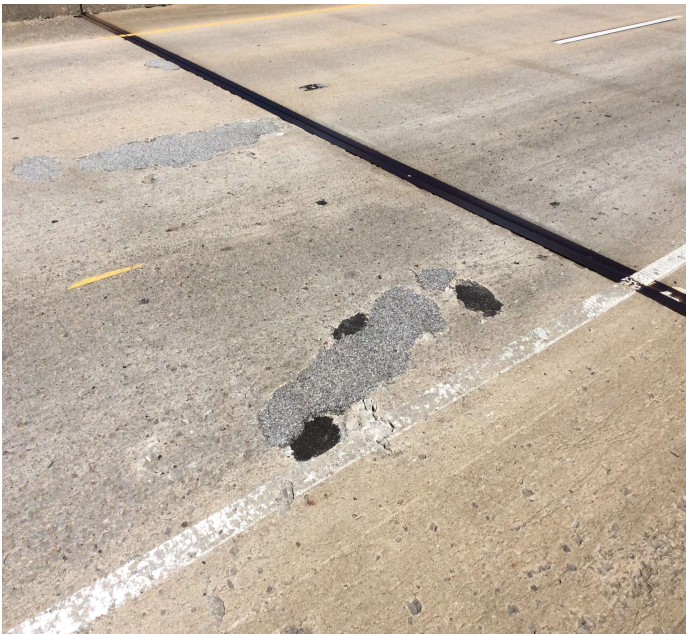
Deck; span # 3

Spalling with rebar exposed.

PHOTO 1      Description      Typ. Spalling in Span 3.

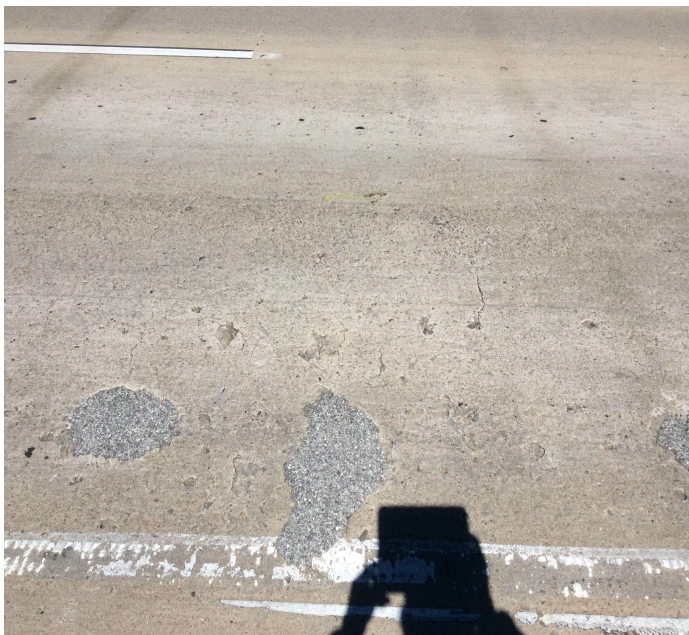
Deck; all spans

Moderate unsealed cracks, most of cracks are transverse.

PHOTO 1      Description      Typ. Cracking & Spalling in Deck.

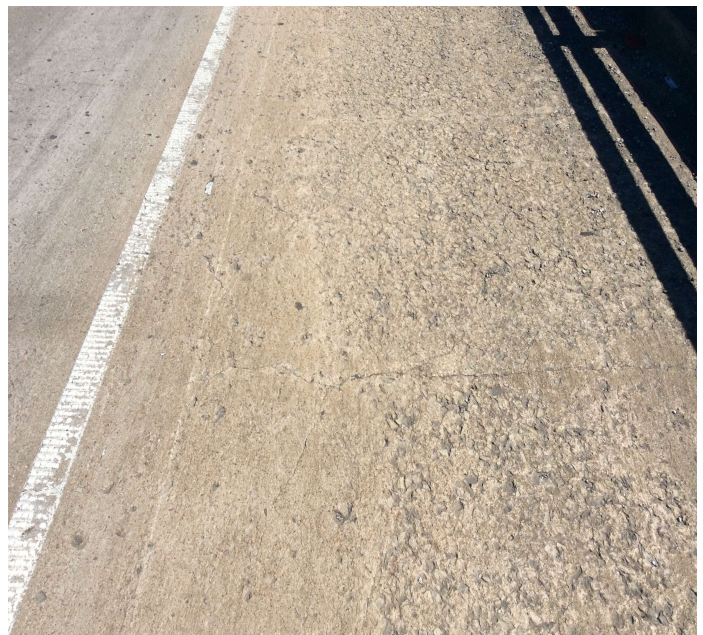
PHOTO 2      Description      Typ. Cracking & Scaling in Deck.

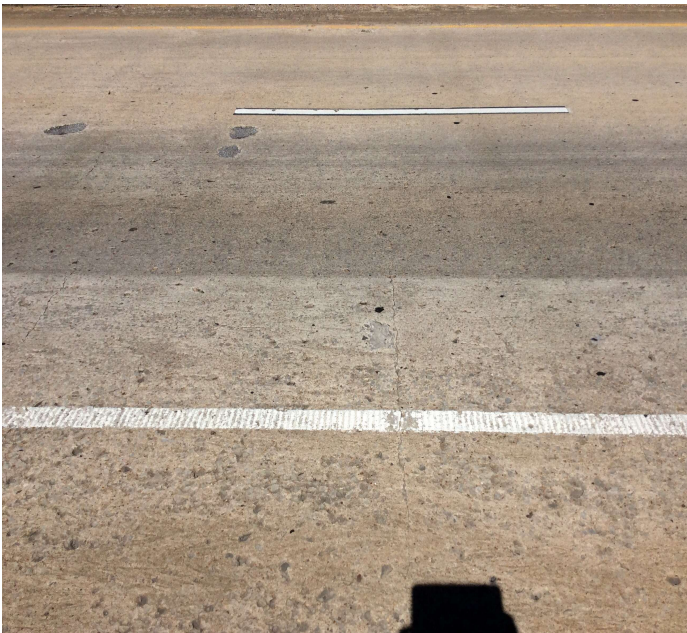
PHOTO 3    Description    Typ. Cracking in Deck.

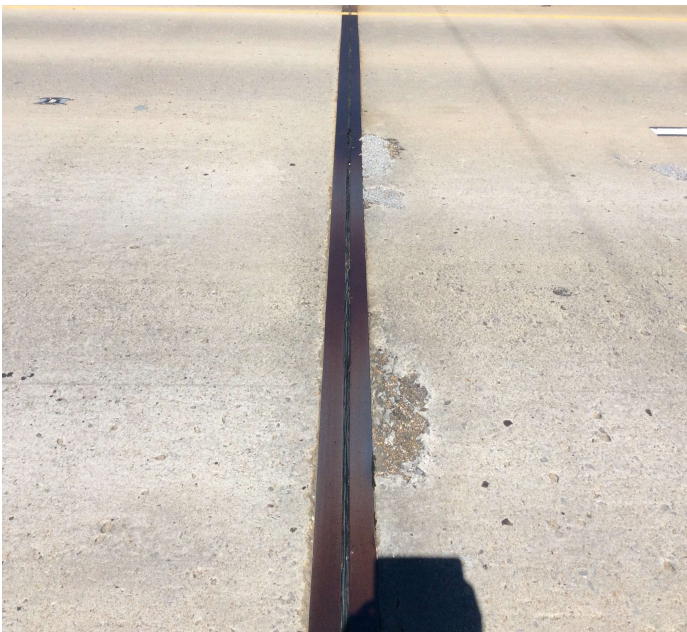
PHOTO 4    Description    Typ. Spalling at Joints.

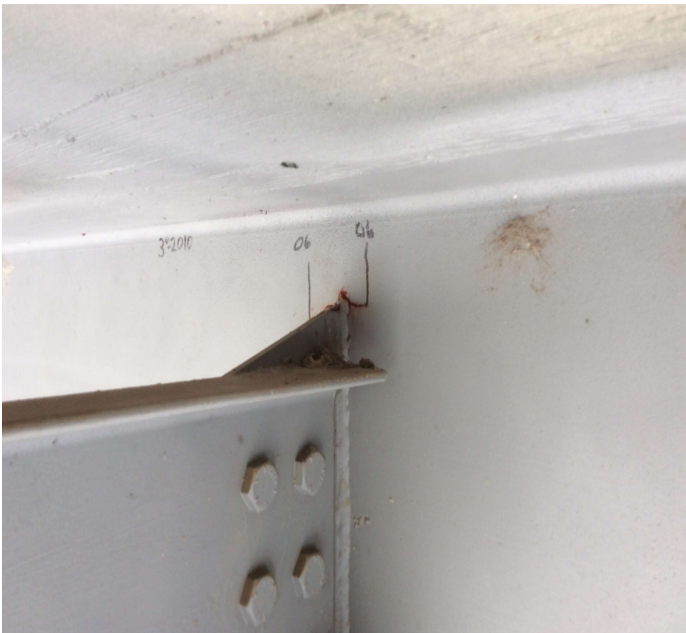
Span # 1 – beam #s 4 & 6

Span # 2 – beam #s 1 & 2 & 3 & 4 & 6.

Span # 3 – beam #s 1 & 4 & 6 & 7.

Span # 4 – beam # 4 at both diaphragms at left side of beams.

Horizontal cracks have developed in web above diaphragms.

Several new cracks have developed and some of old cracks have grown since last inspection.

PHOTO 1      Description      Typ Cracking in Beams.

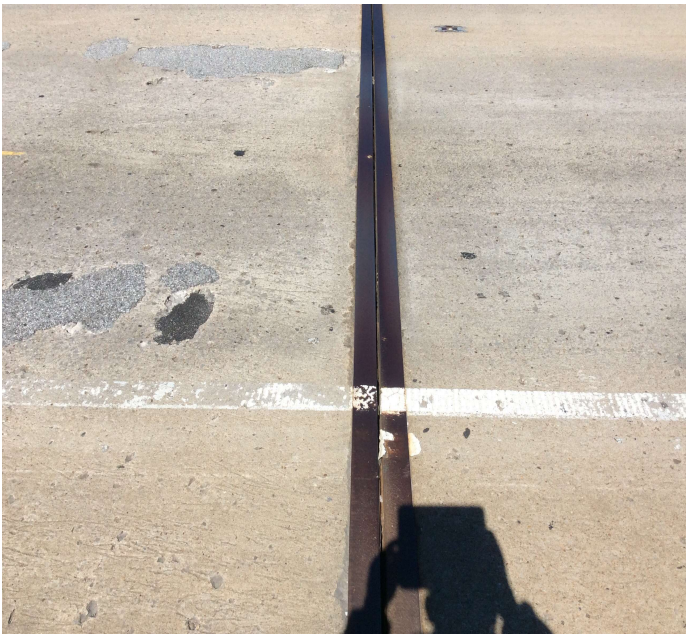
Deck joint #s 4 & 5.  
Joint material is missing.  
Joints 6, 7 & 8 have Failed Areas.

PHOTO 1      Description      Seal Failed at Joints.
