Bridge Inspection Report

05055
SH 299-SEC 0- 0.17
over
I 30-SEC 12- 36.34

Structure Number: 05055

Facility Carried: SH 299-SEC 0-0.17

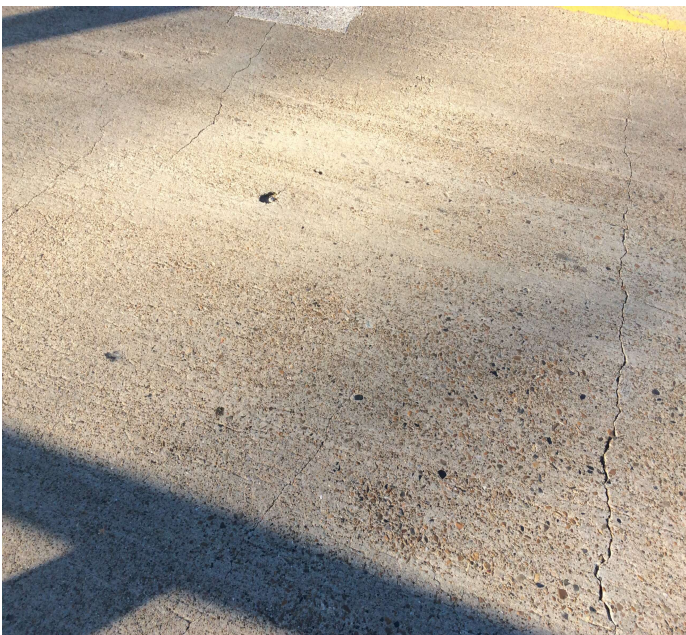
CONCRETE DECK CRACKS IN ALL SPANS
NUMEROUS TRANSVERSE DECK CRACKS.

PHOTO 1 Description Deck cracks span 5

Work Code: Repair

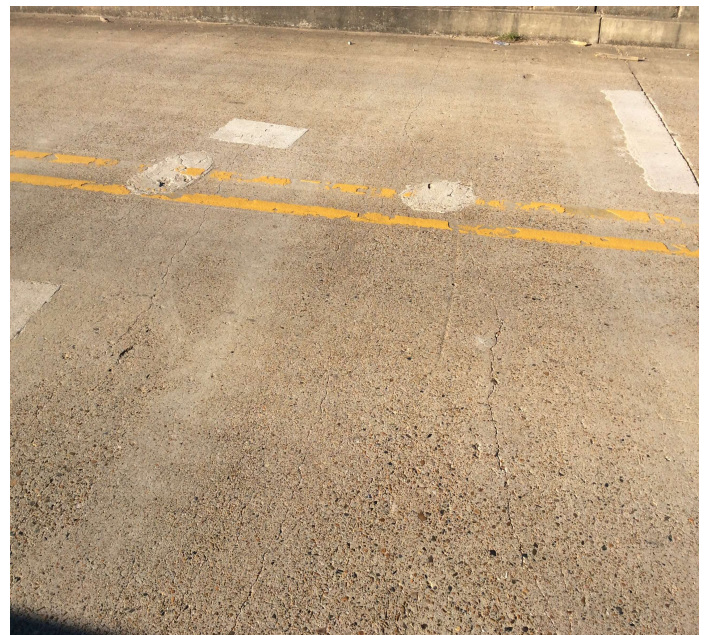
PHOTO 2 Description Span 3 deck cracks

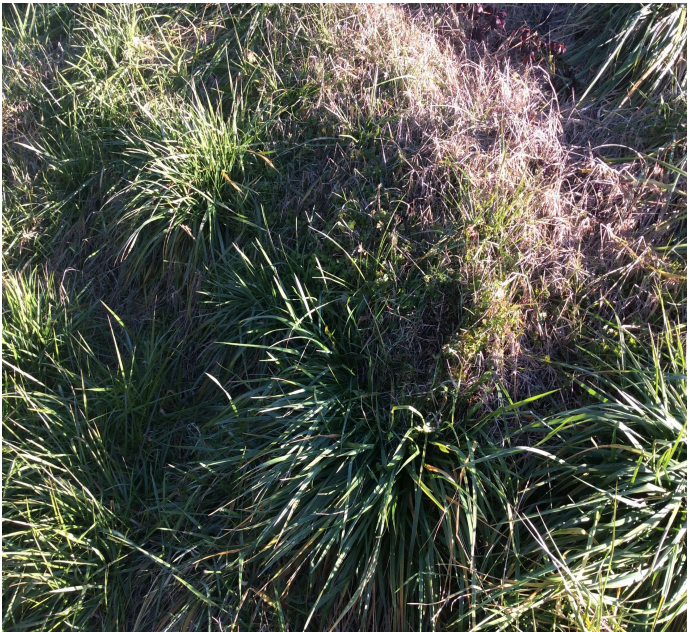
SLOPE DRAINS FROM APPR. GUTTERS

DRAINS ARE STOPPED UP AT BOTTOM, ONE IS COMPLETELY COVERED UP..

PHOTO 1 Description Slope drains

Work Code: Clean
