# Bridge Inspection Report

**05060**  
**SH 332-SEC 7-1.67**  
**over**  
**I 30-SEC 13 - 42.46**

Structure Number: 05060

Facility Carried: SH 332-SEC 7-1.67

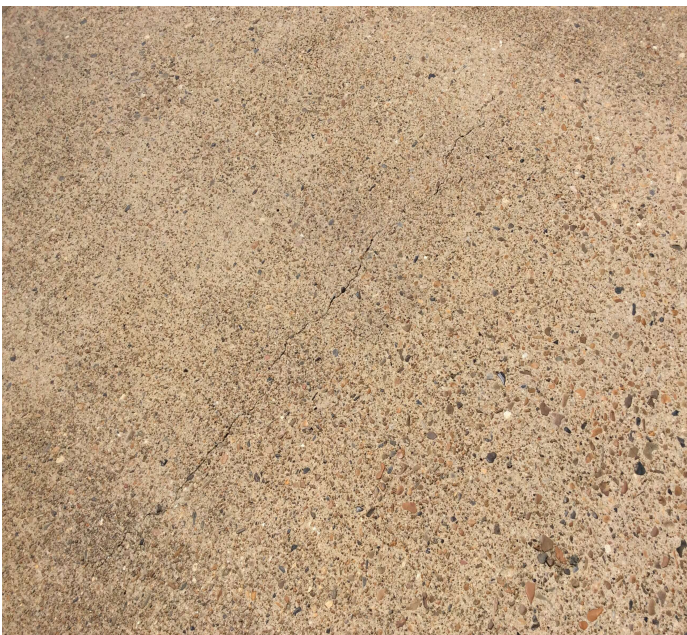
SPANS HAVE SEALABLE DECK CRACKS

PHOTO 1    Description    Unsealed cracks in all spans
