Bridge Inspection Report

05061
US 371 SEC 4 -3.00
over
I 30- SEC-13- 43.95

Structure Number: 05061

Facility Carried: US 371 SEC 4 -3.00

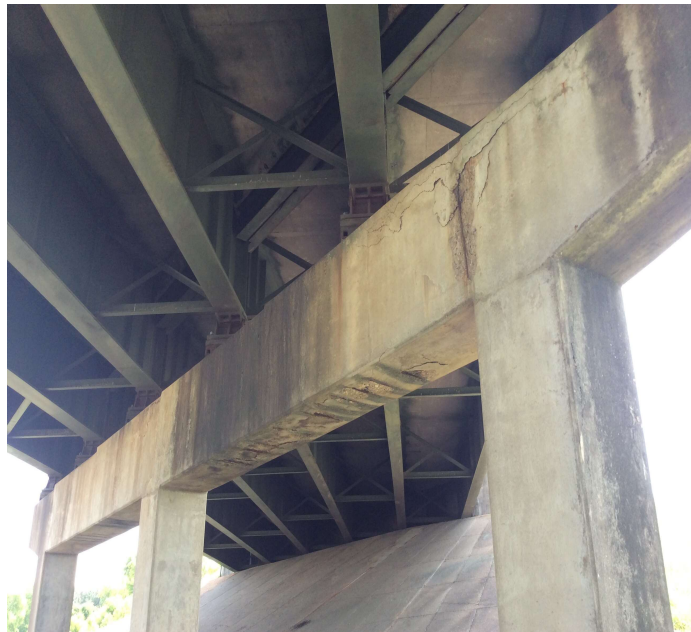
BENT #5 @ BOTTOM AND
BOTH FACES OF CAP SPALLS W/ REBAR EXPOSED, SOME SECTION LOSS TO REBAR. COLUMN 1 SPALL WITH
REBAR EXPOSED.

PHOTO 1 Description BT 5 DELAM, SPALL, REBAR EXPOSED

Repairs done per this inspection.

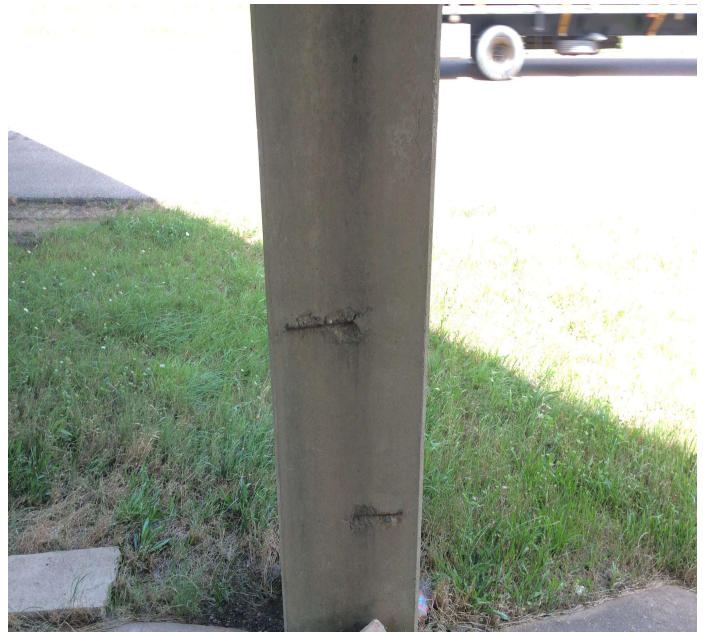
PHOTO 2 Description BT 5 spall rebar exposed ,small delam

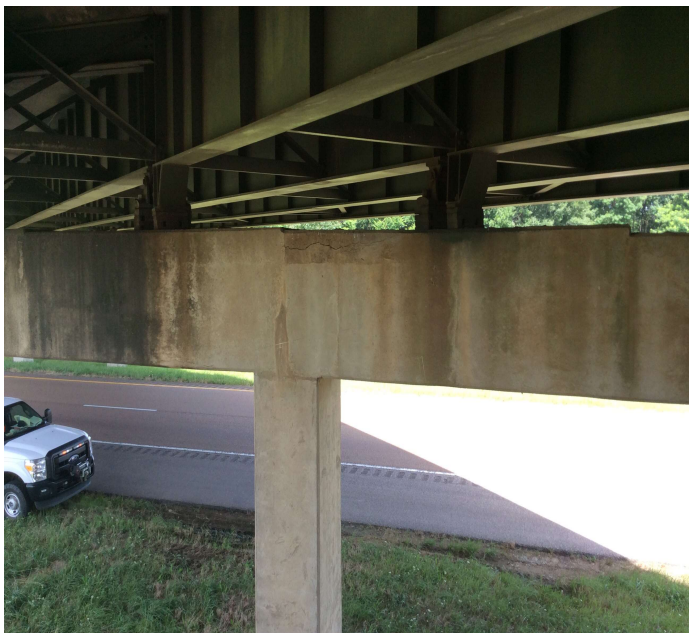
BT.5 SOME VERTICAL CRACKS IN CAP BETWEEN BEAMS 3 & 4
AND ON RIGHT SIDE CAP ABOVE COLUMN 3

PHOTO 3 Description CRACKING AT BT 5 CAP PHOTO AT
BM 3

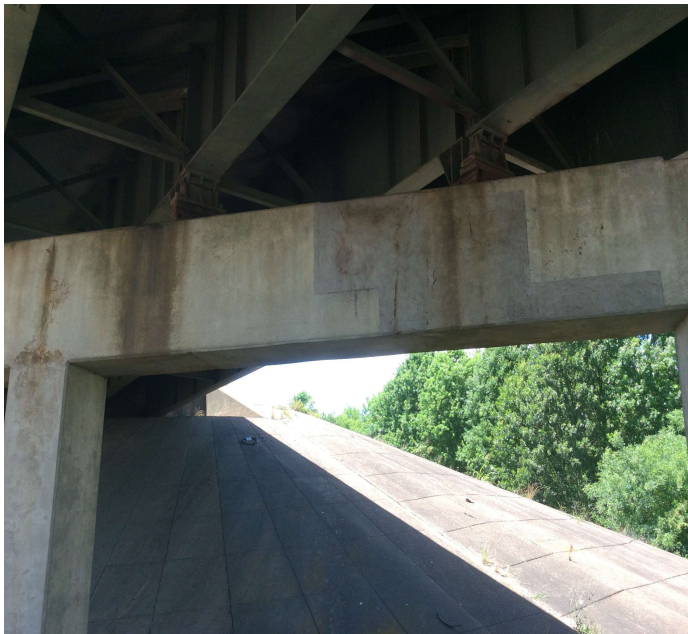
CONCRETE COLUMN AND CAP AT
BENT #2, COLUMN #1 COLUMN AND CAP HAVE VERTICAL & HORIZONTAL CRACKS. IN SIZE FROM 0.005 TO
0.035

PHOTO 1 Description Patch area BT 2 cap

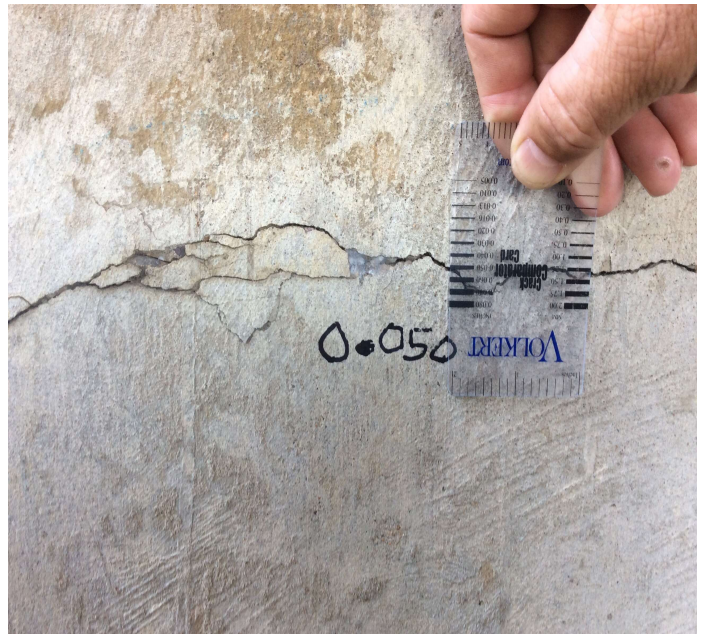
PHOTO 2 Description BT 2 column 1 horz crack.

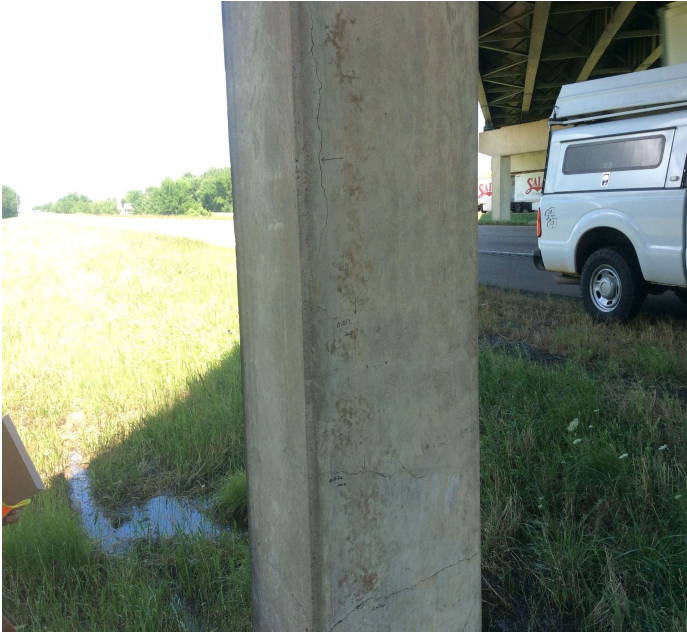
PHOTO 3 Description BT 2 column 1 horz crack.

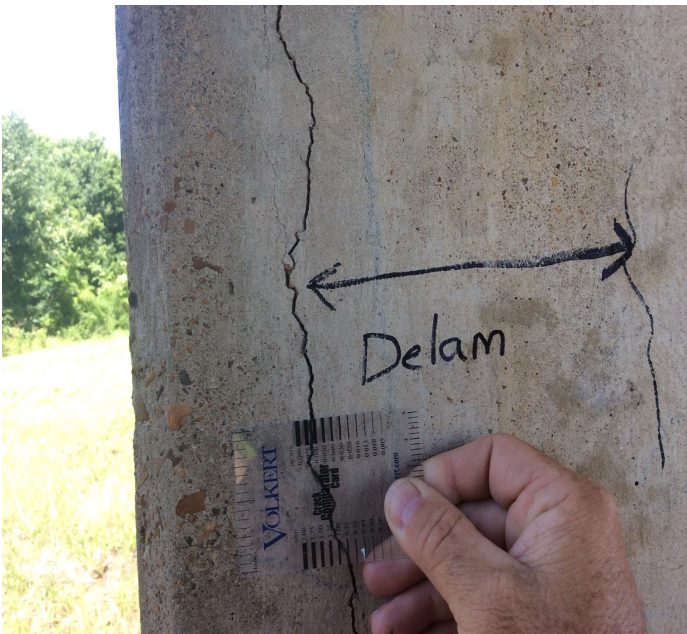
PHOTO 4 Description BT 2 column 1 delam cracks

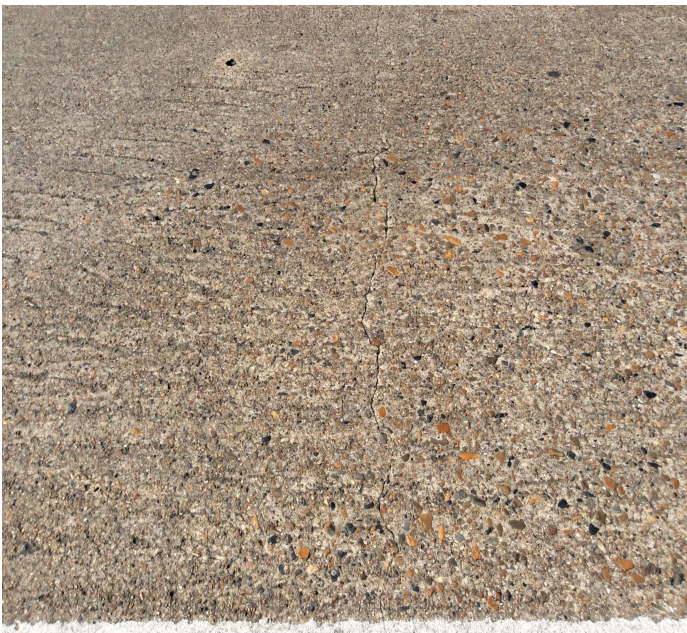
Sealable Deck Cracks all Spans

PHOTO 1 Description Sealable deck cracks all spans

AMS will handle.
