Bridge Inspection Report

05063
SH 19-SEC 5-1.80
over
I 30-SEC 13-46.19

Structure Number: 05063

Facility Carried: SH 19-SEC 5-1.80

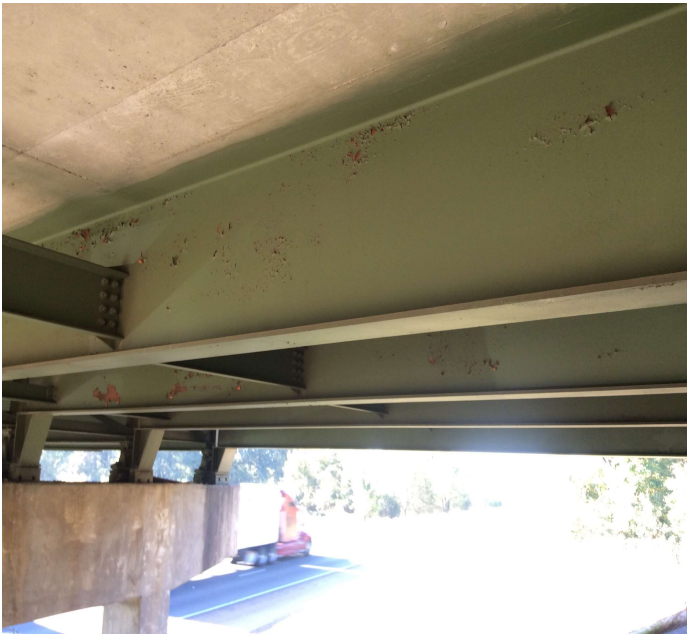
PAINT IS PEELING OFF IN VARIOUS LOCATIONS
ON STEEL BEAMS IN ALL SPANS

PHOTO 1 Description Paint peeling in various locations

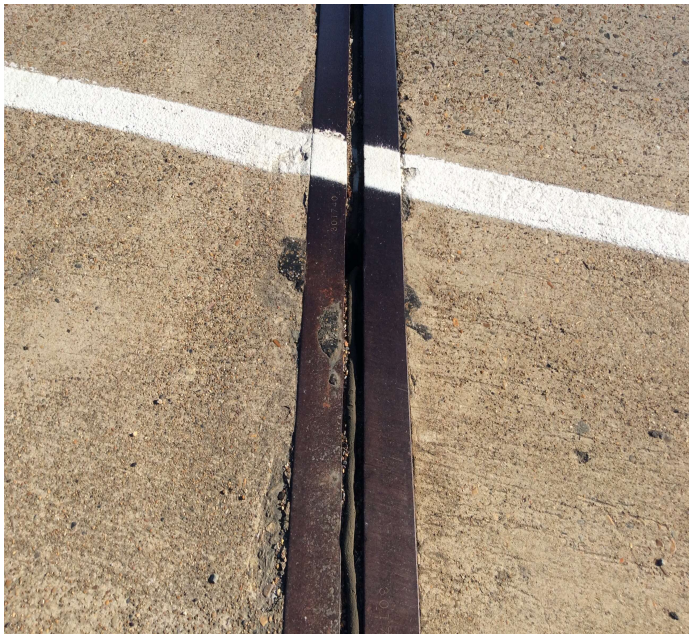
JOINT BENT #2 SOME OF THE JOINT MISSING
LAST 3' OF SEAL IS PUSHING UP OUT OF JOINT WITH 1' MISSING ON LEFT SIDE.
BENT #5 SOME DETERIORATION AND OR MISSING.

PHOTO 1 Description Bent 2 joint 1 foot missing at left white line

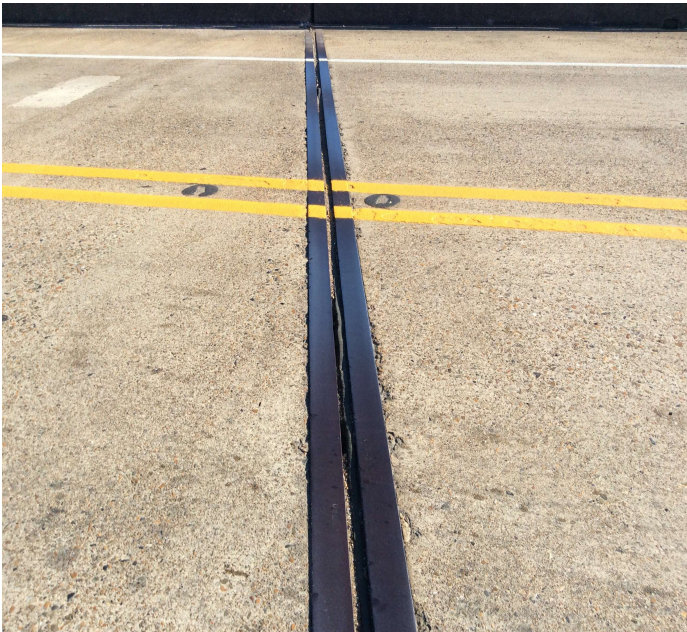
PHOTO 4 Description Bent 2 joint

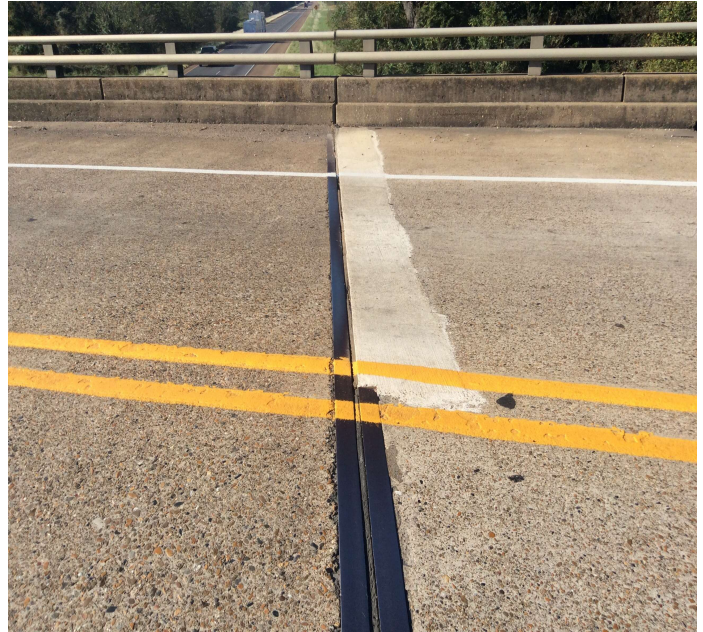
PHOTO 5 Description Bent 5 joint deterioration

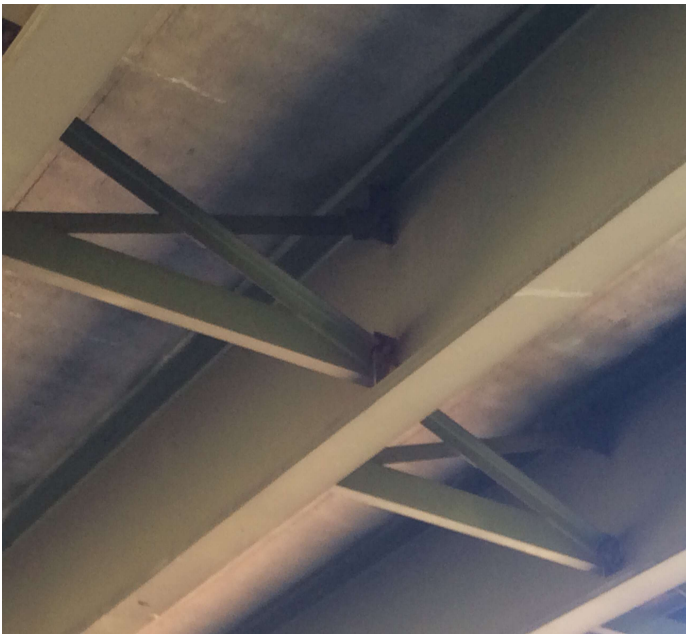
STEEL DIAPHRAM IN
SPAN #4- 3rd BAY 3rd DIAPHRAM
LOOSE CONNECTION AND ONE MISSING BOLT.

PHOTO 1	Description	Missing bolt 3rd diaphragm span 4 bay
		3

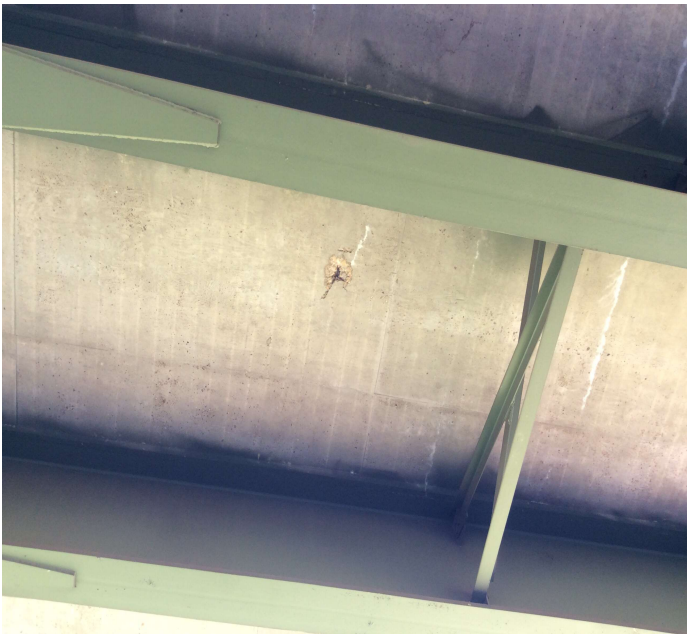
SPAN 2 BAY 2, SPAN 3 BAY 4 SPALLS WITH REBAR ON BOTTOM OF DECK.

PHOTO 1 Description Span 3 spalls bottom of deck

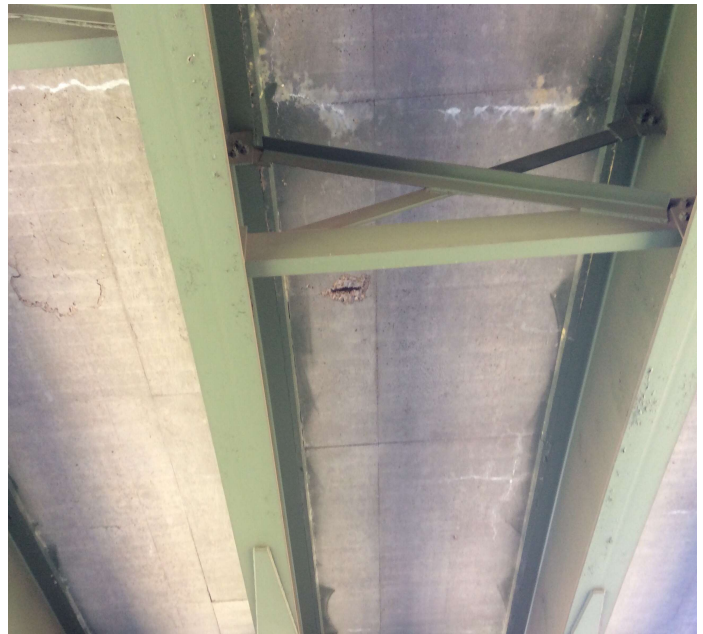
PHOTO 2 Description Span 3 bay 2 spall

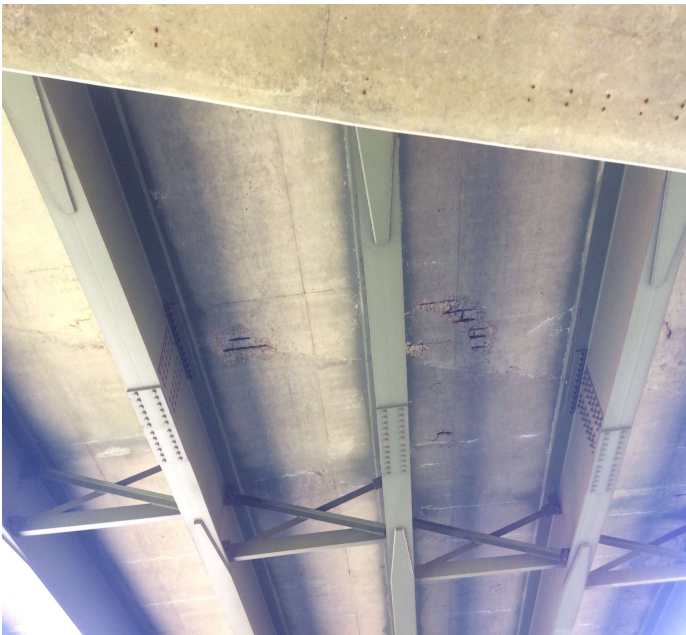
PHOTO 3 Description Span 2 all bays spalls with rebar

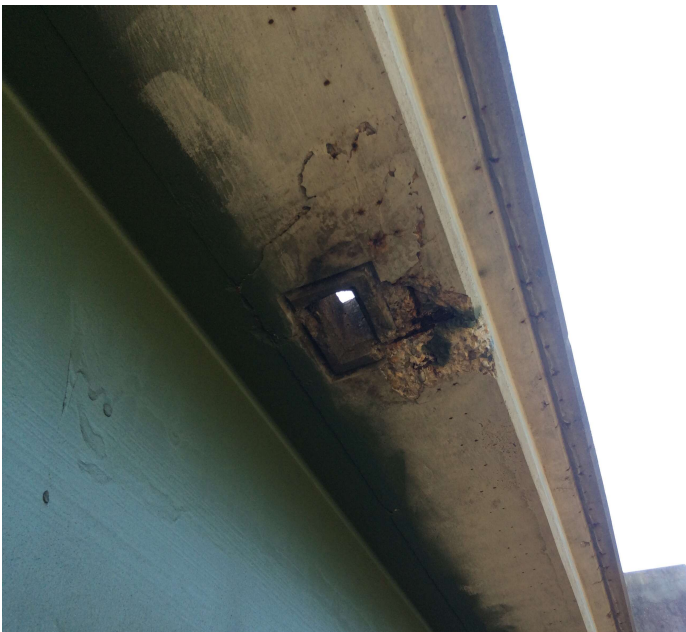
SPAN 1 DECK DRAINS SPALLS WITH REBAR EXPOSED.

PHOTO 4 Description Spalls at drains

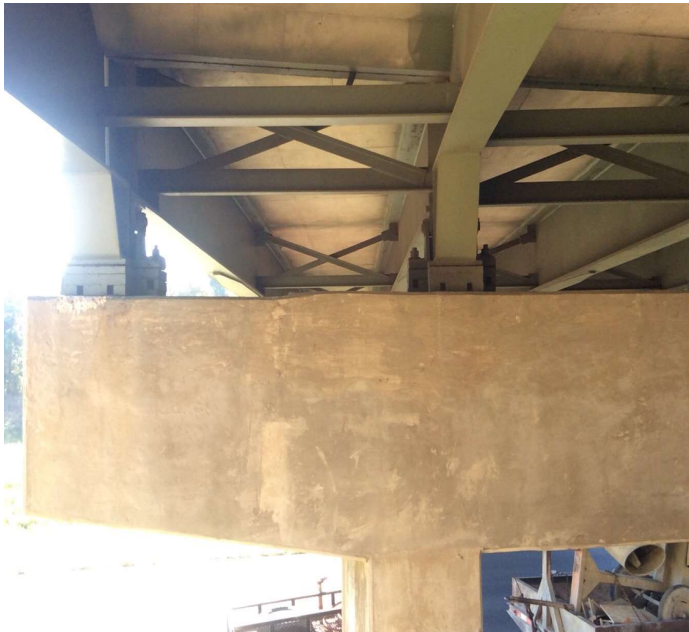
NORTH FACE BENT 5 CAP HORIZONTAL CRACKING UNDER BEAM 4, 5, and 6. WITH SPALL UNDER BEAM 6 BEARING

PHOTO 1	Description	Bent 5 cap north face. Crack under beam 4, 5, and 6 and spall under bent 6 bearing
---------	-------------	--

CHIPPED OUT REPOURED SPALLS
