Bridge Inspection Report

B5020
I-30, EB-13-52.27
over
BLACK CREEK

Structure Number: B5020

Facility Carried: I-30, EB-13-52.27

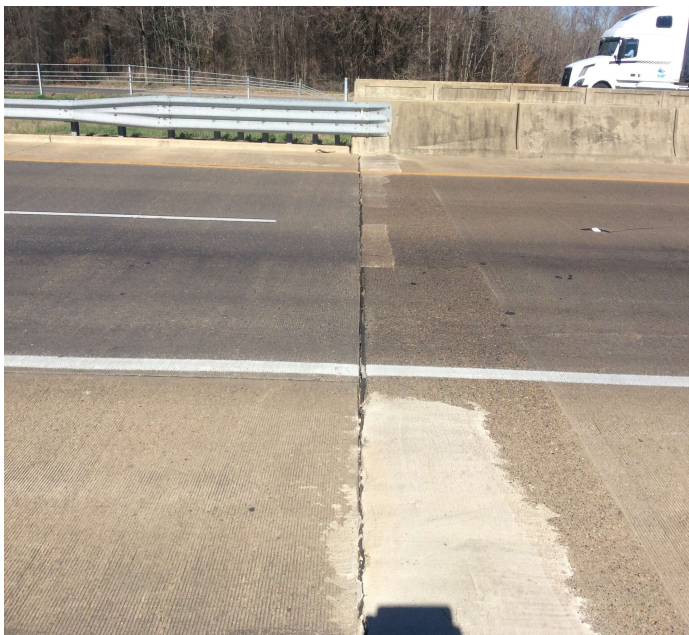
JOINTS AT BENTS 1 AND 8 .
JOINTS NEED TO BE FILLED.

PHOTO 1 Description JOINTS AT BENTS 1 AND 8 .
JOINTS NEED TO BE FILLED.

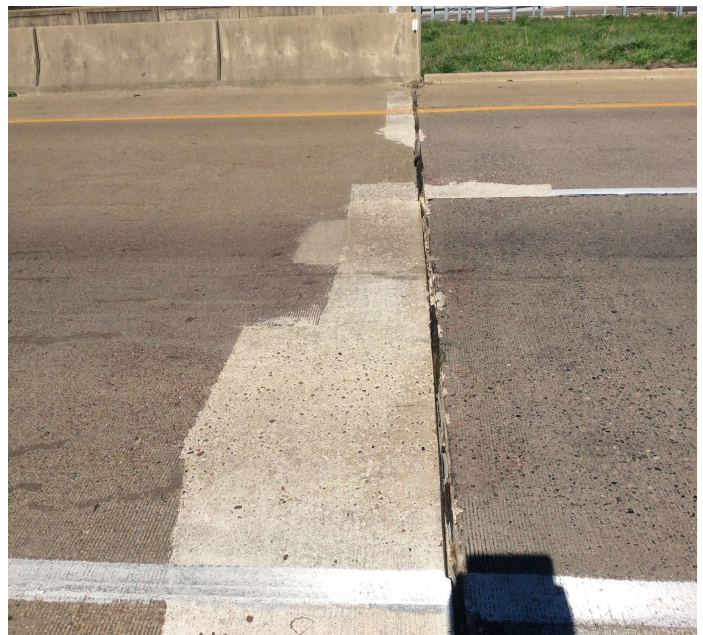
PHOTO 2 Description Joint material missing in joint 8.

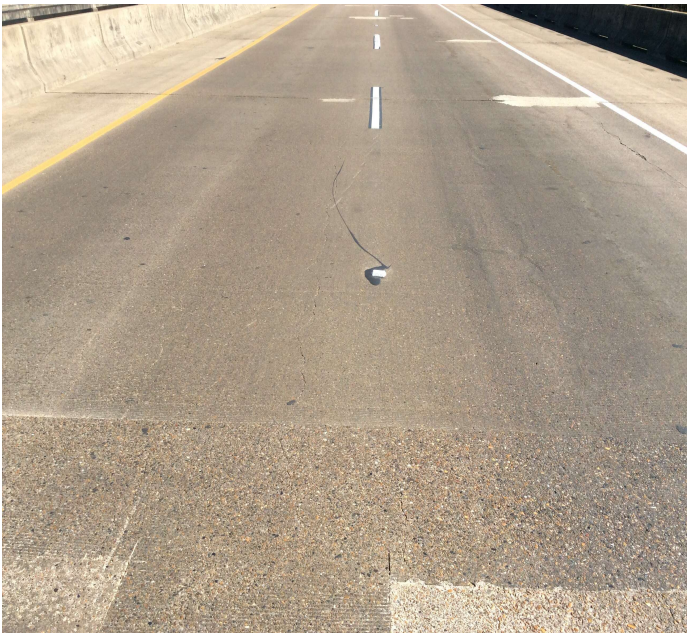
PHOTO 1 Description

CRACKS IN ALL SPANS

LARGE SEALABLE DECK CRACKS IN THIN CONCRETE OVERLAY.

APPROACH SLAB HAS CRACKS AND SOME IN OLD PATCH...
