Bridge Inspection Report

A5021
I 30, WB LNS-52.55
over
LITTLE MISSOURI RELIEF

Structure Number: A5021

Facility Carried: I 30, WB LNS-52.55

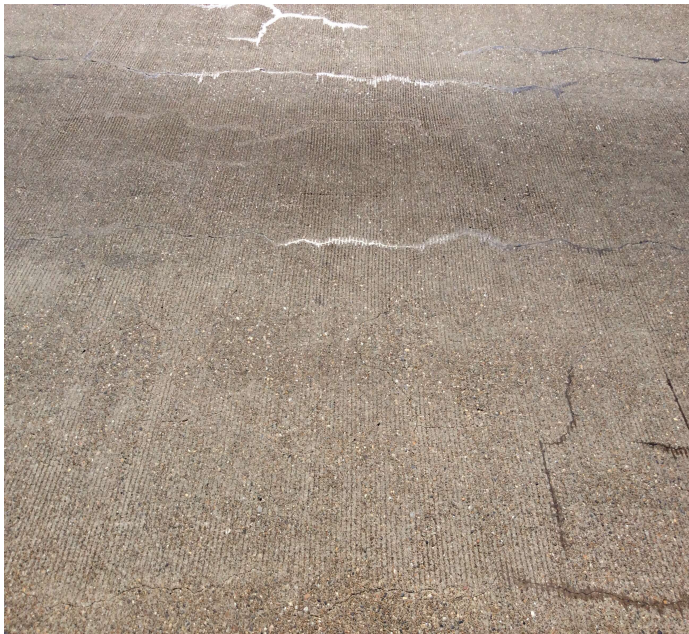
CONC. DECK CRACKS AT ALL SPANS.
NUMEROUS SEALABLE DECK CRACKS
NOTE: SLOW LANE SEALED

PHOTO 1 Description Cracks in deck some sealed some not

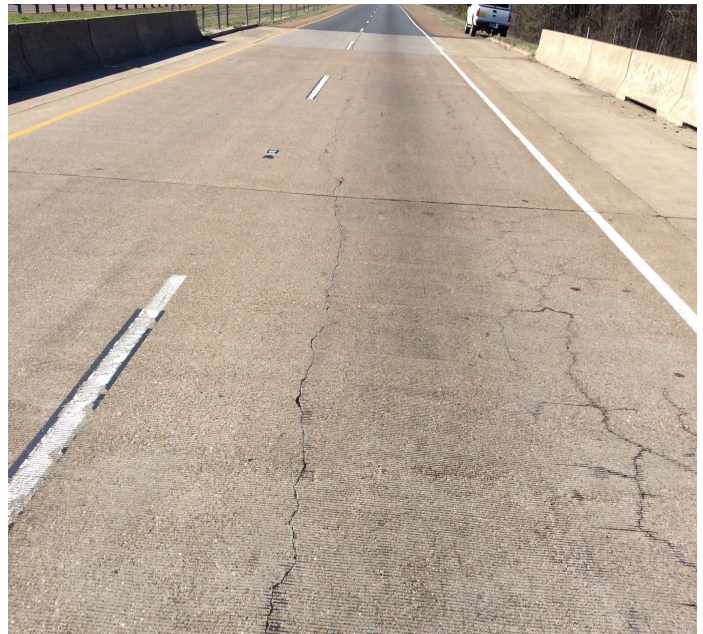
PHOTO 2 Description Cracks in deck

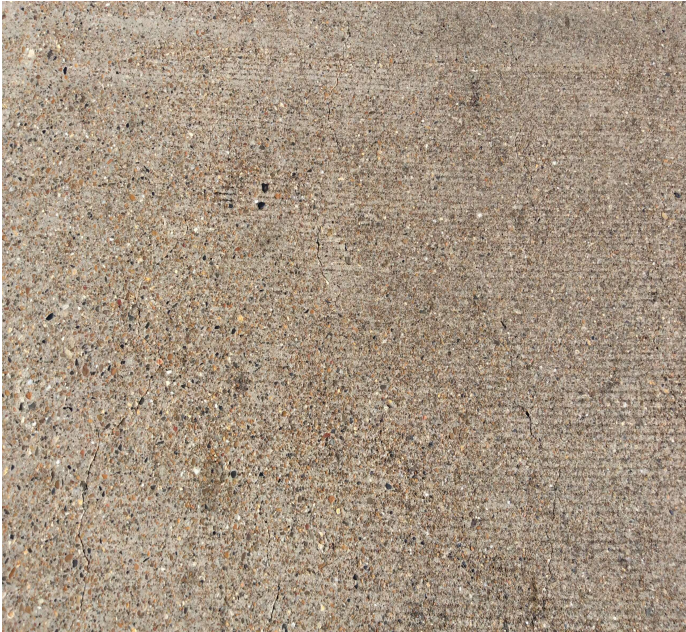
PHOTO 3 Description Deck map cracking

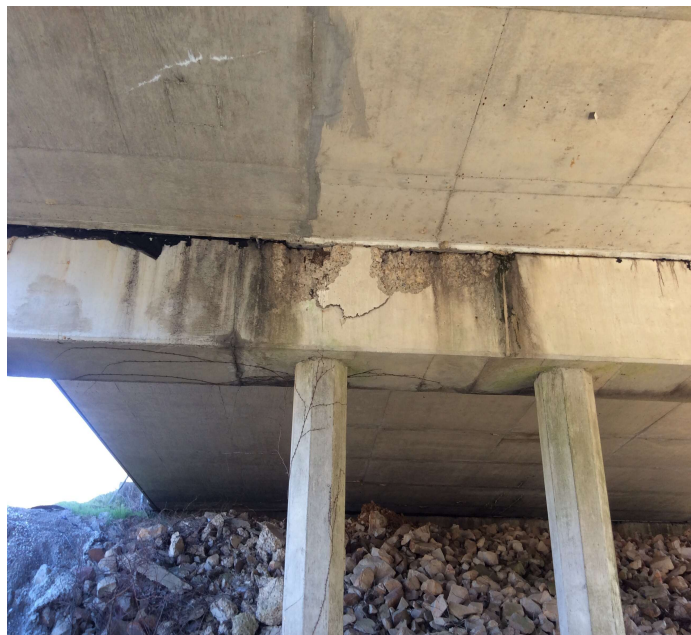
BENT # 18-5'X2' X1.5' SPALL W/REBAR EXPOSED

PHOTO 1 Description BT 18 spall on cap 6 lf

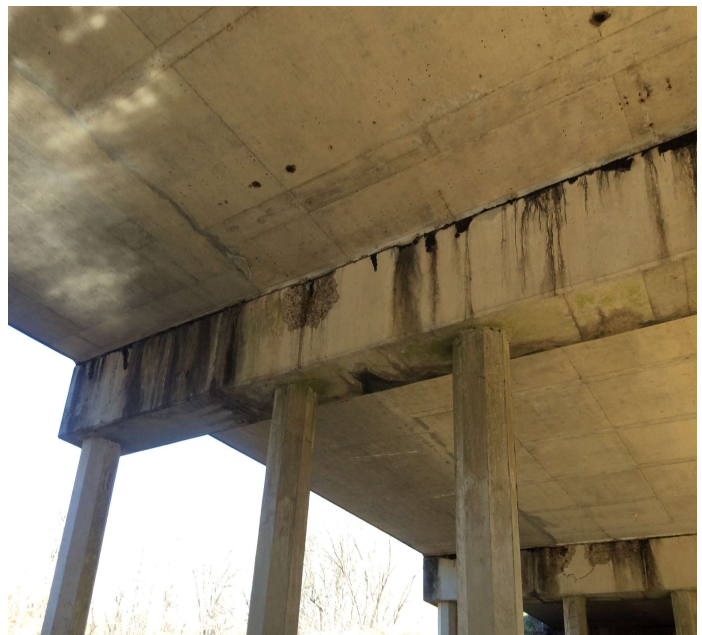
BENT # 17-1.5'X1.5' SPALL W/REBAR EXPOSED; NOT PAINTED.

PHOTO 2 Description BT 17 spall 2 lf

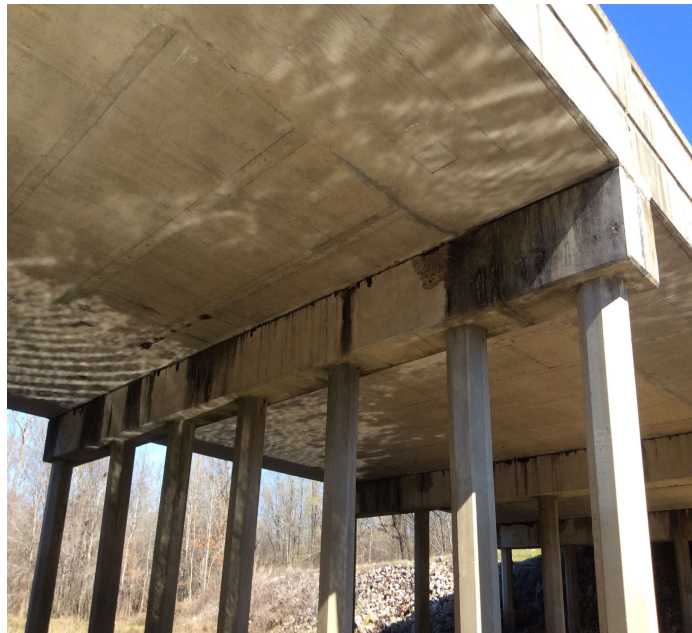
BENT 16 2'X2' DELAM WEST FACE

PHOTO 3 Description BT 16 spall 3 LF

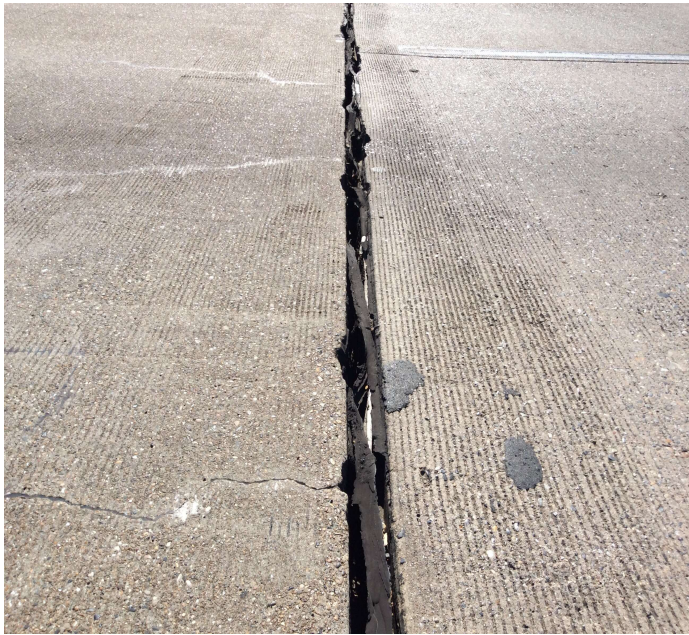
PHOTO 1 Description CONSTRUCTION JOINTS
OVER BENTS JOINT MATERIAL IS
COMING OUT OF JOINTS AT
VARIOUS LOCATIONS.

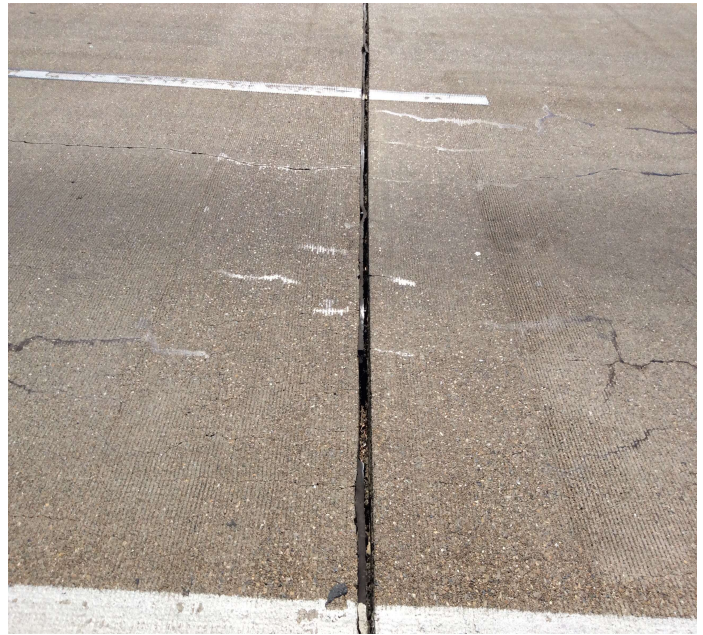
CONSTRUCTION JOINTS
OVER BENTS JOINT MATERIAL IS COMING OUT OF JOINTS AT VARIOUS LOCATIONS.

PHOTO 2 Description Joints

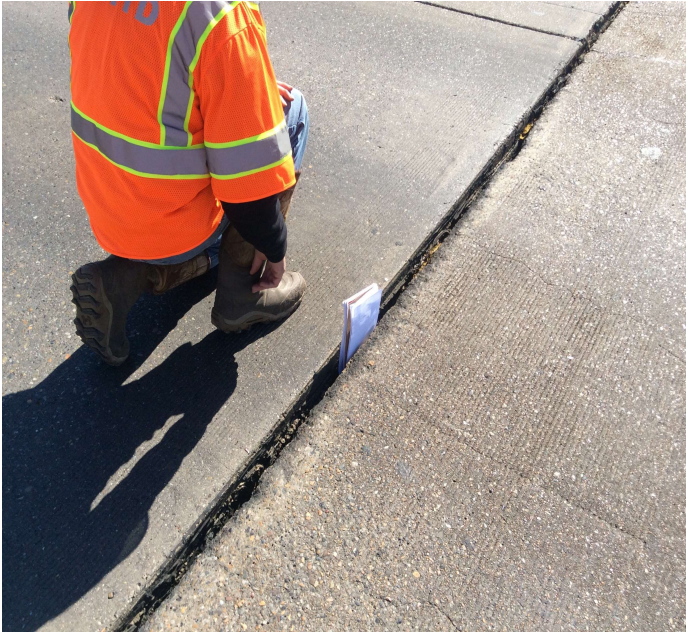
PHOTO 3	Description	CONSTRUCTION JOINTS OVER BENTS JOINT MATERIA L IS COMING OUT OF JOINTS AT VARIOUS LOCATIONS.
---------	-------------	---

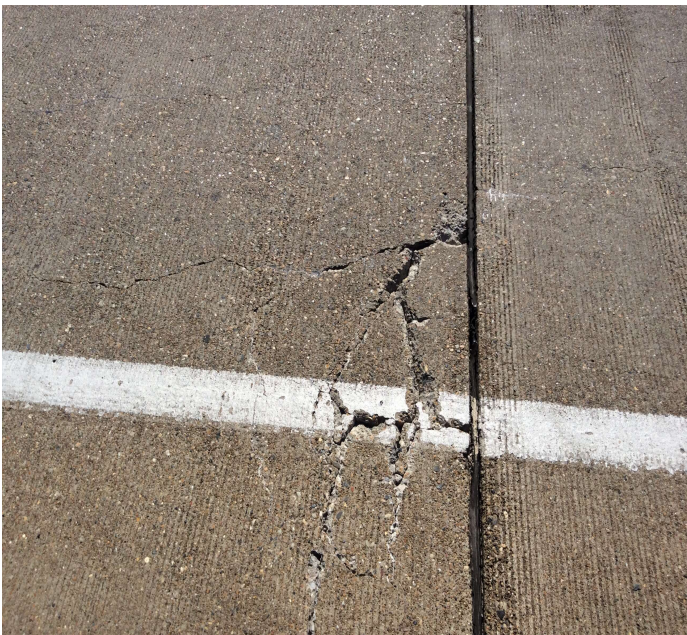
CONCRETE DECK IS CRACKED AND SMALL SPALLS IN SLOW LANE AT BENT 11 WHITE LINE.

PHOTO 1 Description Deck spall in slow lane at bent # 11

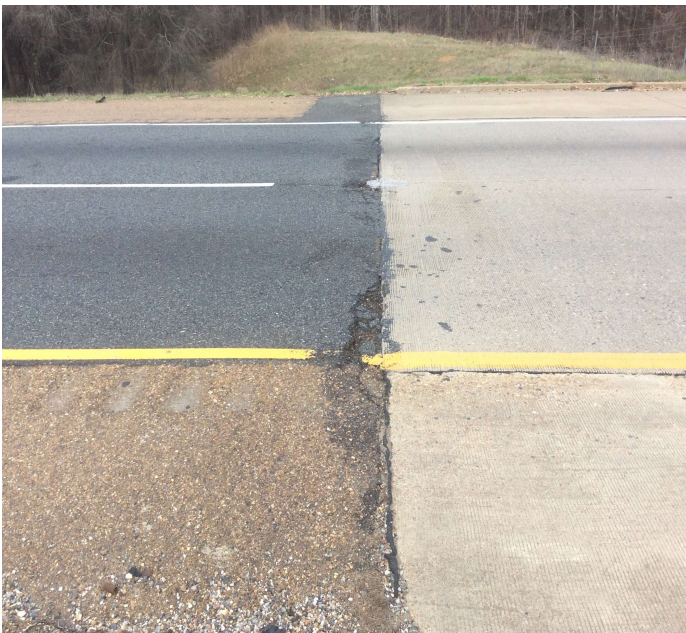
PHOTO 1 Description

BEGINNING OF APPROACH ASPHALT STARTING TO POTHOLE.

AMS will handle
