Bridge Inspection Report

B5021
I-30, EB LNS-52.55
over
LITTLE MISSOURI RELIEF

Structure Number: B5021

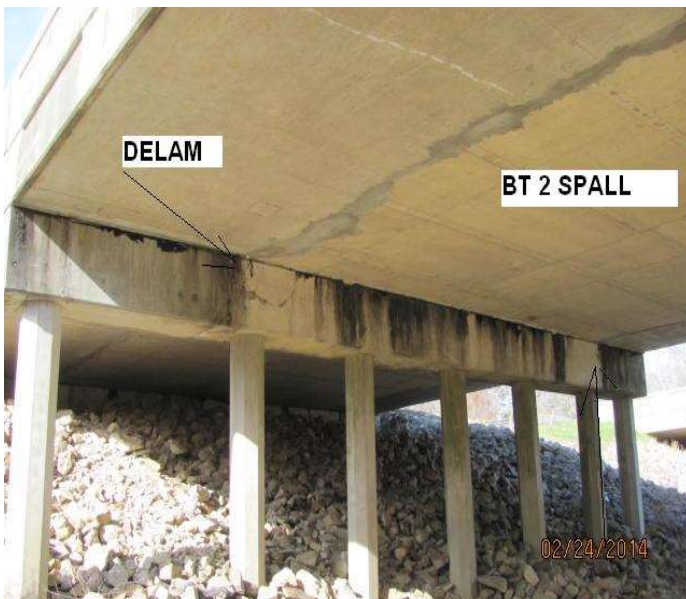
PHOTO 1 Description

BENT 2 CAP DELAMN AND SPALL

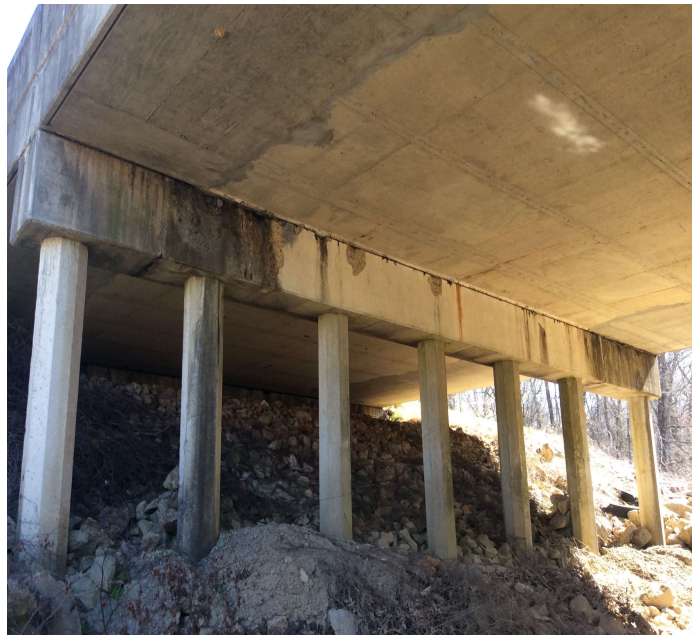
BENT'S #6,7&18-- APPROX. 2' X 4' SPALLS WITH REBAR EXPOSED.

PHOTO 1 Description BT 18 spall 8 LF

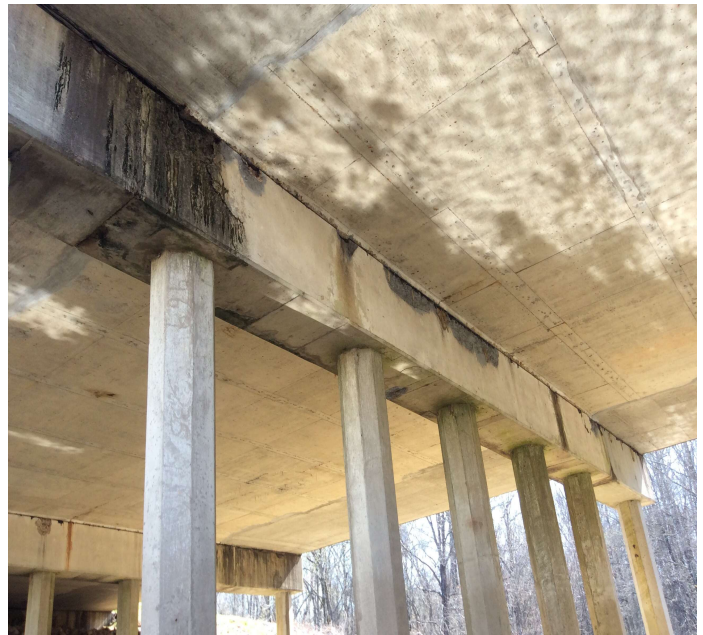
#17 MINOR SPALLS ; STATE FORCES HAVE PAINTED MOST OF THESE SPALLS

PHOTO 2 Description BT 17 spall 13 LF

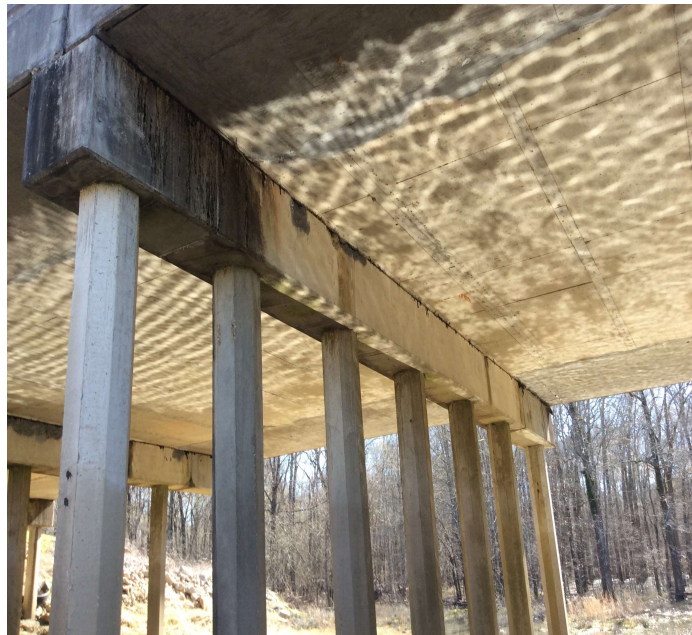
PHOTO 3 Description BT 16 spall 4 LF

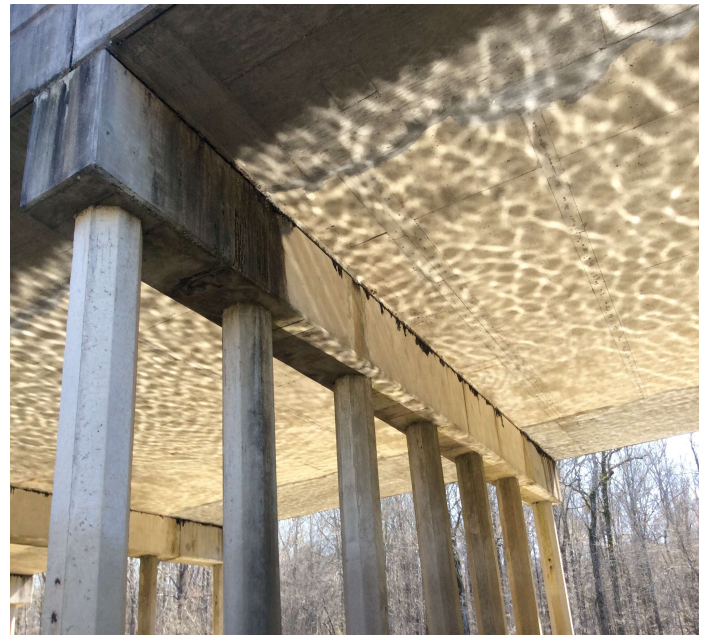
PHOTO 5 Description BT 15 spall 2 LF

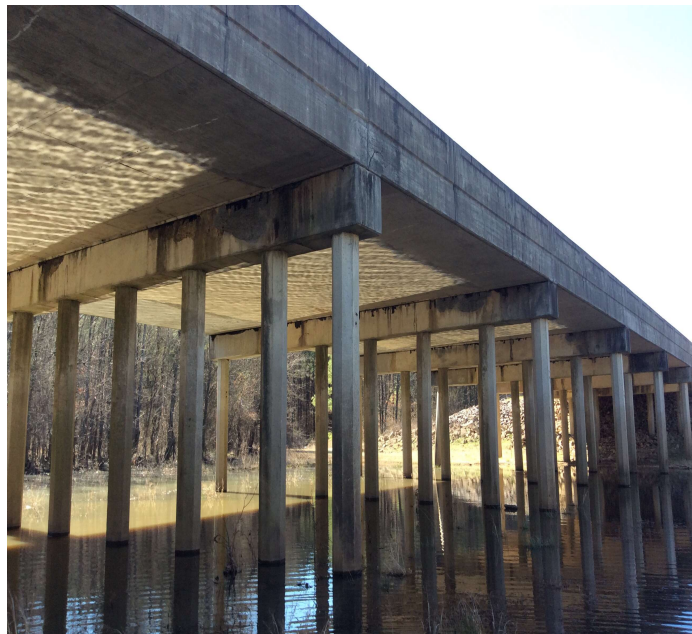
PHOTO 4 Description Spalls at bent 7,6,5

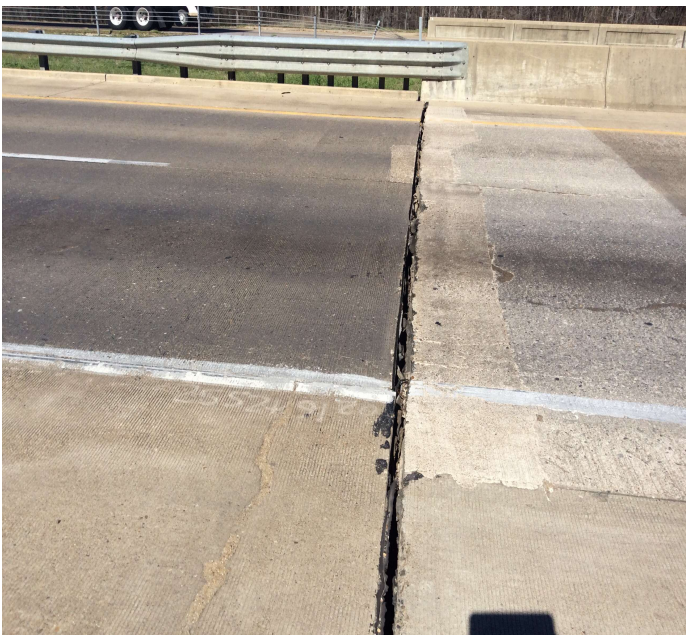
PHOTO 1 Description CONSTRUCTION JOINTS
OVER BENTS JOINT MATERIAL IS
COMING OUT OF JOINTS AT
VARIOUS LOCATIONS

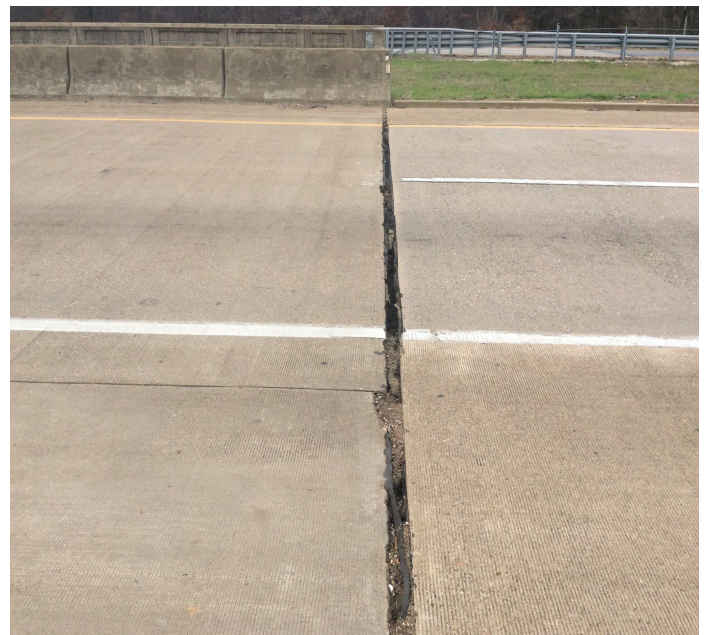
PHOTO 2 Description

OVER BENTS JOINT MATERIAL IS COMING OUT OF JOINTS AT VARIOUS LOCATIONS

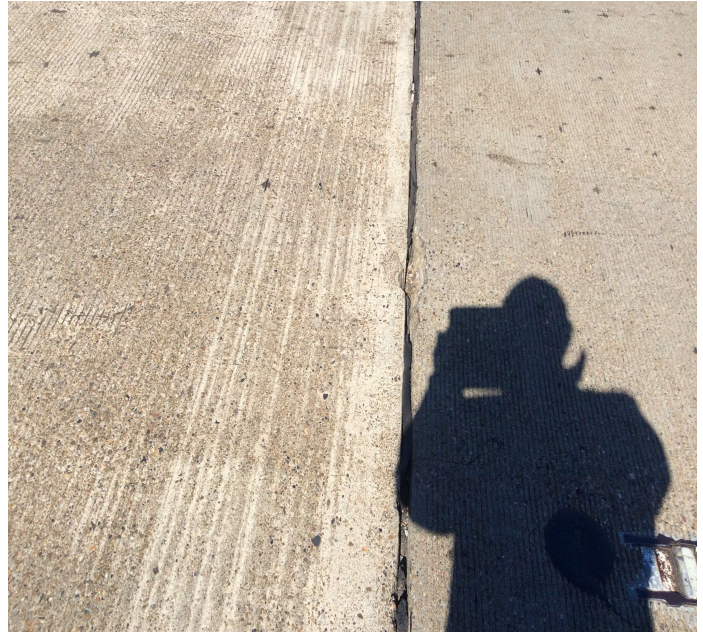
PHOTO 5 Description

CONSTRUCTION JOINTS
OVER BENTS JOINT MATERIAL IS
COMING OUT OF JOINTS AT
VARIOUS LOCATIONS

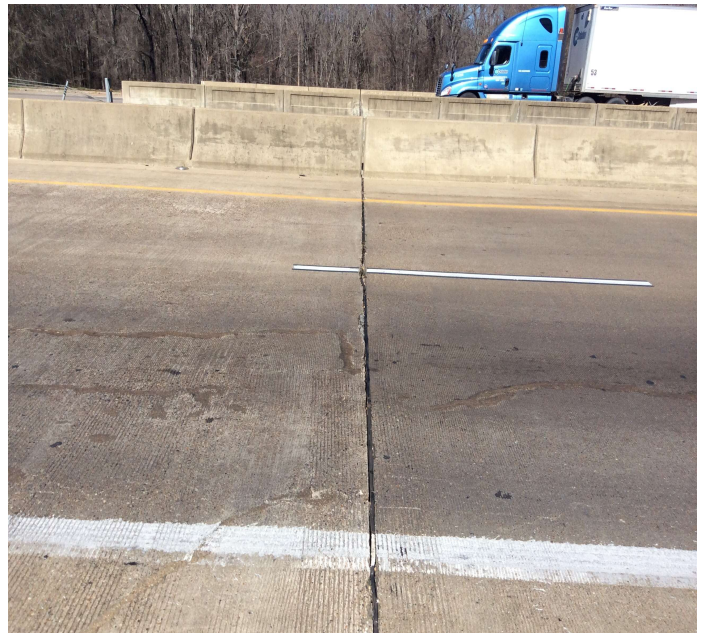
PHOTO 6 Description

CONSTRUCTION JOINTS
OVER BENTS JOINT MATERIAL IS
COMING OUT OF JOINTS AT
VARIOUS LOCATIONS
