# Bridge Inspection Report

**A5022**  
**I-30-13-52.97 W.B.**  
**over**  
**LITTLE MISSOURI RIVER**

IDENTIFICATION		INSPECTIONS	
(1) STATE CODE	056 - Arkansas	(90) INSPECTION DATE	02/20/2018
(8) STRUCTURE NUMBER	A5022	(91) DESIGNATED INSPECTION FREQUENCY	24

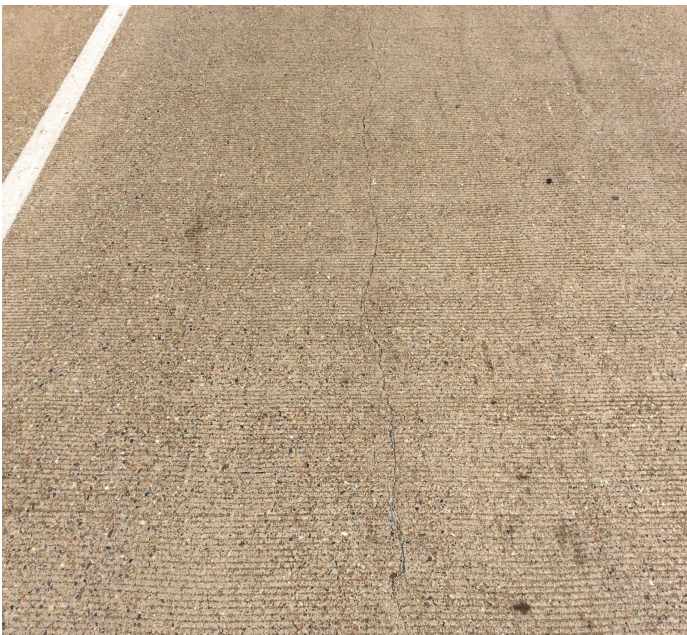
ALL SPANS IN BRIDGE DECK HAVE SEALABLE DECK CRACKS.

PHOTO 1      Description      Sealable deck cracks all spans

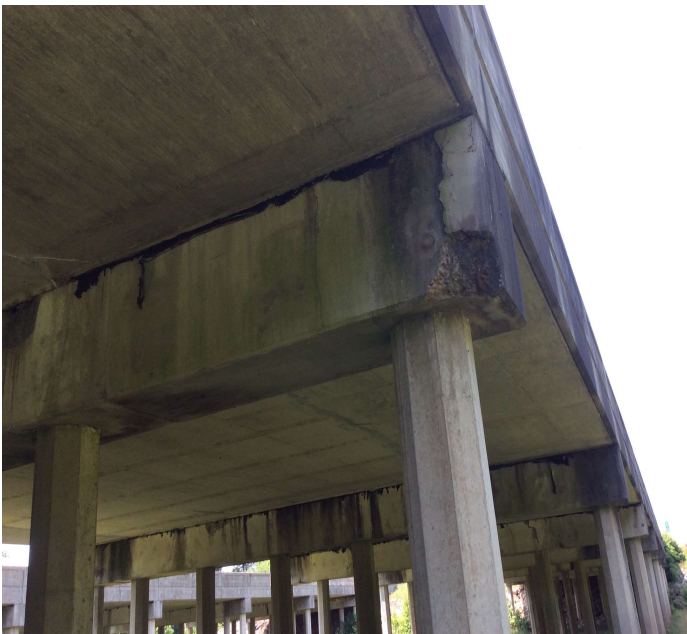
MINOR SPALLS W/REBAR EXPOSED

PHOTO 1      Description      BT 8 lt end cap spall rebar exposed

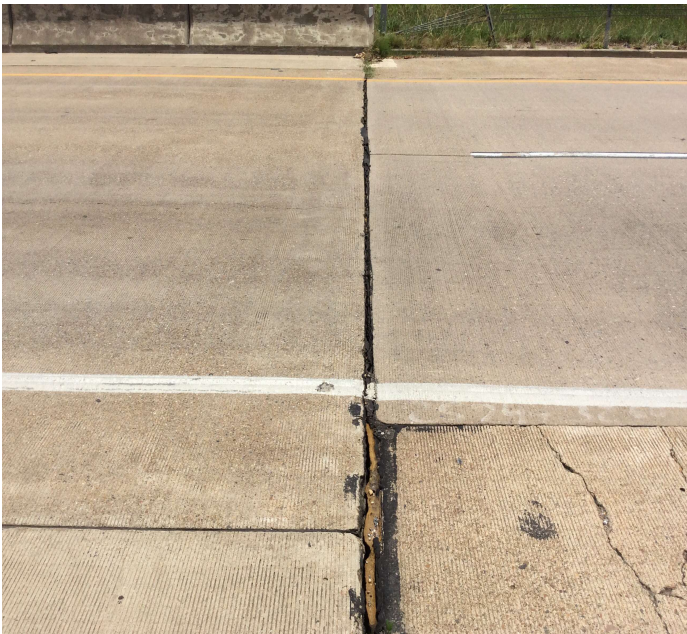
NEED TO BE CLEANED AND FILLED WITH NEW D-200

PHOTO 1      Description      Bent 1 joint missing material

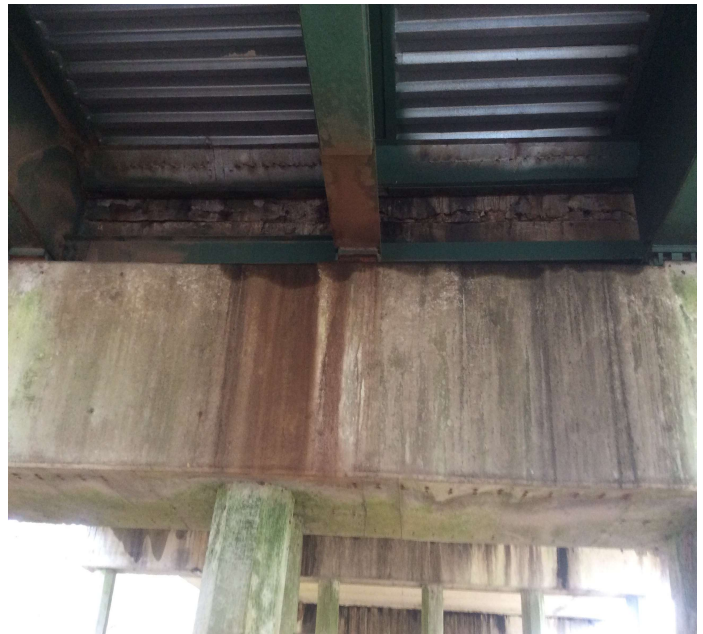
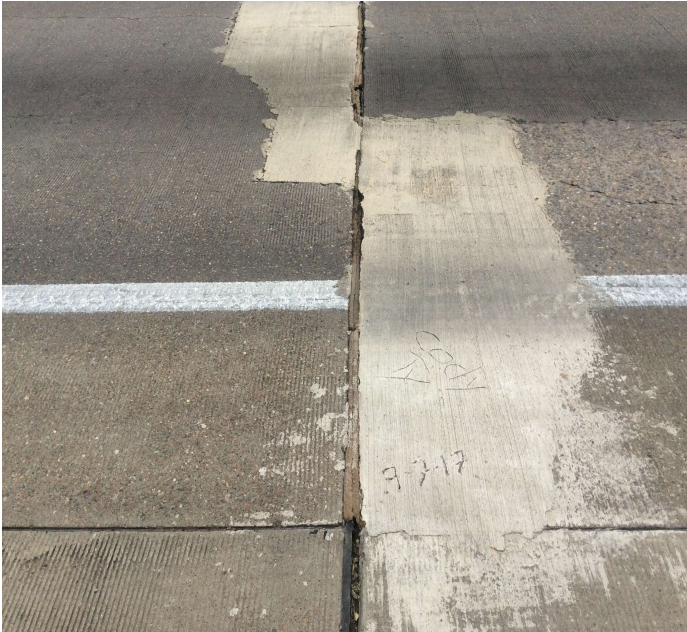
CONSTRUCTION JOINTS;

VARIOUS LOCATIONS

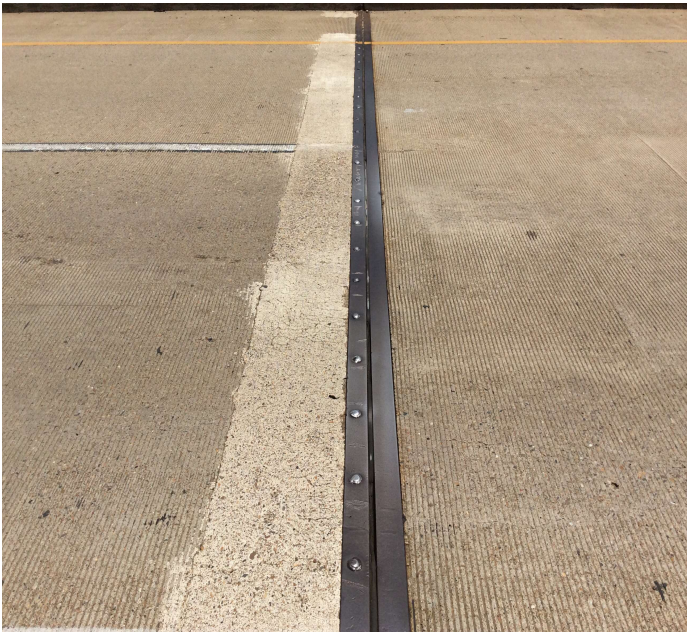
PHOTO 4 Description Pier 2 joint

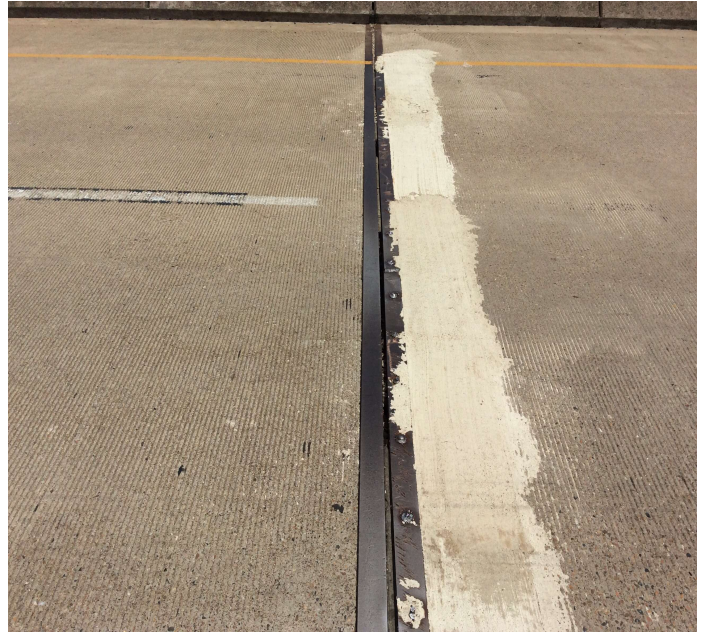
PHOTO 5 Description Pier 1 leaking/ missing 5 ft

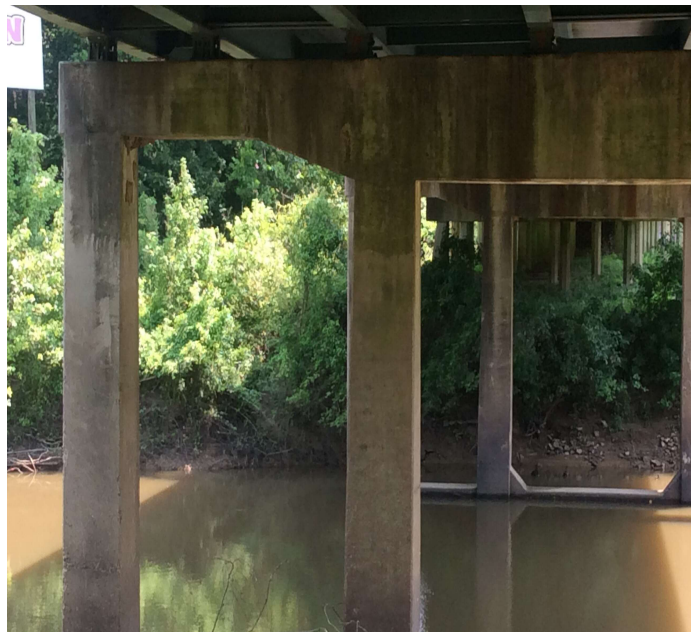
PHOTO 1      Description      Pier 1 in water spall with rebar exposed  
1 sq ft  
On It side at column 2

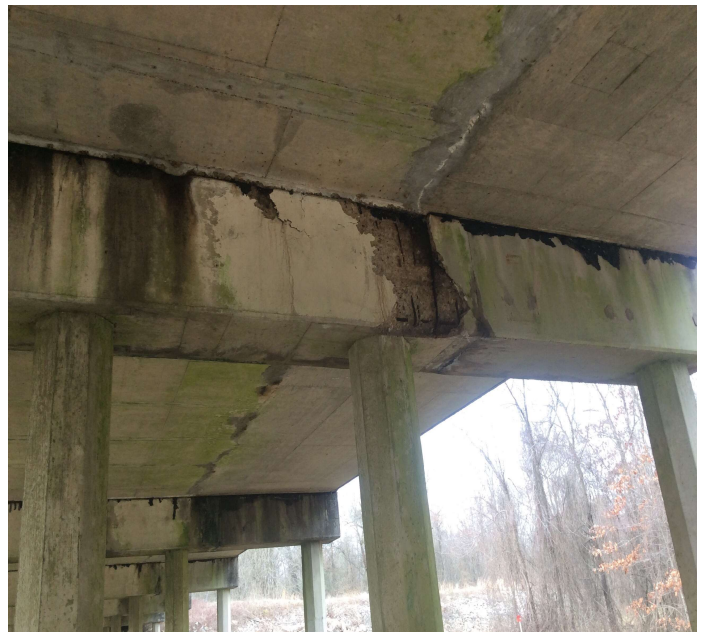
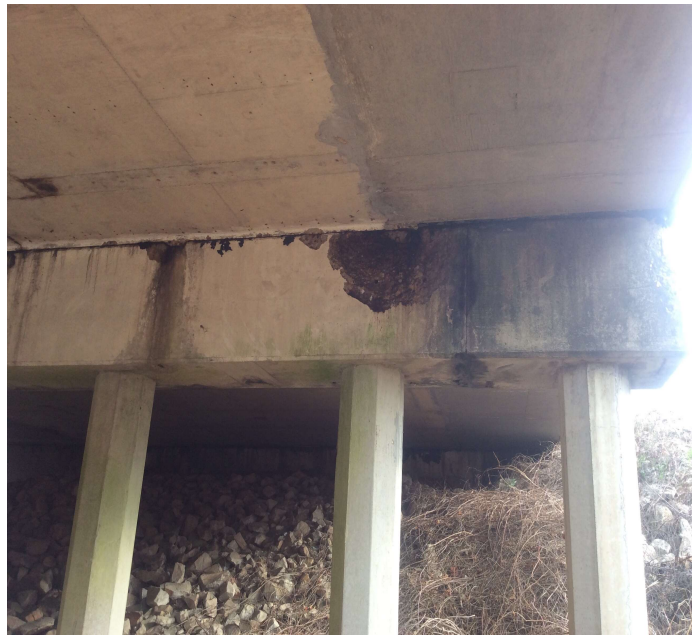
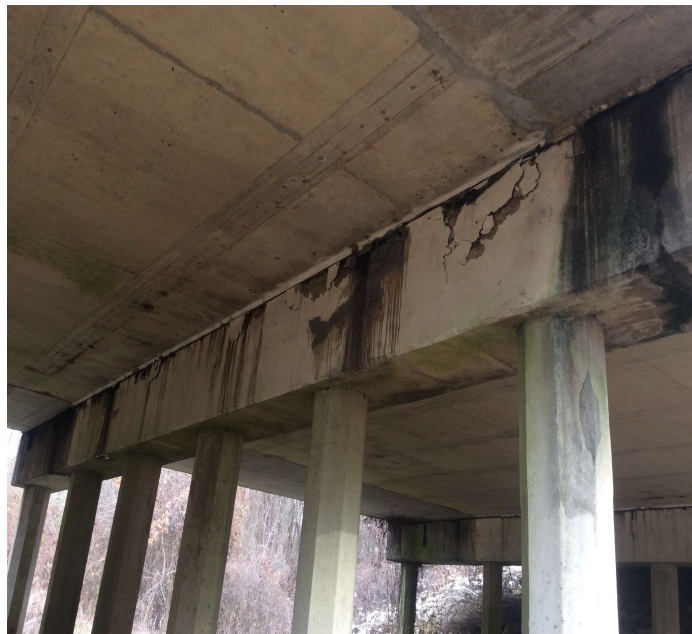
BENTS #2,4,5,6,7,8,9,10,11,13,14,15,16,17, 18,19,20,21,22,23,24,&25 MINOR SPALLS AND DELAMNS@ VARIOUS LOCATIONS ON THE CAPS ,PIER 1 spall with rebar exposed.

BENT 6; LARGE DELAM OVER COLUMN 2 ON THE CAP

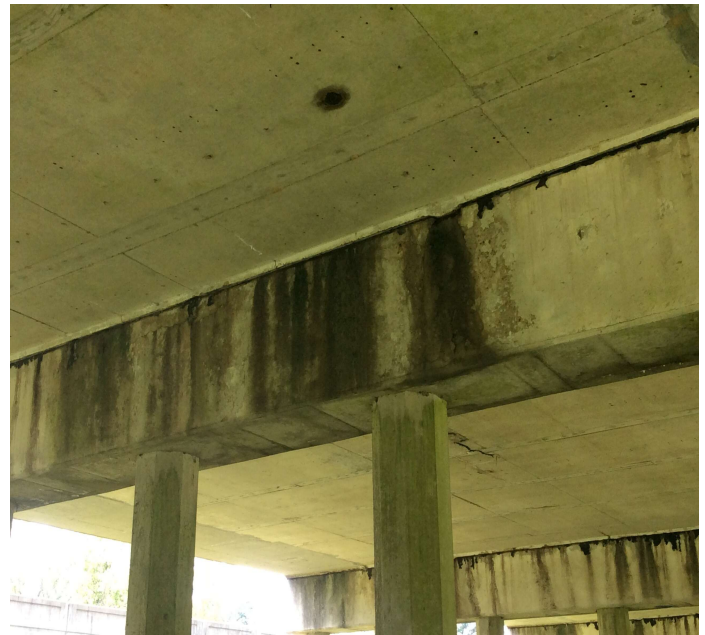
PHOTO 5 Description Bt 14 cracking 9 LF

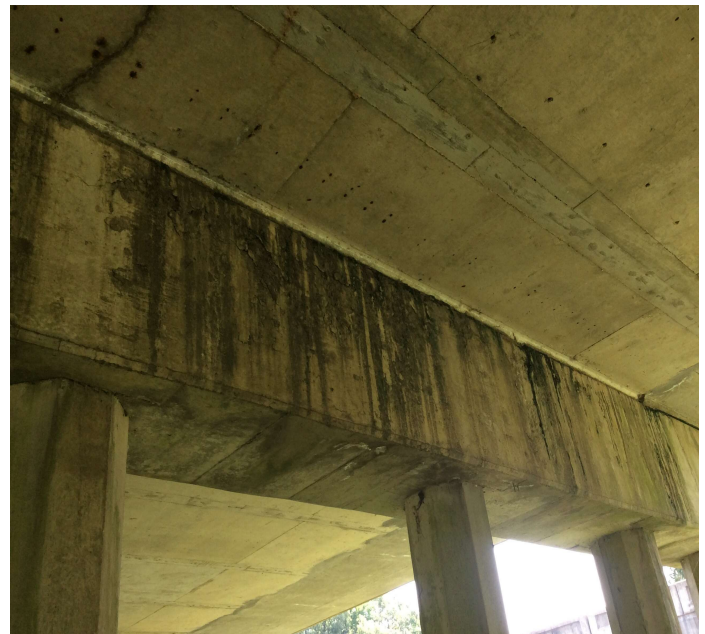
PHOTO 6 Description BT 14 spalls less than 1" depth  
12 LF total

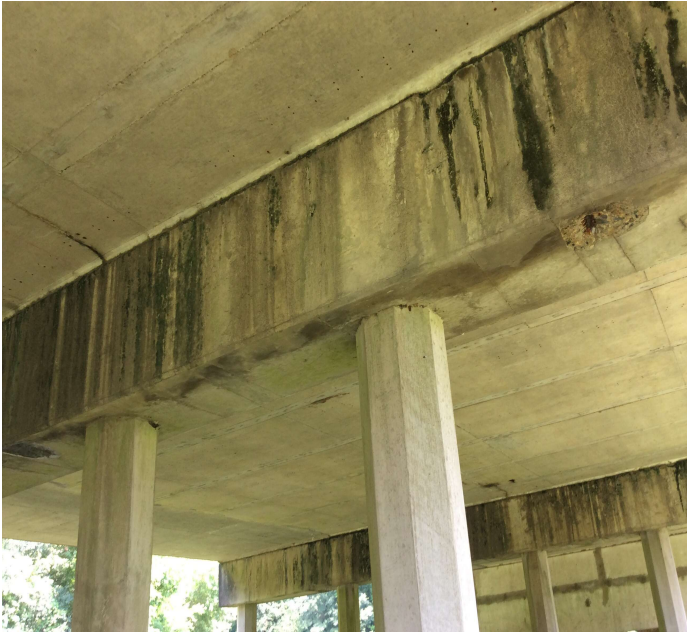
PHOTO 7 Description BT 13 spall with rebar exposed and delam  
Spall rebar 3 LF

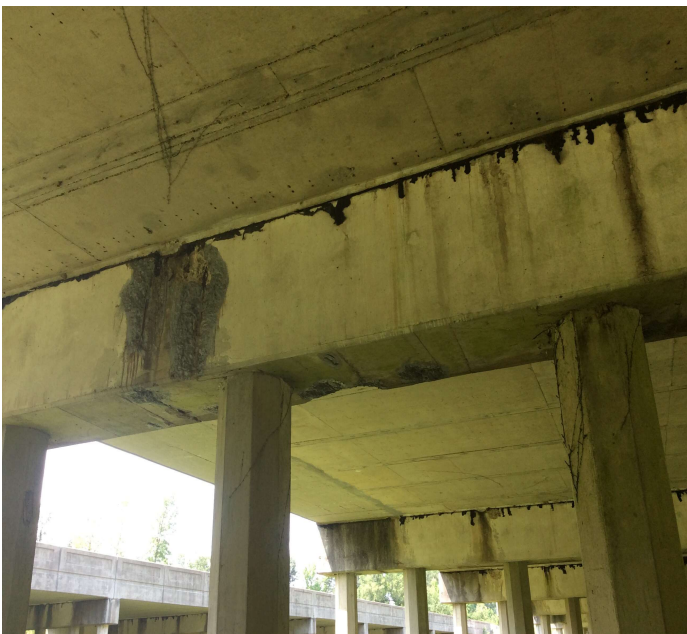
PHOTO 8 Description BT 11 spalls rebar exposed 10 LF

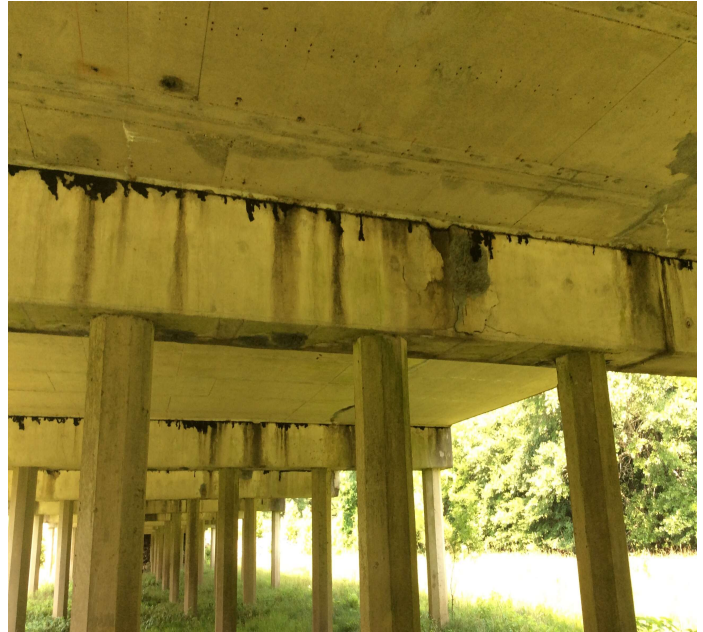
PHOTO 9 Description BT 10 spalls rebar exposed and delam  
9 total LF .  
6 LF rebar  
3 LF delam

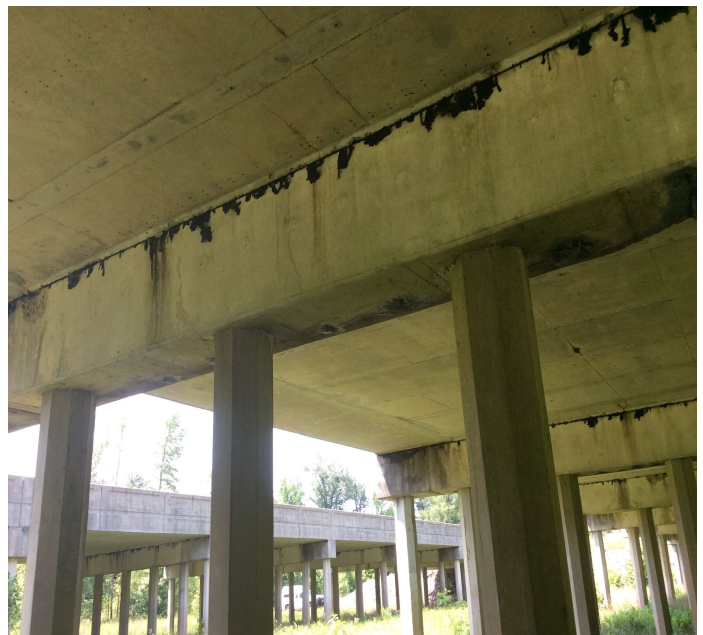
PHOTO 10 Description BT 9 cap spalls and rebar total 9 LF .  
6 LF rebar exposed  
2 LF delam

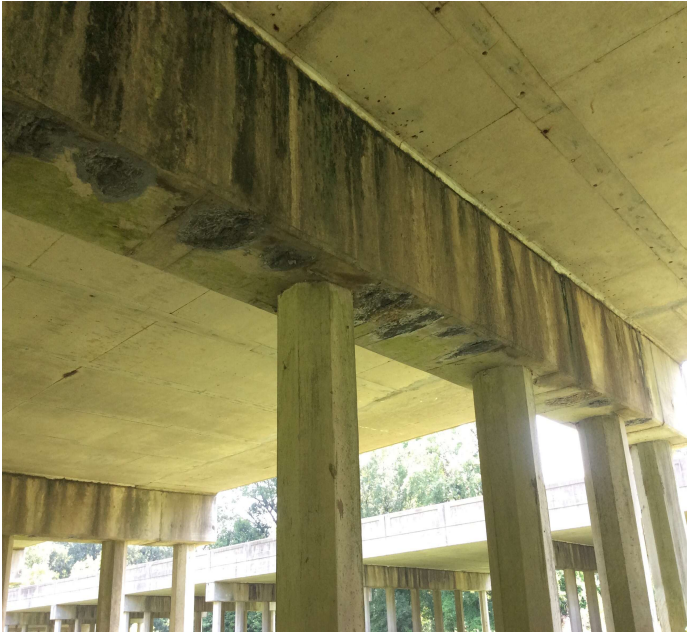
PHOTO 11 Description BT 8 spalls rebar exposed  
13 LF total

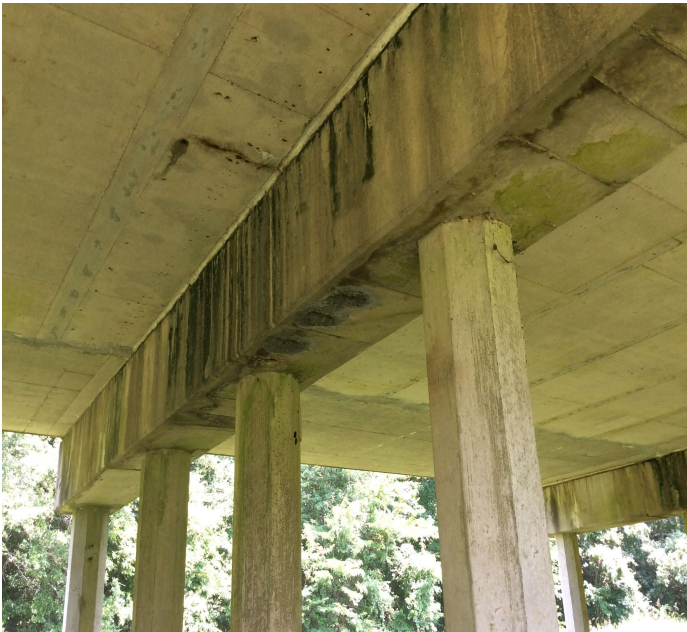
PHOTO 12 Description BT 7 spalls and delam total 6 LF  
Spall 2 LF  
Delam 4 LF

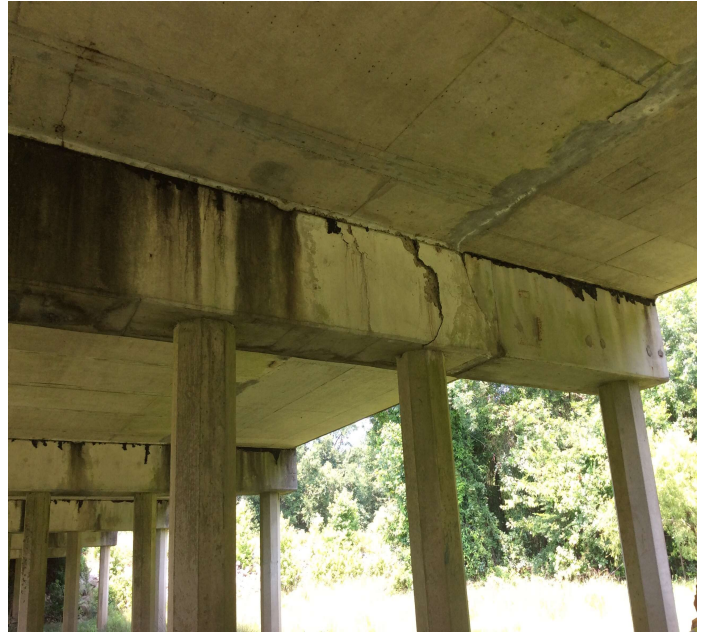
PHOTO 13 Description Bt 6 lt side delam at pile 2 on cap  
2 LF  
Rebar exposed 2 LF on cap also.

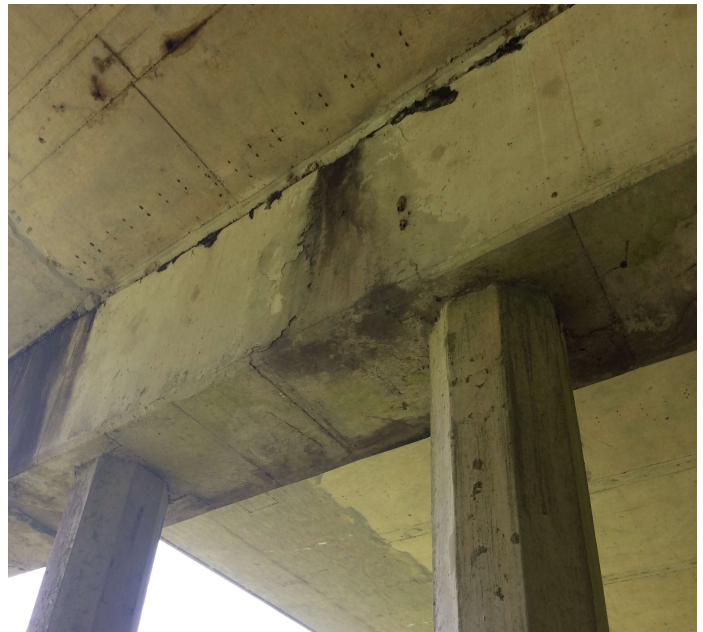
PHOTO 14 Description BT 5 delam on cap at pile 5&6 on cap  
1 LF

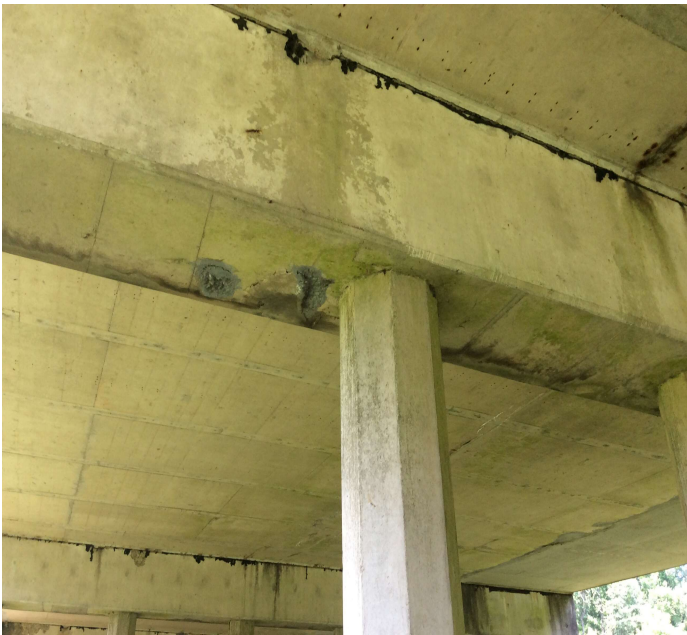
PHOTO 15 Description BT 4 cap 2 LF rebar exposed  
1 LF delam

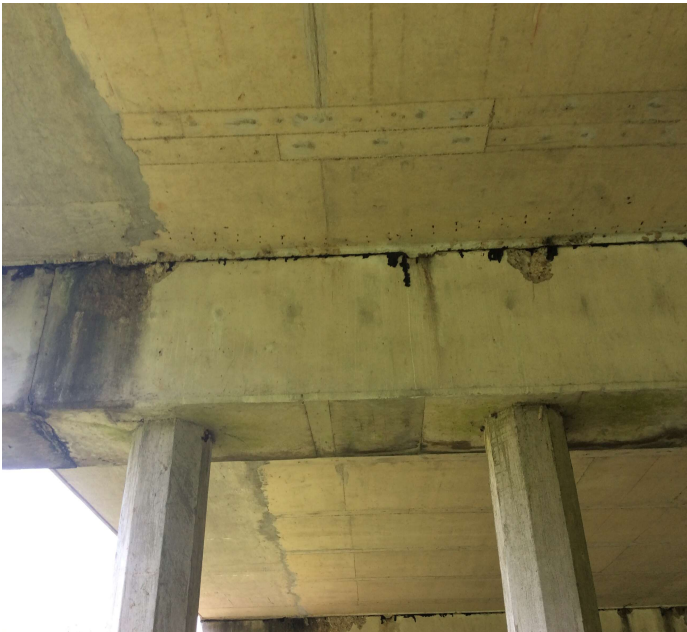
PHOTO 16 Description BT 3 cap spalls  
3 LF

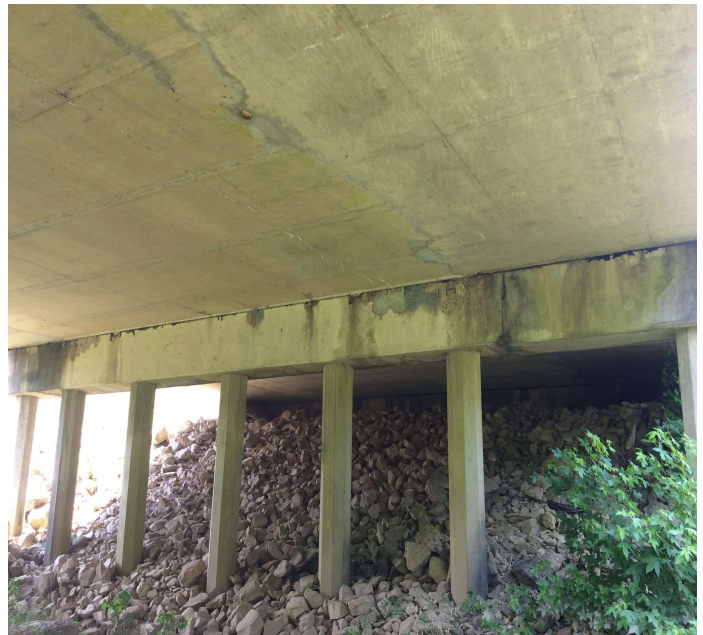
PHOTO 17 Description BT 2 cap spalled and some rebar  
exposed  
Spall 10 LF  
Rebar exposed 3

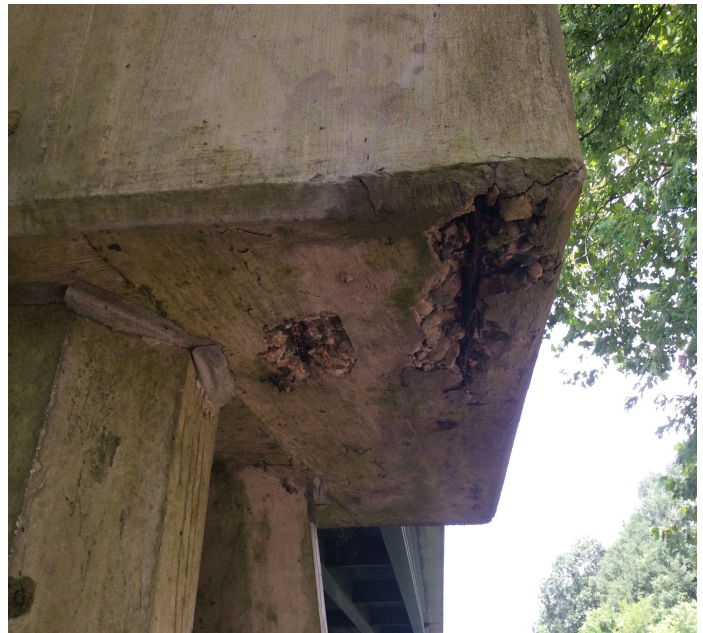
PHOTO 18 Description Bent 16 spall rebar exposed, bottom of  
cap, north end.

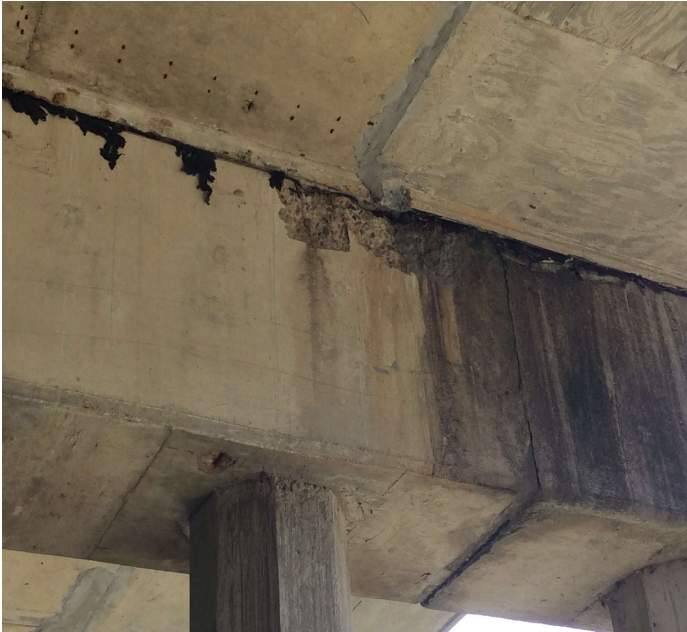
PHOTO 19    Description    Bent 17 spalls top of cap west face south end

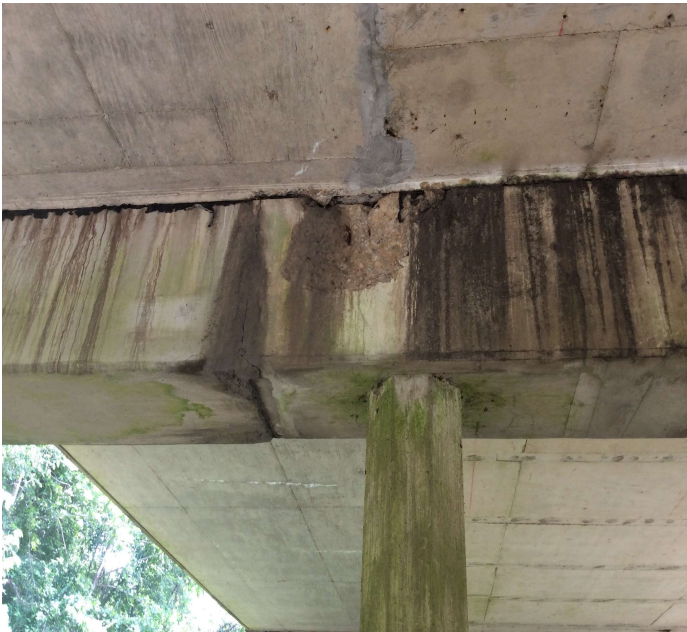
PHOTO 20    Description    Bent 18 spalls with rebar exposed.

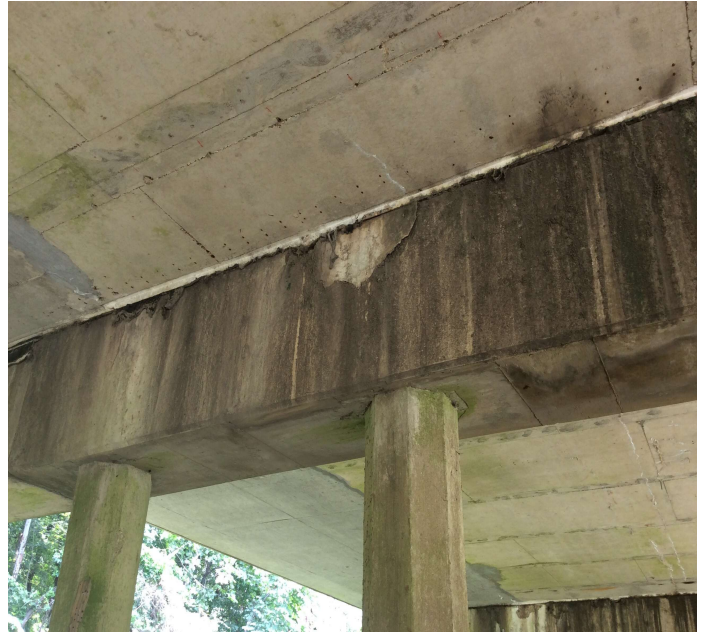
PHOTO 21    Description    Bent 19 delamn on west face,small spall with rebar exposed on east face south end

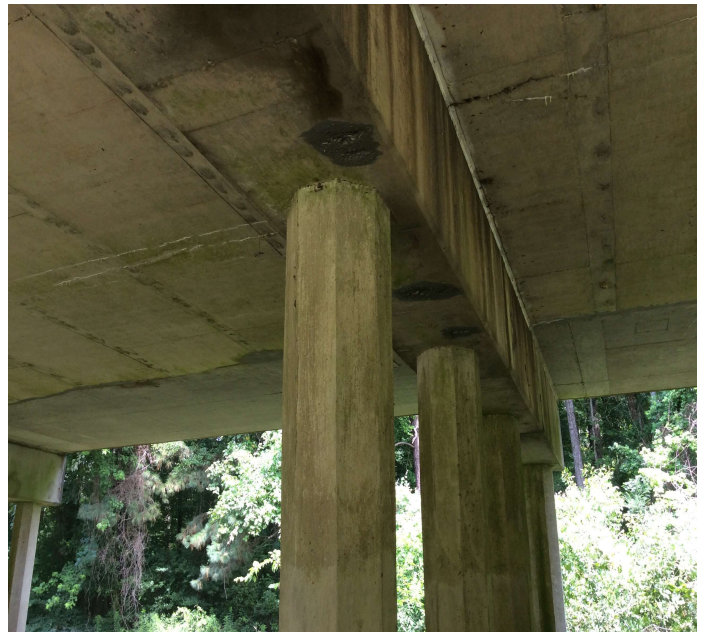
PHOTO 22    Description    Bent 20 spalls on cap

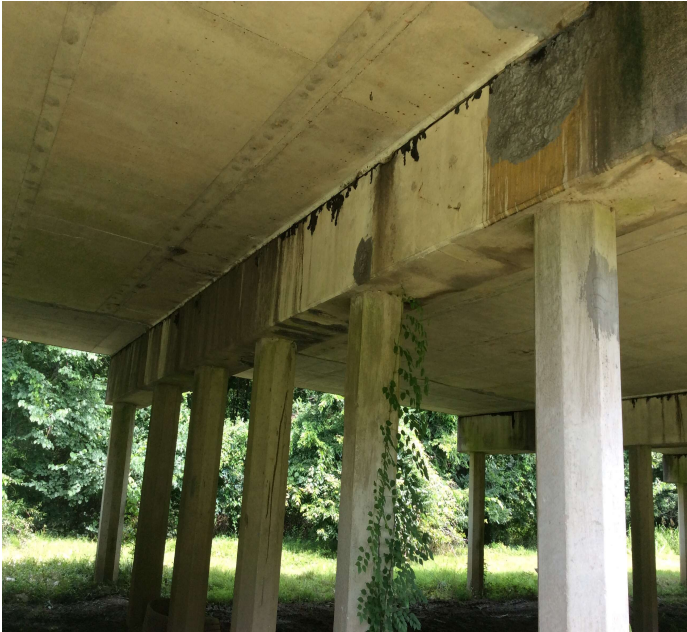
PHOTO 23    Description    Bent 21 spalls and spalls with rebar exposed

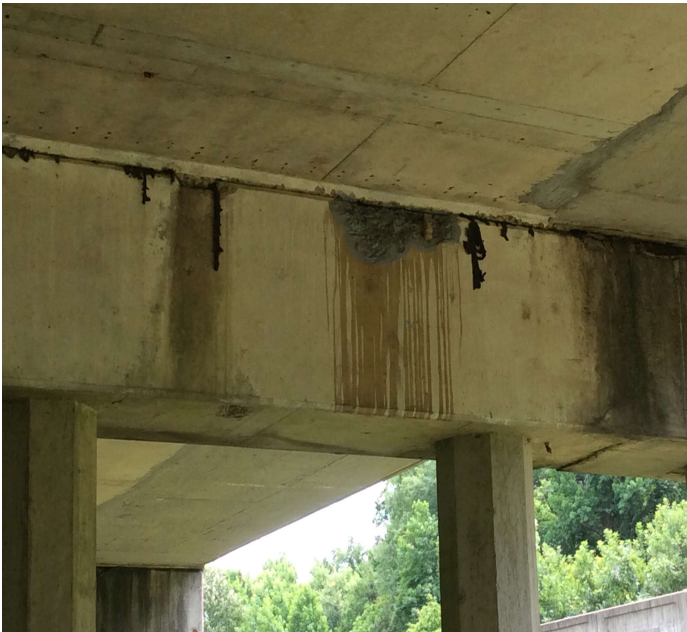
PHOTO 24    Description    Bent 22 spall west face

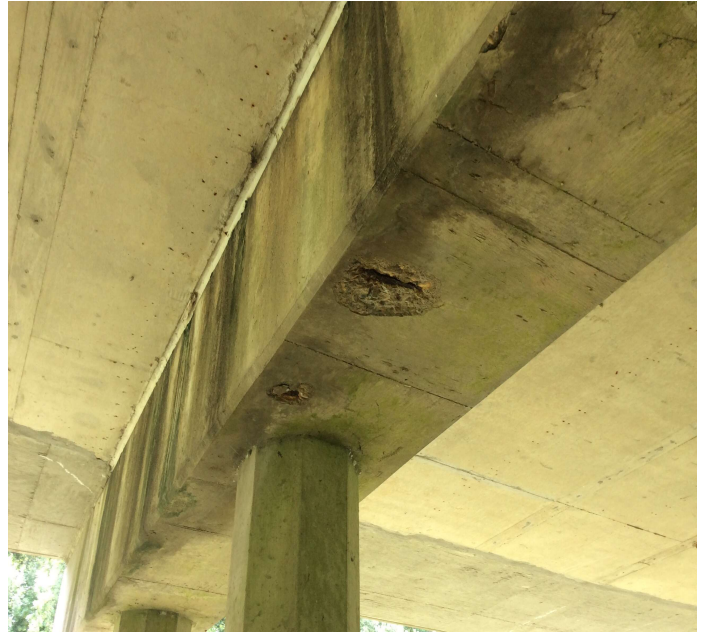
PHOTO 25    Description    Bent 23 spalls rebar exposed

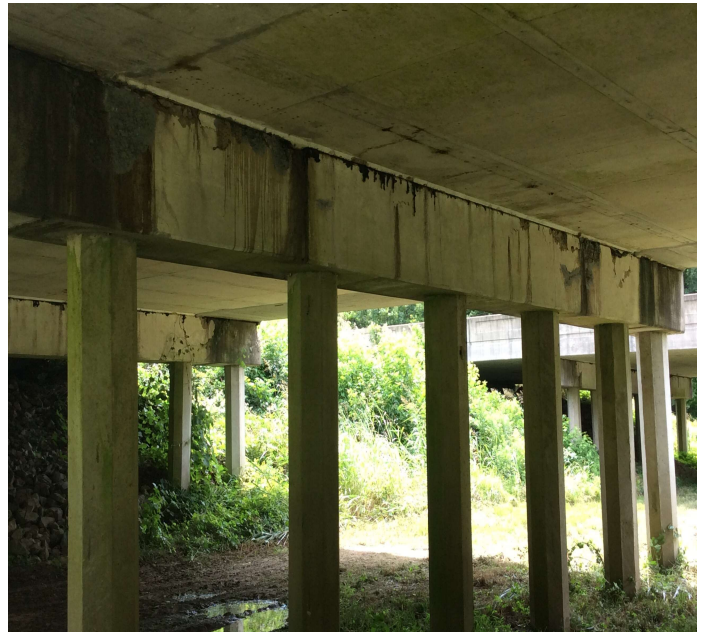
PHOTO 26    Description    Bent 24 spalls and delamns.

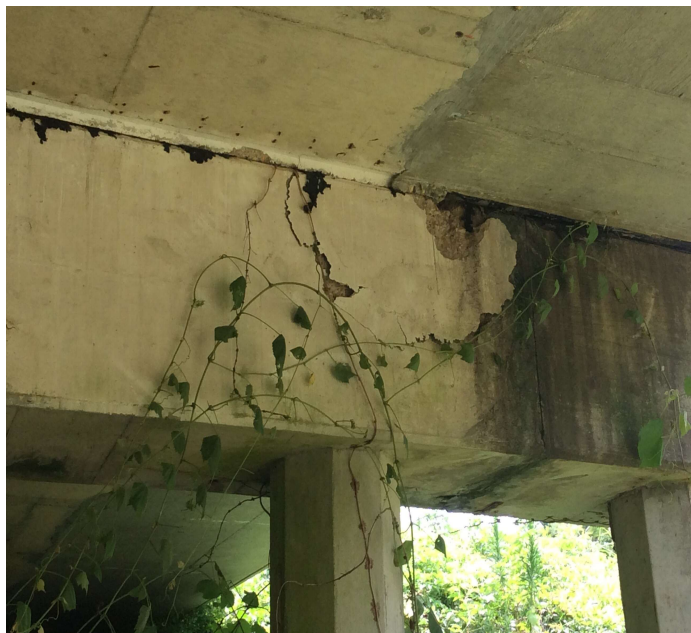
PHOTO 27    Description    Bent 25 spalls and delamns.

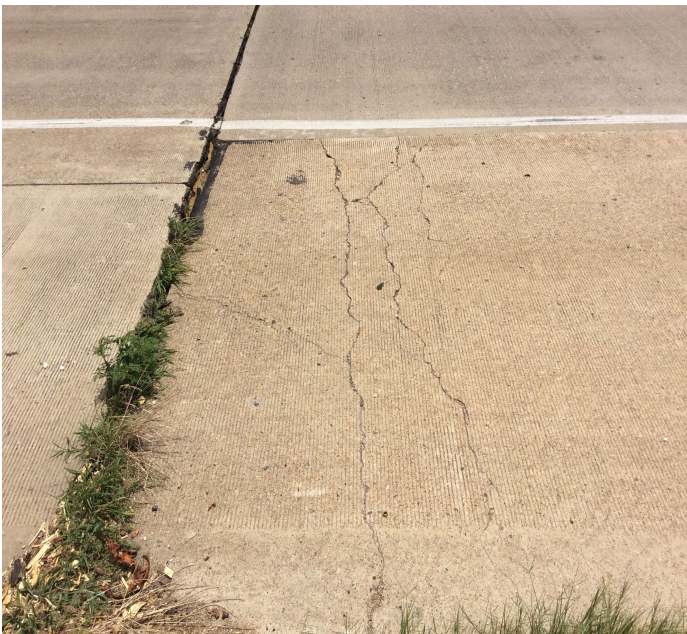
RT. SHOULDER HAS SOME SETTLEMENT AND CRACKING IN IT

PHOTO 1 Description Bent 1 approach gutter cracks

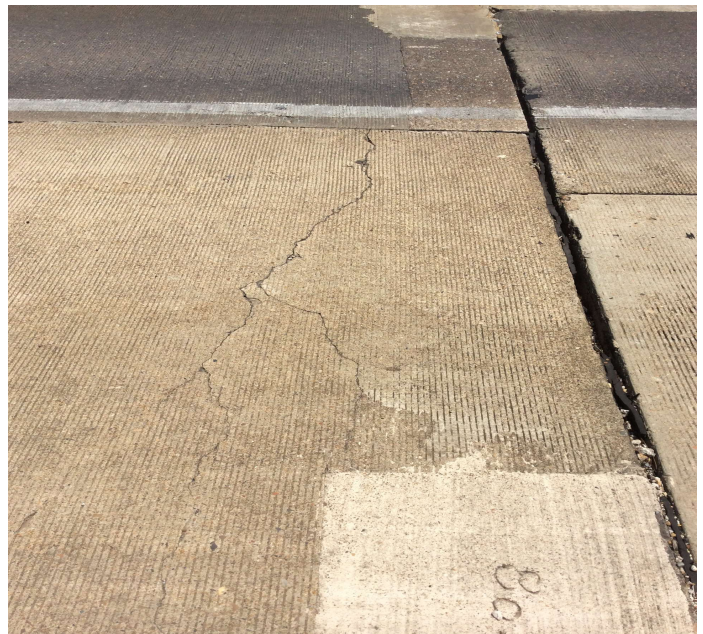
PHOTO 2 Description Approach gutter on east end of bridge

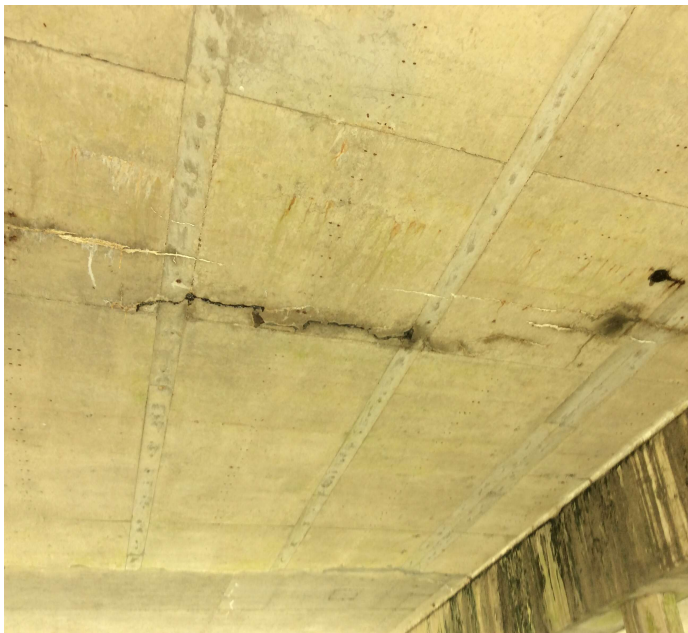
PHOTO 1      Description      Span 13 bottom deck small delam  
With efflorescence staining .  
36 sq ft total

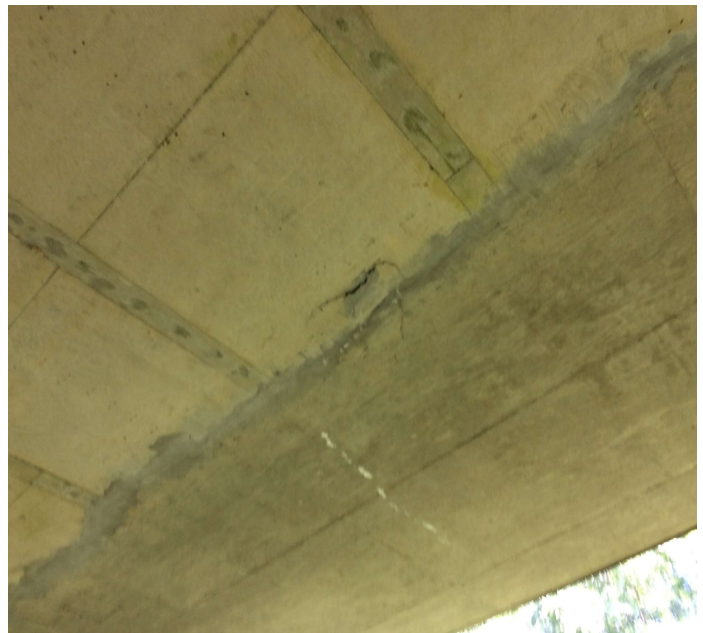
PHOTO 2      Description      Span 7 delam 4 sq ft

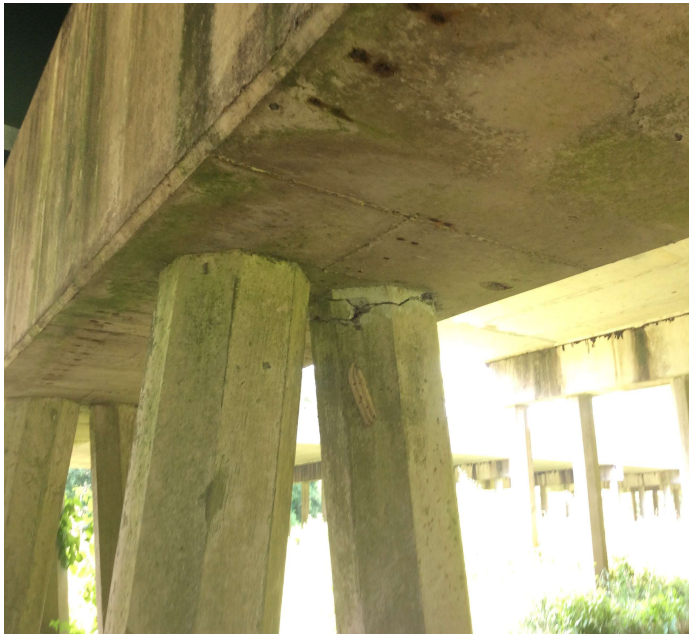
PHOTO 1      Description      BT 15 main Spain pile 4 cracking in top of concrete pile

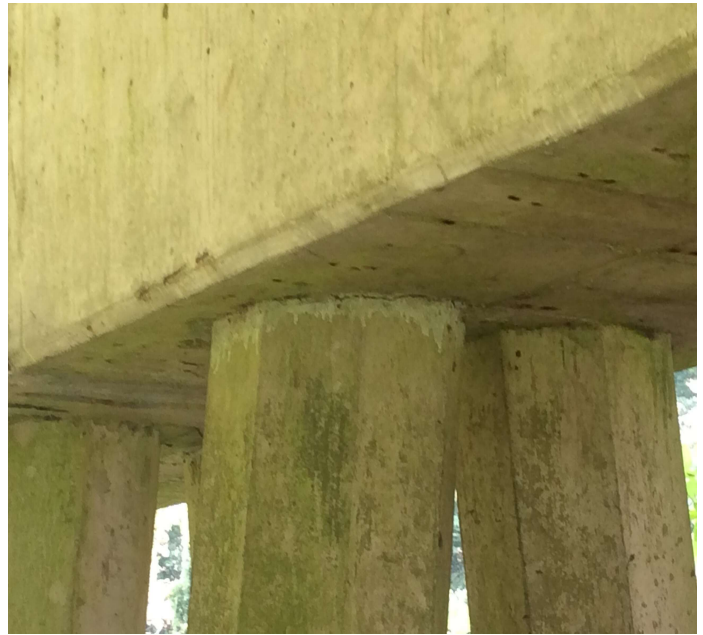
Cracking at top of concrete pile  
2&3 BT 15 main Span

PHOTO 2      Description      BT 15 main Spain pile 3 cracking in top of concrete pile

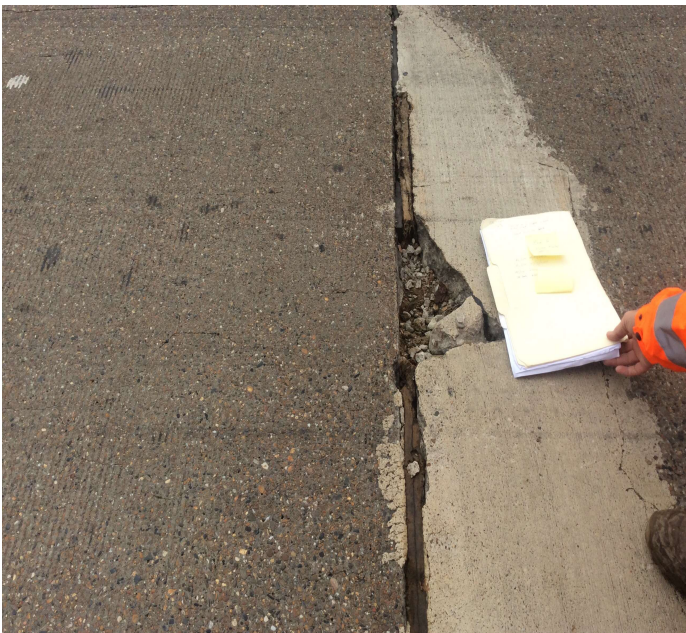
HOLE IN DECK BENT 21 SLOW LANE.

PHOTO 1    Description    HOLE IN DECK BENT 21 SLOW LANE

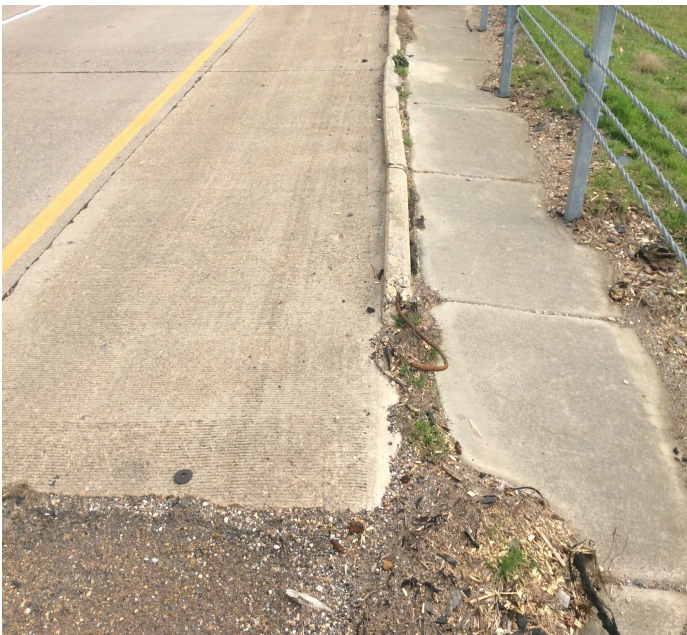
PHOTO 1      Description      WHEEL GUARD BROKEN WITH  
REBAR EXPOSED 15 ft.

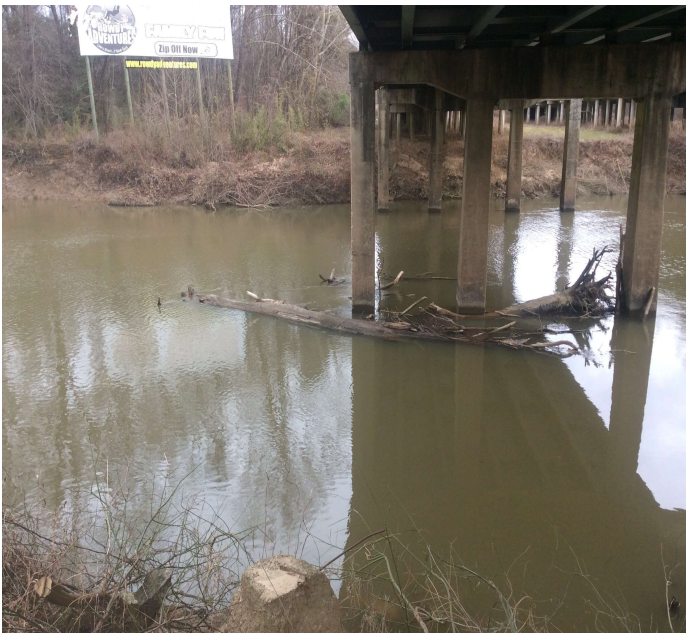
DRIFT AGAINST BENT IN CHANNEL NEEDS TO BE REMOVED
