Bridge Inspection Report

B5022

I-30-13-52.97 E.B.

LITTLE MISSOURI RIVER

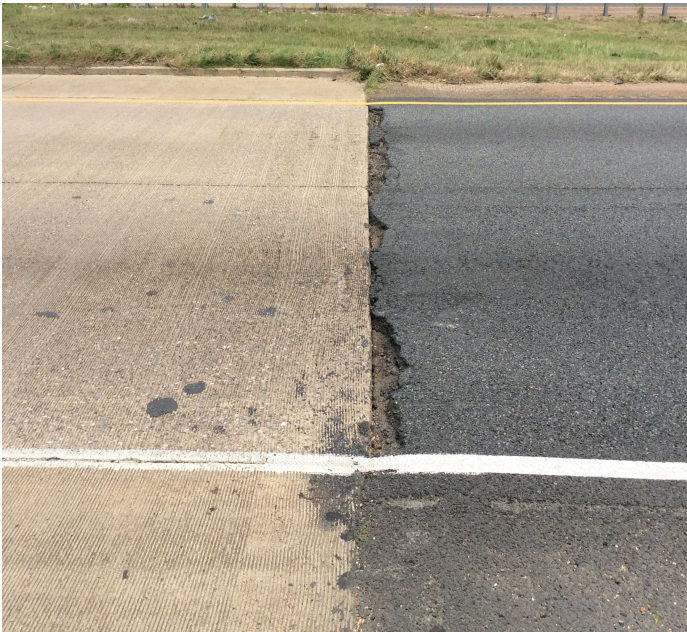
BEGIN BRIDGE ASPHALT RUTTING ,END BRIDGE ASPHALT HAS POT HOLES AND SOME RUTTING SEE PHOTO'S

PHOTO 1 Description End of approach slab west bound lanes
deep ruts and pot holes

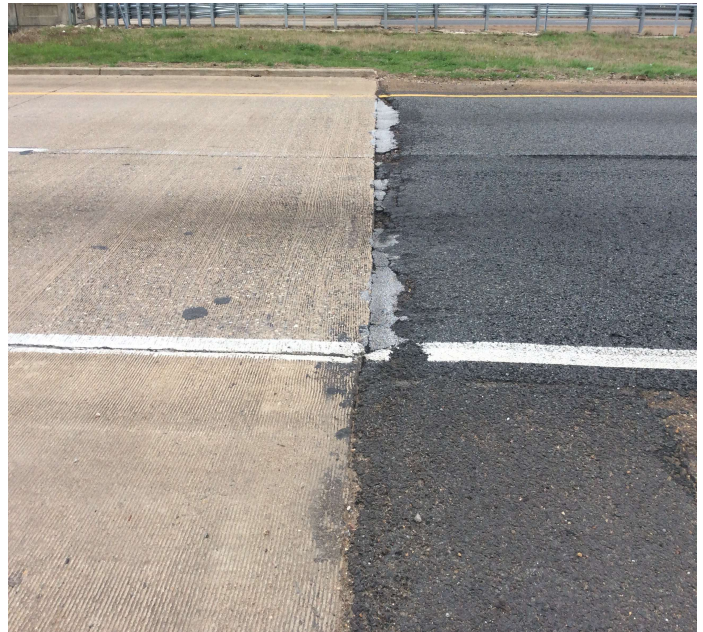
PHOTO 2 Description ASPHALT AT END OF APPROACH
NEEDS REPAIR.

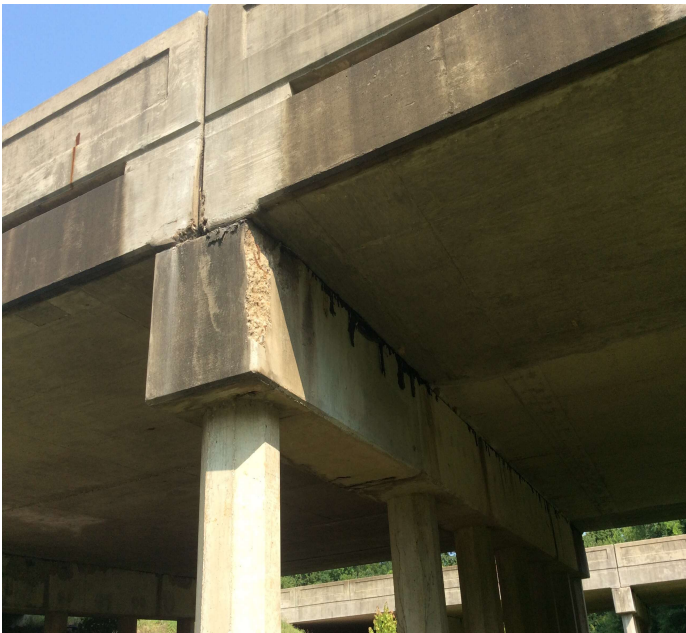
BENT #3 RT & LT END OF CAP LARGE SPALL ON END

PHOTO 1 Description Bent 3 cap spall on rt and lt ends
3 LF

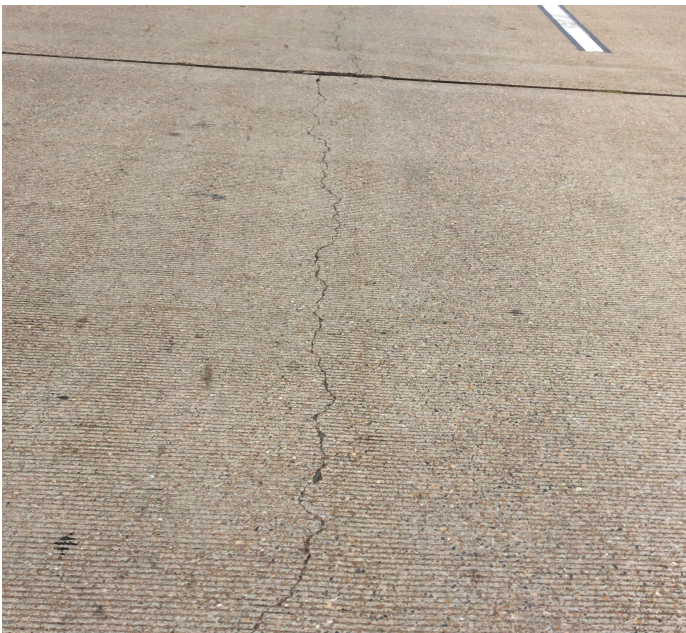
DECK CRACKS IN ALL SPANS NUMERIOUS SEALABLE DECK CRACKS

PHOTO 1 Description Span 27 deck cracks

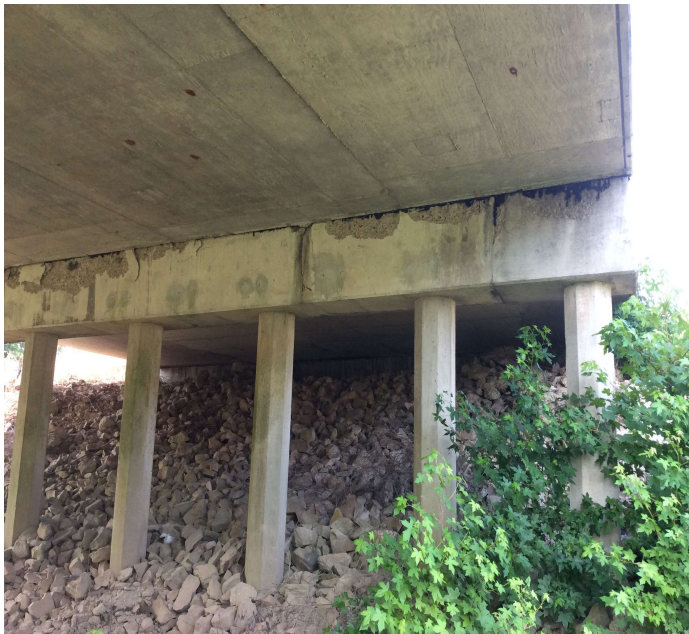
BENTS # 2,4,5,6,7,9,10,13,14,15,16,18,19,20,21,22, 23,24,& 25 MINOR TO LARGE SPALLS AND DELAMINATIONS @ VARIOUS LOCATIONS ON THE CAPS.

PHOTO 1 Description BT 2 cap spalls
18 LF

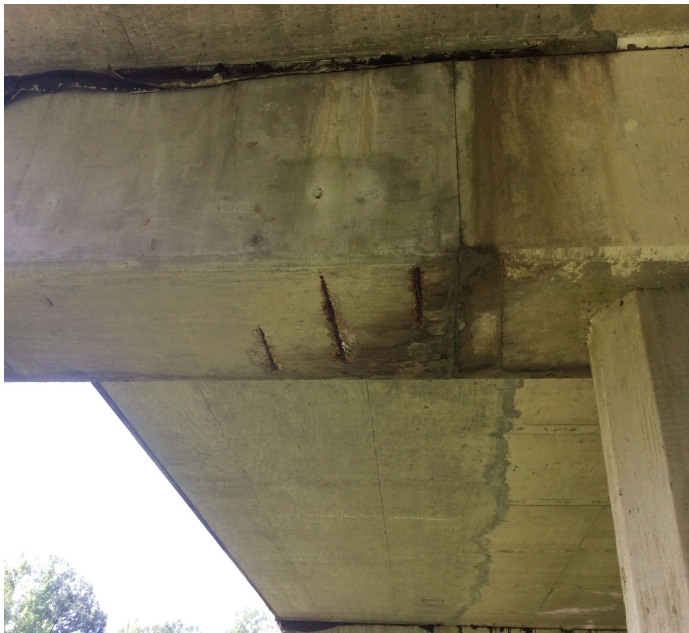
PHOTO 3 Description Bottom cap spall rebar exposed 2 LF
Between pile 6 & 7

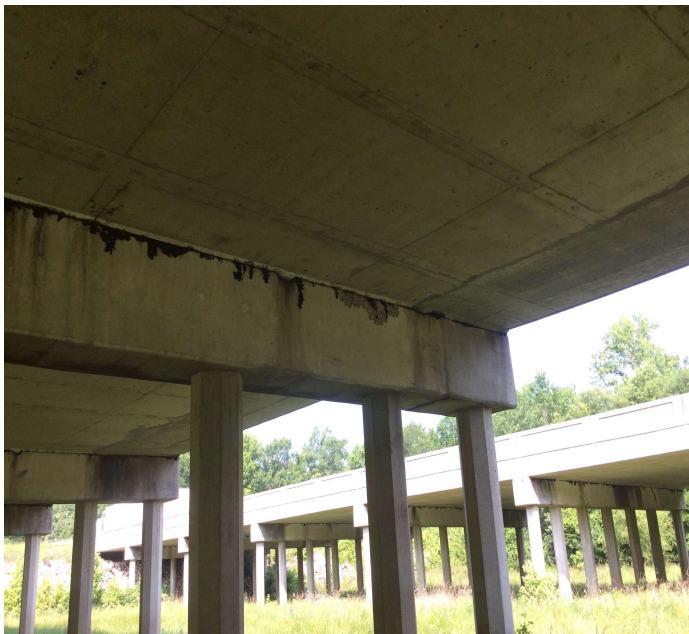
PHOTO 4 Description BT 7 cap spall 3 LF at pile 3

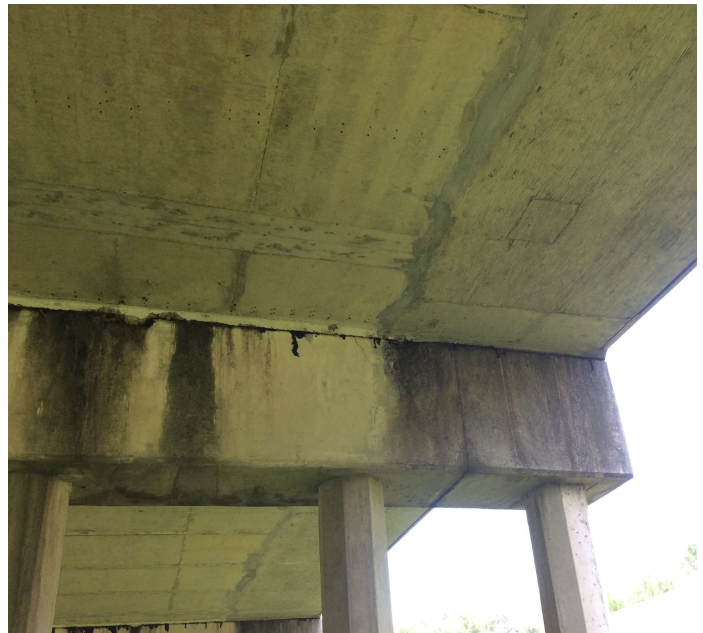
PHOTO 5 Description BT 9 spall at pile 2 for 2 LF

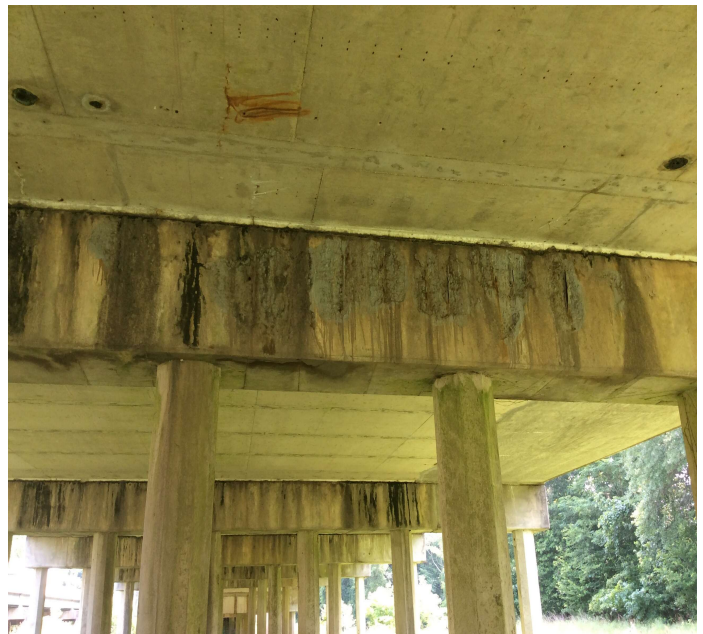
PHOTO 6 Description BT 10 spalls with rebar exposed 10 LF
Area has some paint

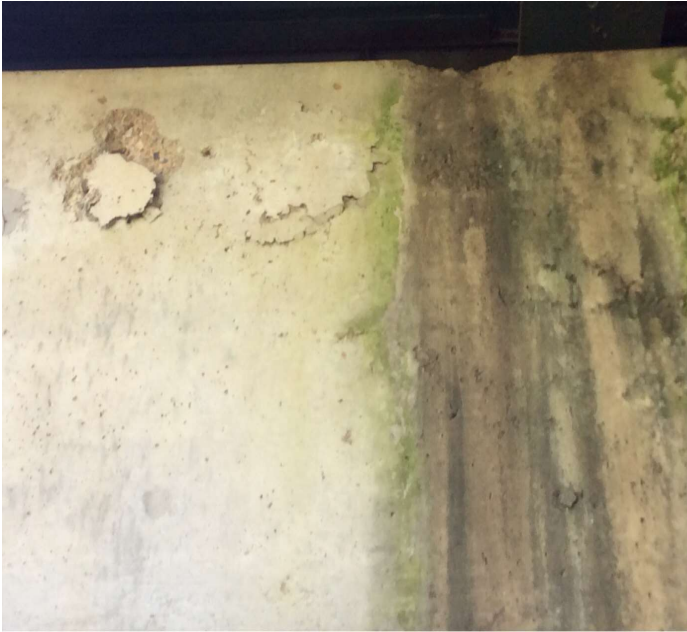
PHOTO 11 Description Delams at bent 16

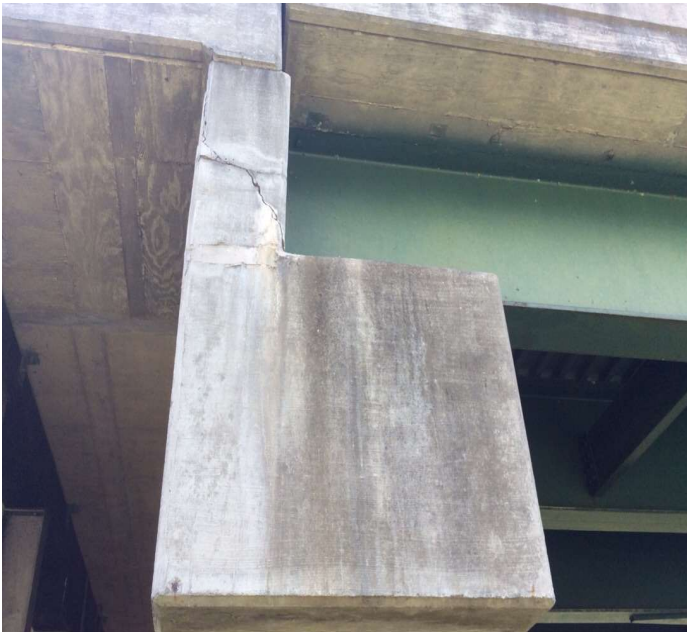
PHOTO 12 Description Crack in riser at bent 16

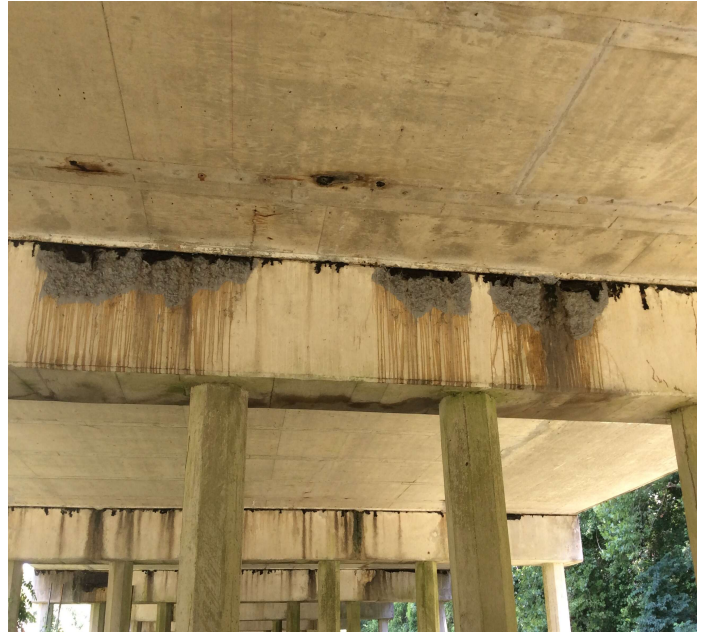
PHOTO 13 Description Bent 18 large spall west face

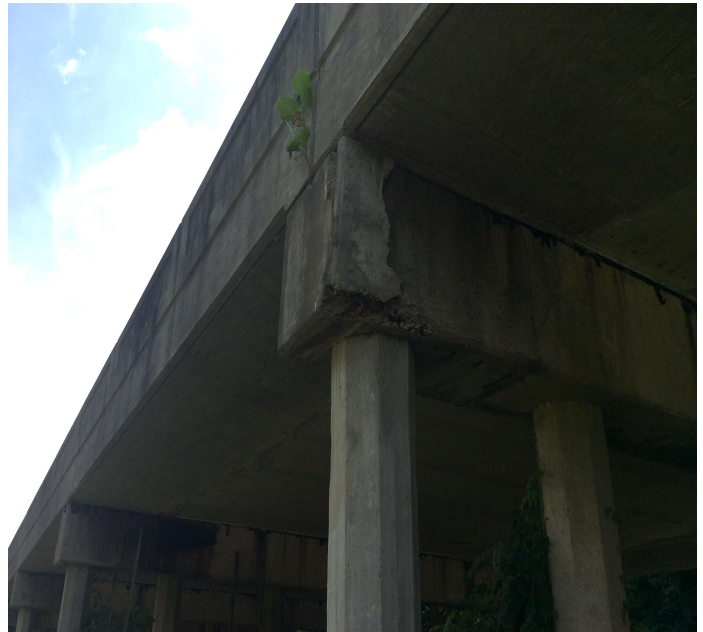
PHOTO 14 Description Bent 19 west face north end of cap.

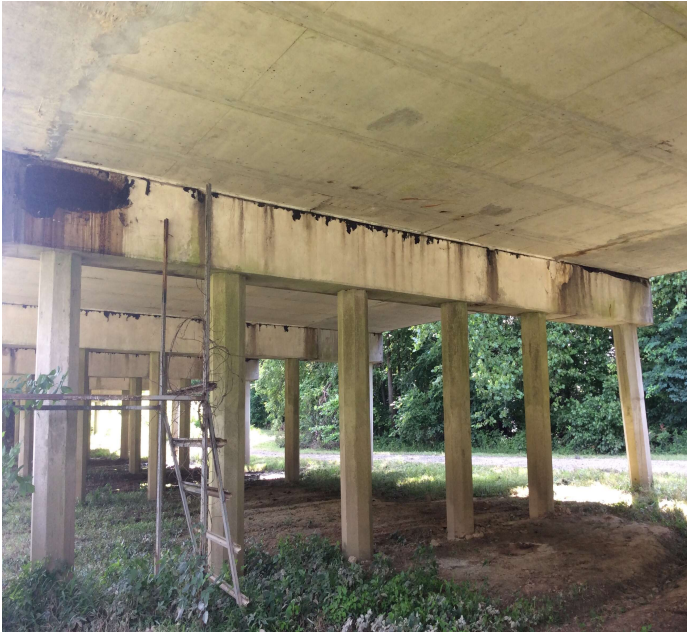
PHOTO 15 Description Bent 20 spall with rebar, and delams.

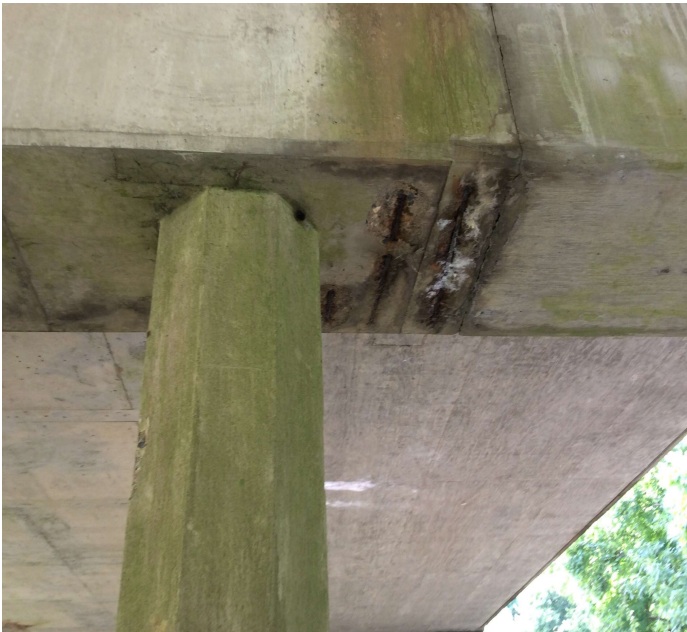
BENT #21 CAP SMALL SPALLS W/ REBAR EXPOSED

PHOTO 16 Description Bent 21 spall with rebar exposed

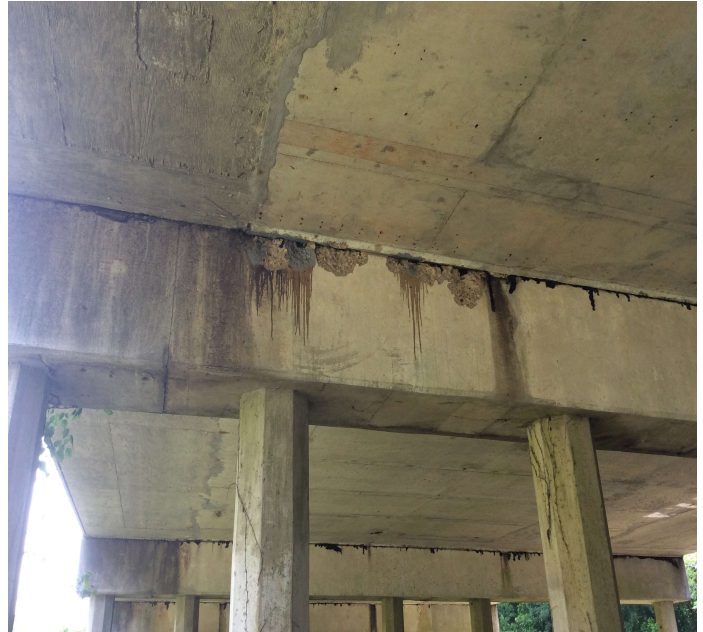
PHOTO 17 Description Bent 22 spall top of cap west face

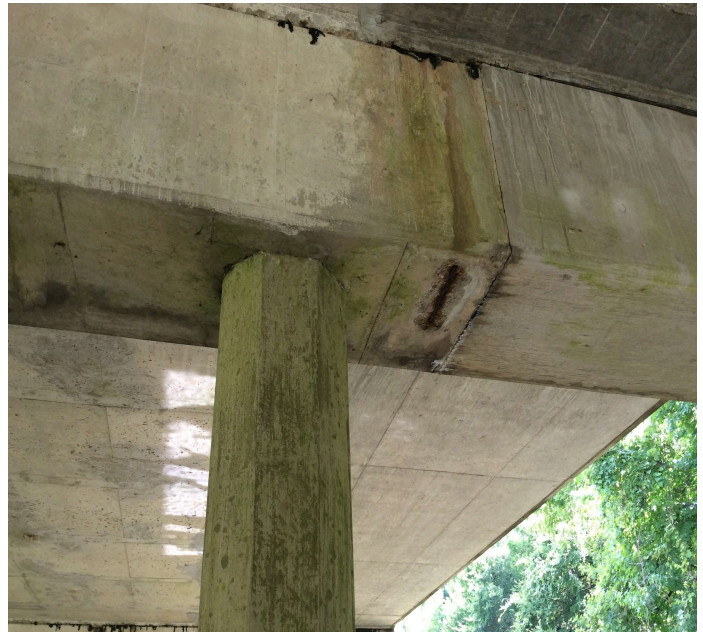
PHOTO 18 Description Bent 22 spall bottom of cap rebar exposed.

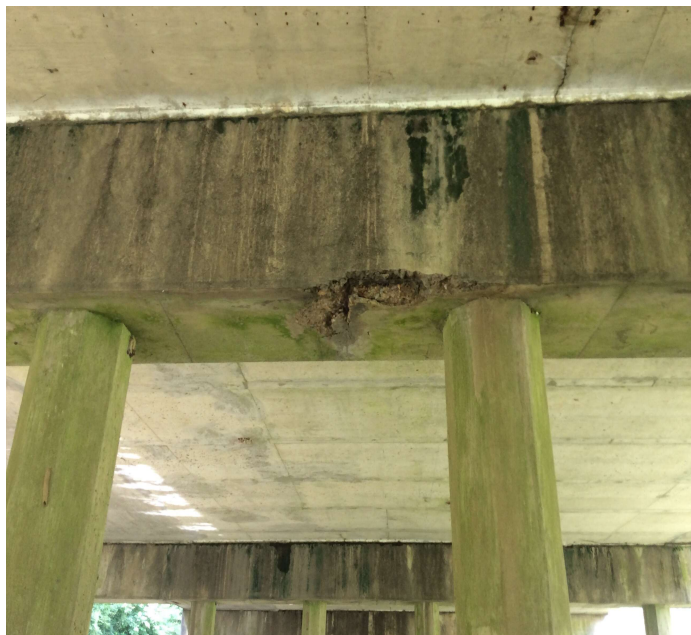
PHOTO 19 Description Bent 23 spall bottom of cap rebar exposed.

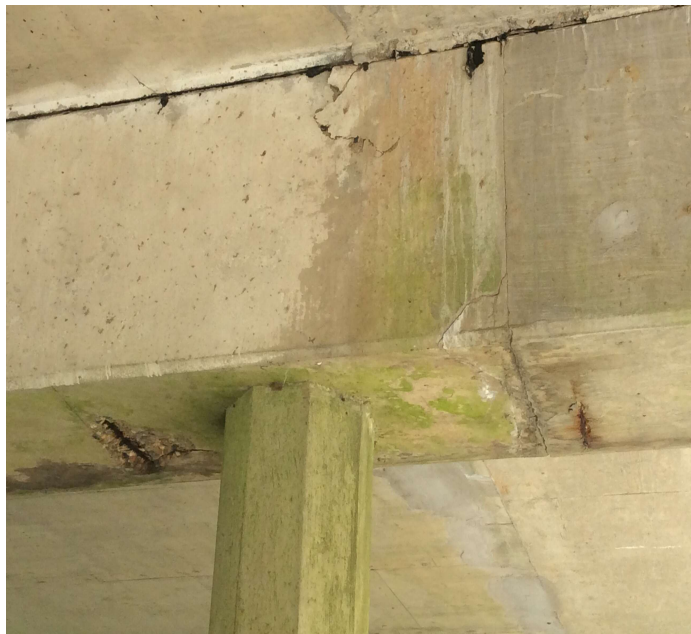
PHOTO 20 Description Bent 24 spalls, spalls with rebar exposed, and delams.

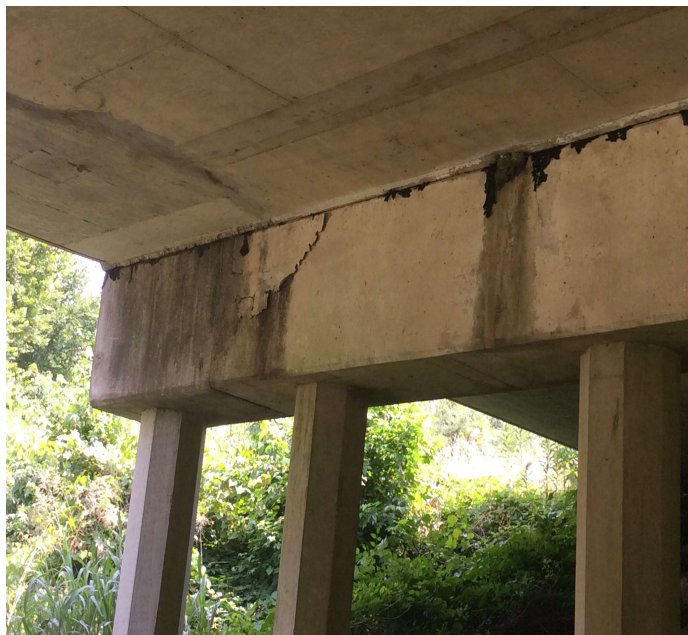
PHOTO 21 Description Bent 25 spalls and delams.

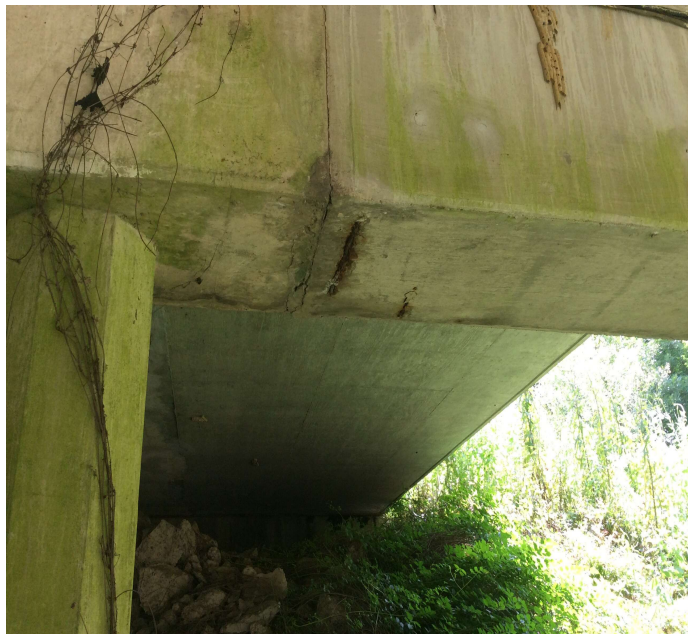
PHOTO 22 Description Bent 25 spall rebar exposed

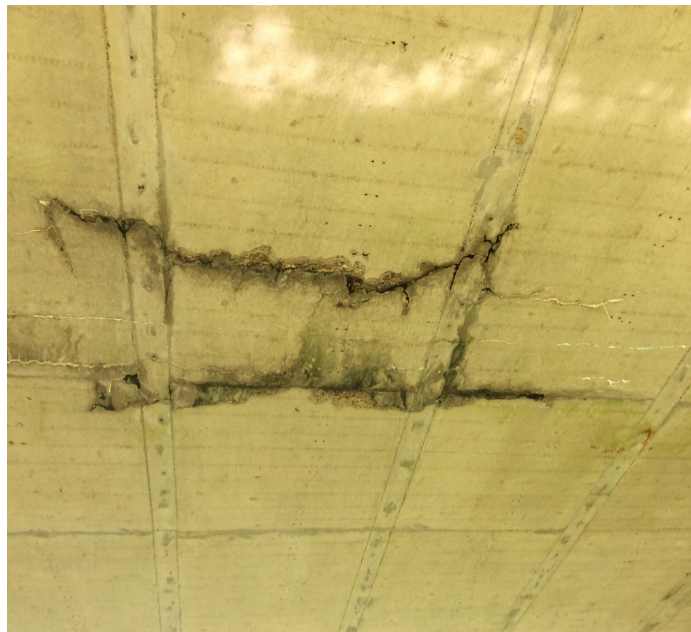
SOFFIT AREA ALONG C/L OF BRIDGE IN SPAN #4. SPALLED AREA APPROX. 3' X 8' =24 sq ft. And efflorescence 10 sq ft

PHOTO 1 Description Lg delam 8'x 3' and spall 24 sq ft span 4 center bridge

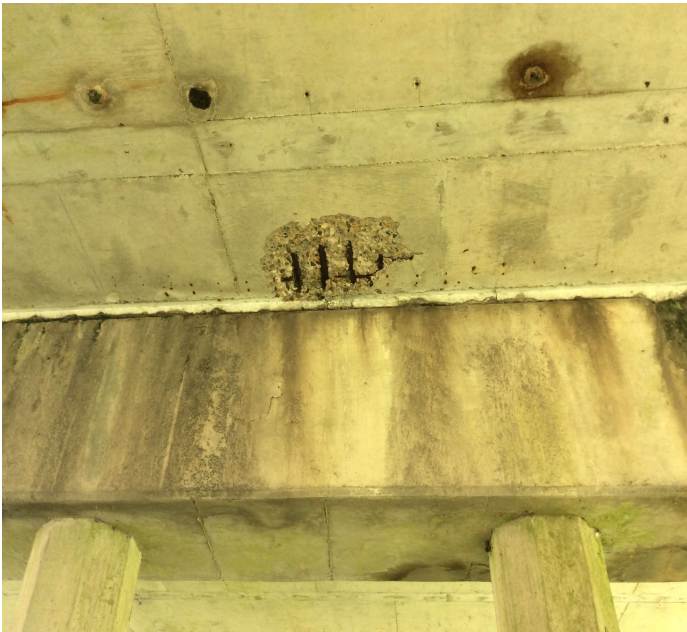
SPAN #8 AT BENT # 9
BETWEEN PILES 4 & 5 SPALL W/REBAR EXPOSED IN SOFFIT

PHOTO 4 Description SPAN #8 AT BENT # 9
BETWEEN PILES 4 & 5 SPALL
W/REBAR EXPOSED
IN SOFFIT 3 sq ft

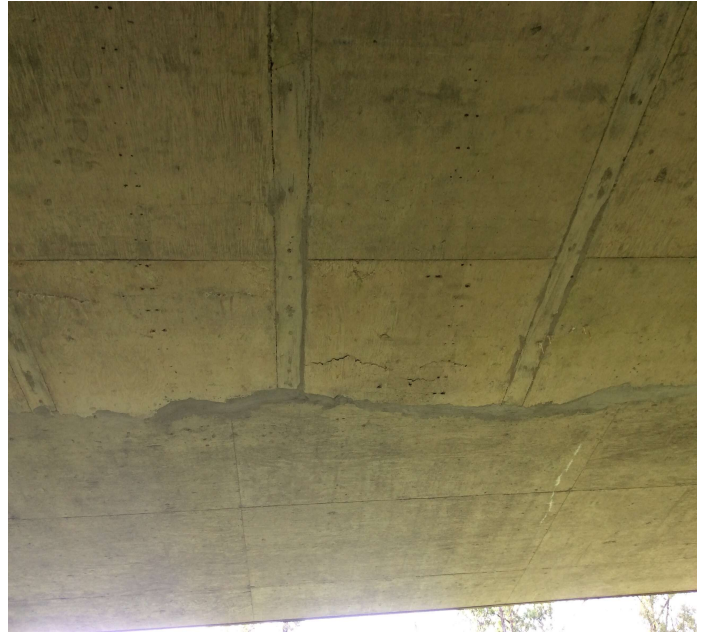
PHOTO 5 Description Delam bottom deck 4 sq ft
Efflorescence also.

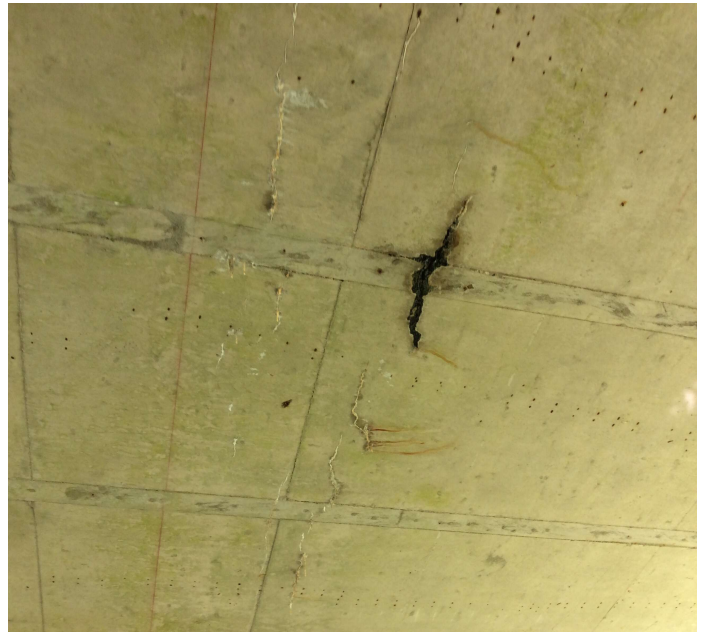
PHOTO 6 Description Span 12 efflorescence 40 sq ft white
stain 2 sq ft black stain

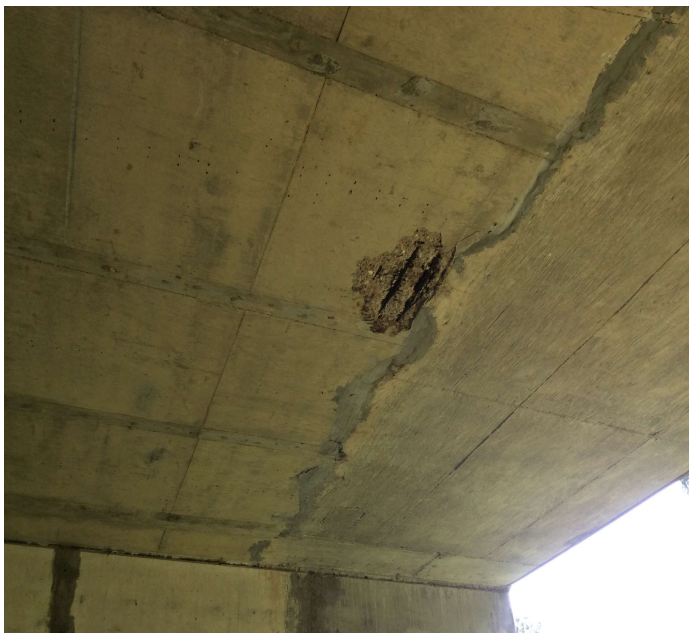
SPAN #14, RT. SIDE Spall rebar
Exposed .

PHOTO 7 Description Span 14 spall rebar exposed
4 sq ft section loss to rebar.

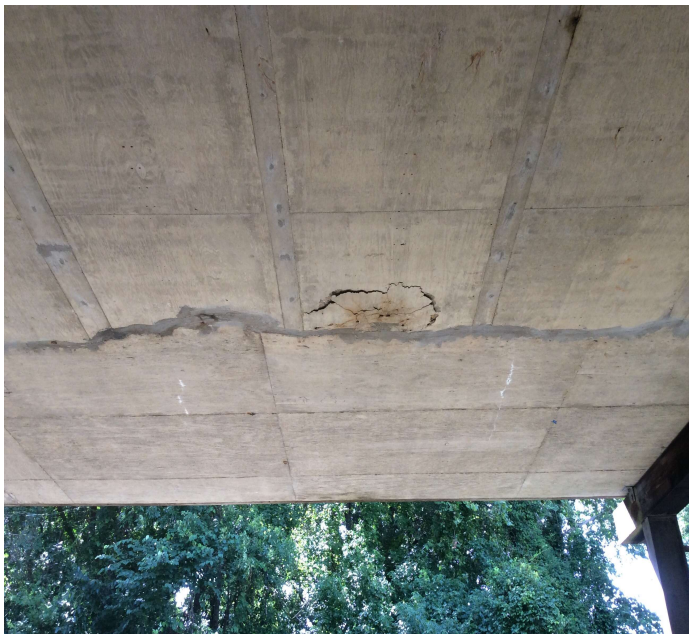
PHOTO 8 Description Span 18 delam

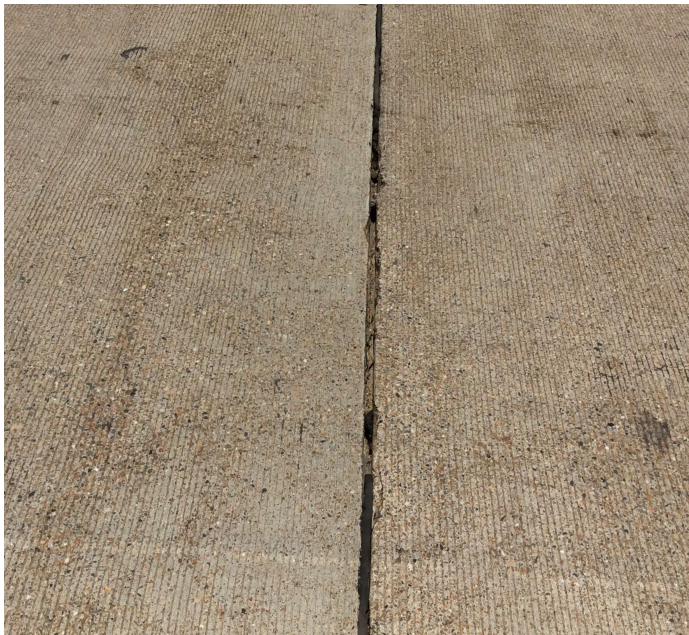
ALL DECK CONSTRUCTION JOINTS VARIOUS LOCATIONS JOINTS NEED TO BE CLEANED OUT & FILLED W/ NEW D-200

PHOTO 1 Description Construction joints need to be cleaned and refilled

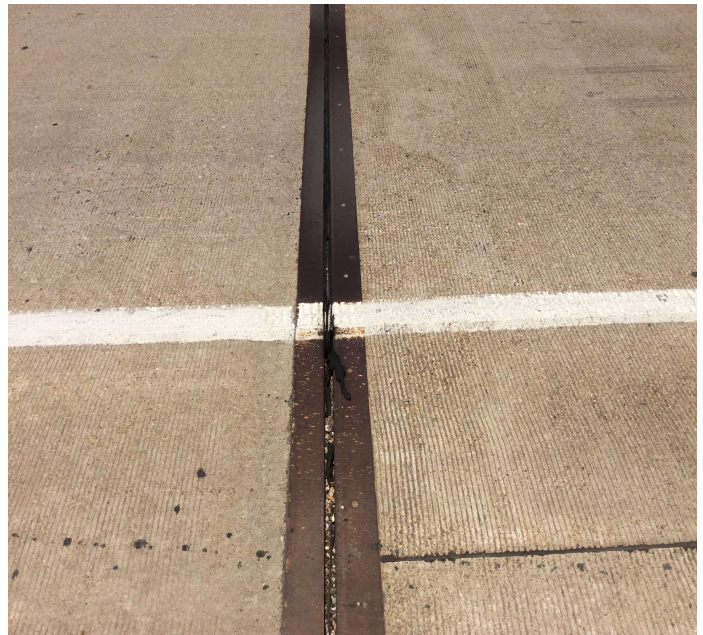
PHOTO 2 Description Bent 16 joint needs cleaned and refilled

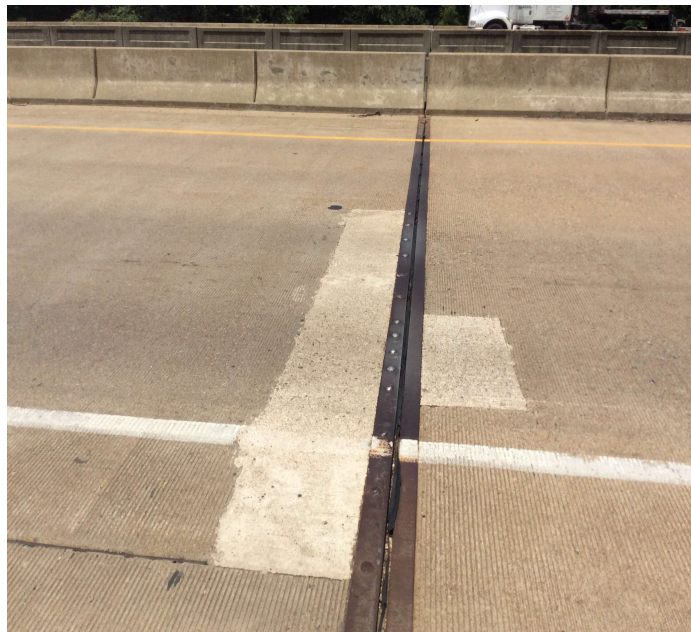
PHOTO 4 Description Bent 15 joint missing material,leaking

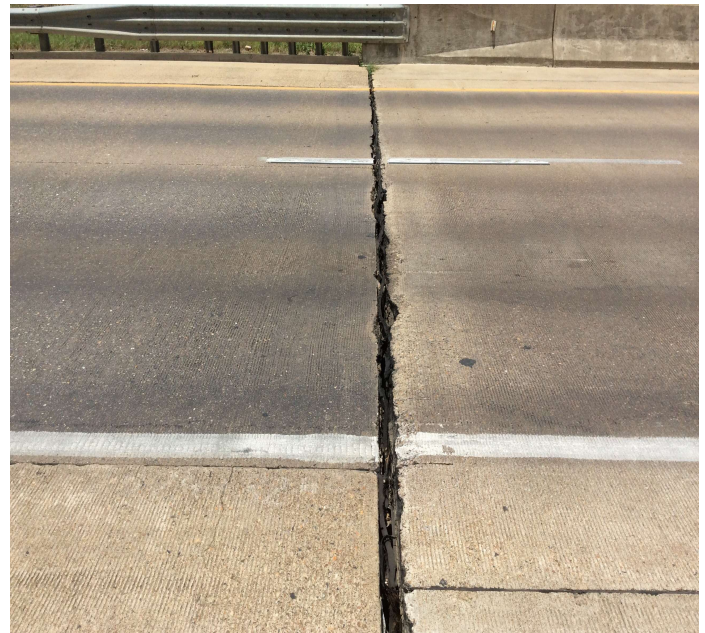
PHOTO 5 Description Bent 1 missing material 2 1/2"

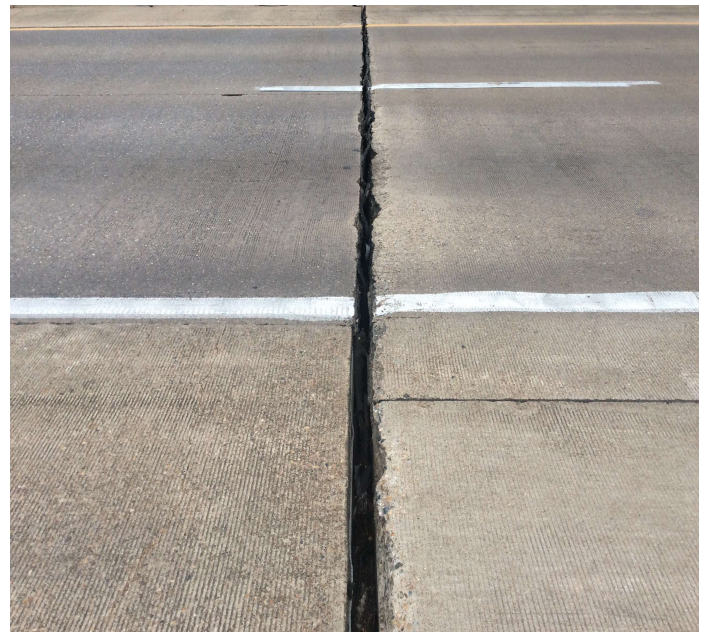
JOINT AT END BENTS & APPROACH SLABS JOINT IS OPEN WIDE AND NEEDS FILLED. ASPHALT AT END OF APPROACH SLAB HAS POT HOLES .

PHOTO 6 Description JOINT MATERIAL MISSING BEGINNING OF BRIDGE.

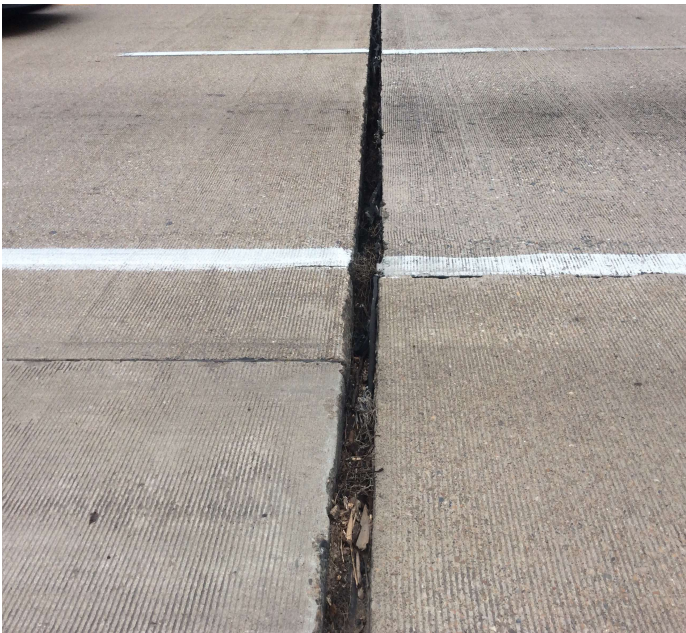
PHOTO 7 Description JOINT MATERIAL MISSING END OF BRIDGE

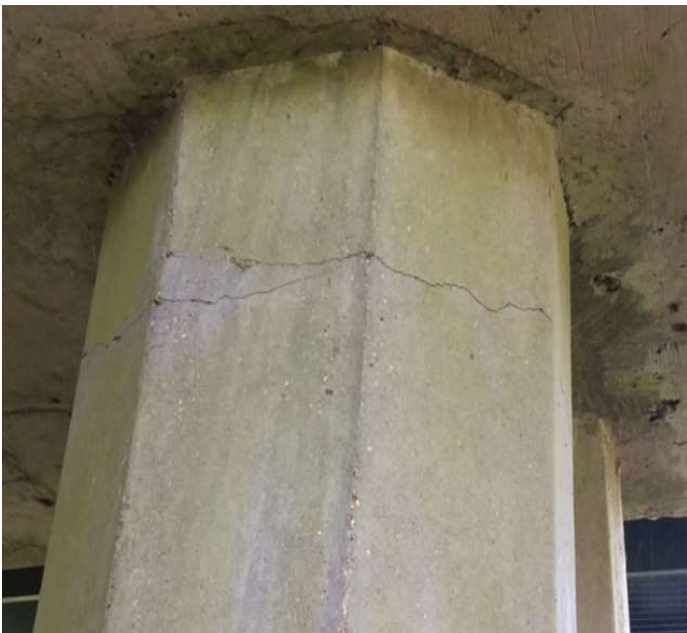
BT 18 has a small crack in pile 2 at top...
