Bridge Inspection Report

A5056
I 30, WB LNS-38.42
over
CARUSE CREEK

Structure Number: A5056

| IDENTIFICATION | | INSPECTIONS | |
|---|---|---|---|
| (1) STATE CODE | 056 - Arkansas | (90) INSPECTION DATE | 01/30/2017 |

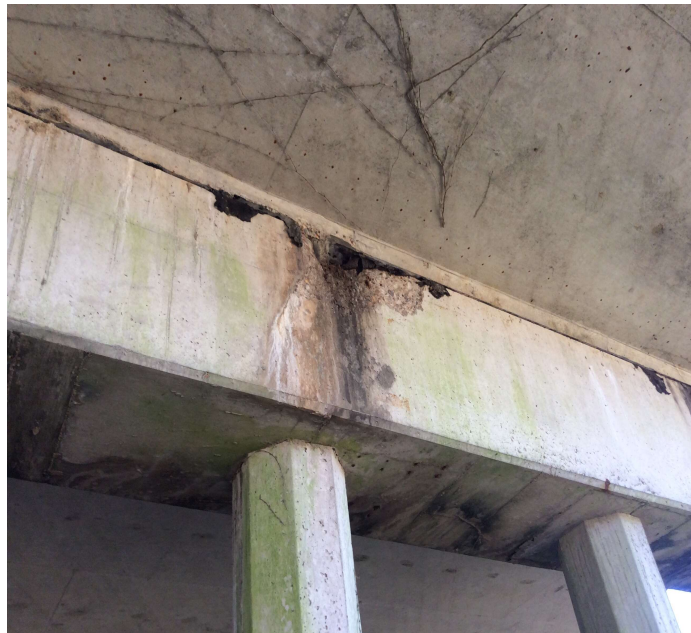
BENT #2, EAST FACE SPALL

PHOTO 1 Description Bent 2 east face

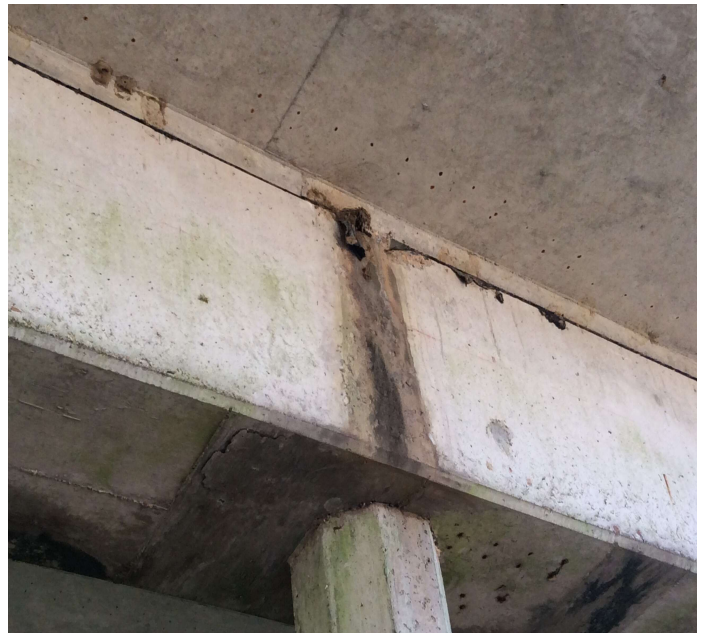
BENT #3, EAST FACE SPALL

PHOTO 2 Description Bent 3 cap east face over pile 3

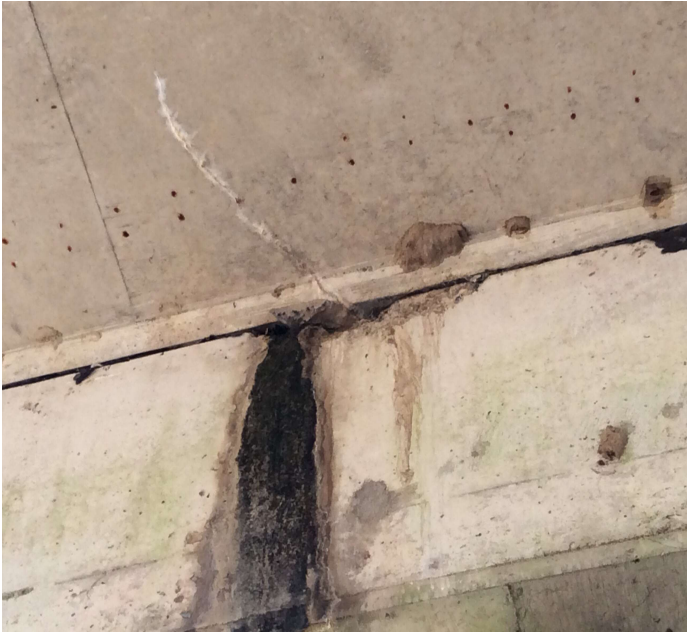
PHOTO 3 Description Bent 3 east face over pile 7

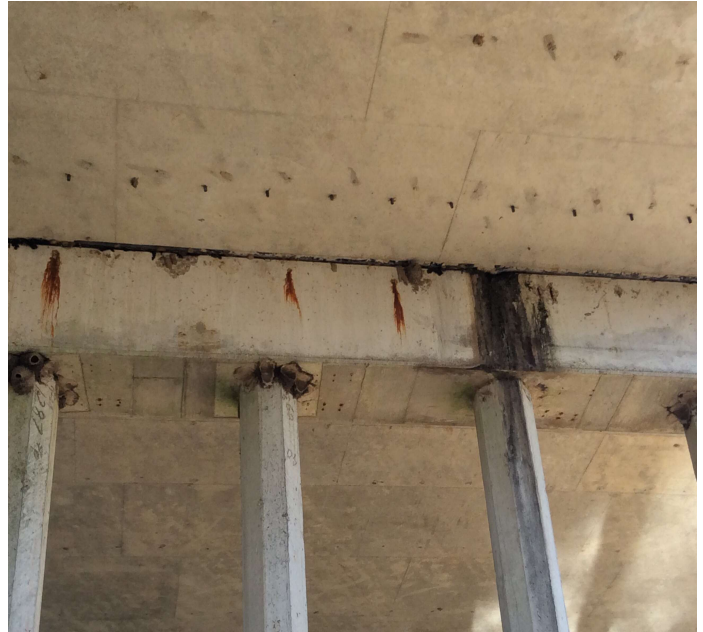
PHOTO 5 Description Bent 5 west face spalls

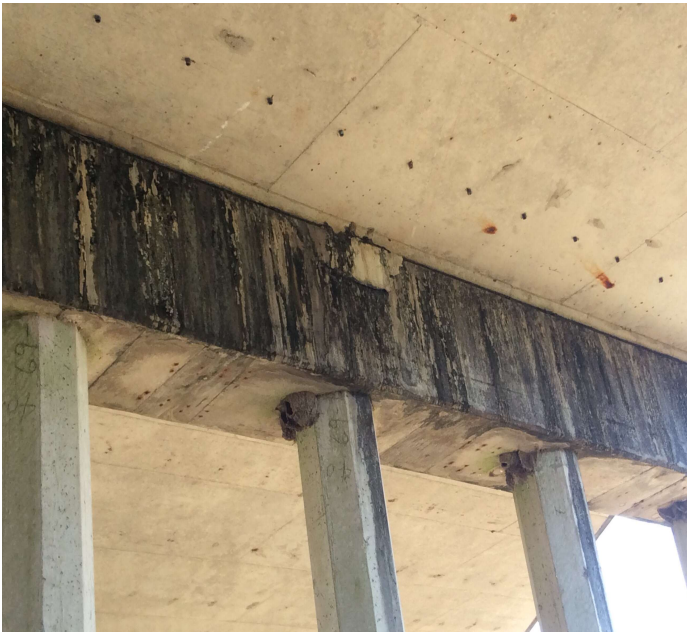
BENT #4, WEST FACE DELAM

PHOTO 4 Description Bent 4 west face delam

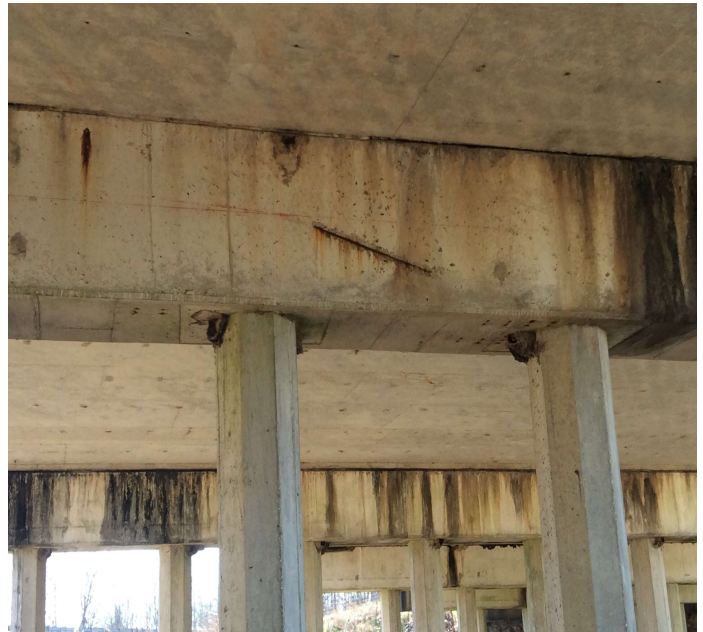
BENT #5 WEST FACE REBAR EXPOSED

PHOTO 6 Description Bent 5 cap west face rebar exposed

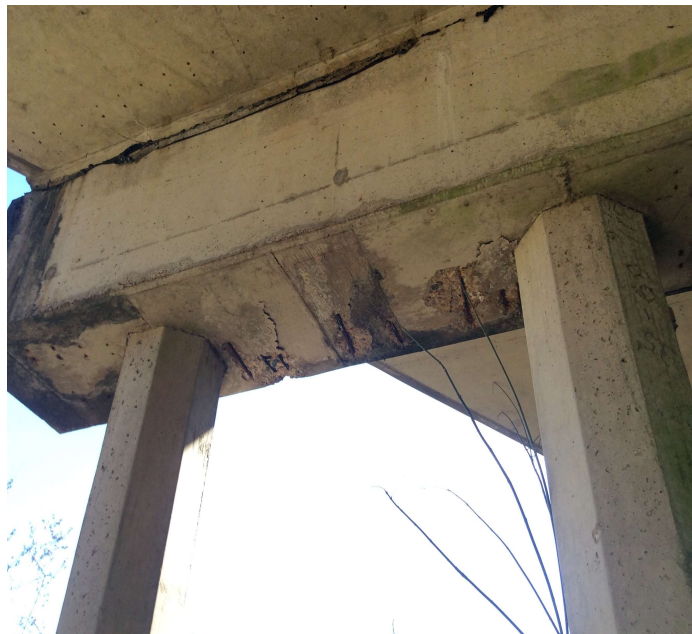
BOTTOM OF CAP SPALLS WITH REBAR EXPOSED

BENT 2 BETWEEN PILING 8&9

PHOTO 1 Description Bottom of cap bent 2 between pile 8 and 9

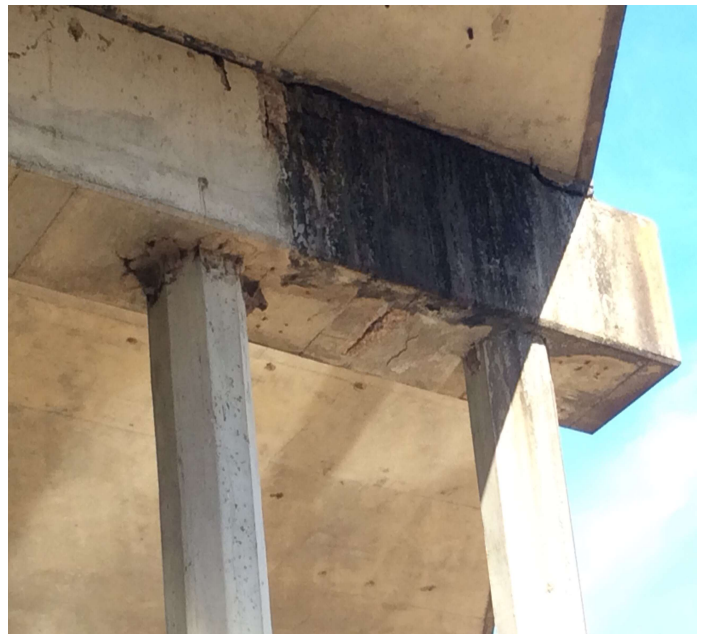
BENT 5 BETWEEN PILING 8&9

PHOTO 2 Description Bottom of bent 5 cap between pile 8 & 9

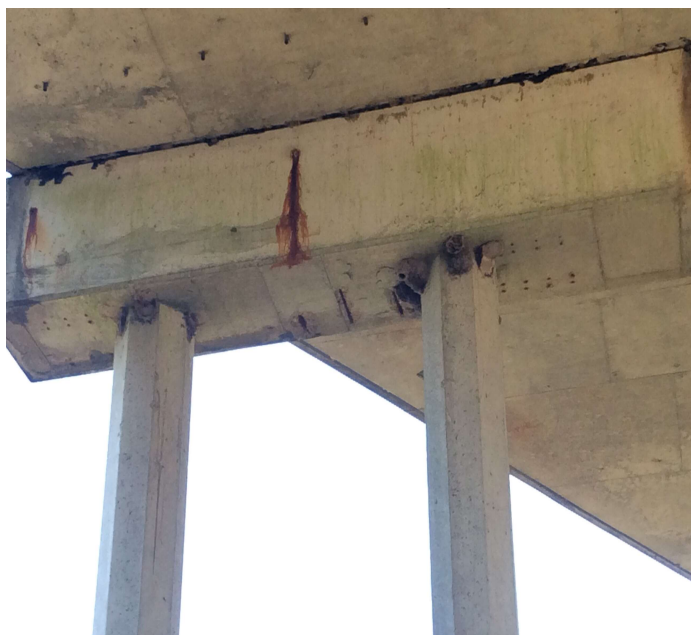
BENT 5 BETWEEN PILING 1&2

| PHOTO 3 | Description | Bottom of bent 5 cap between pile 1 & 2 |

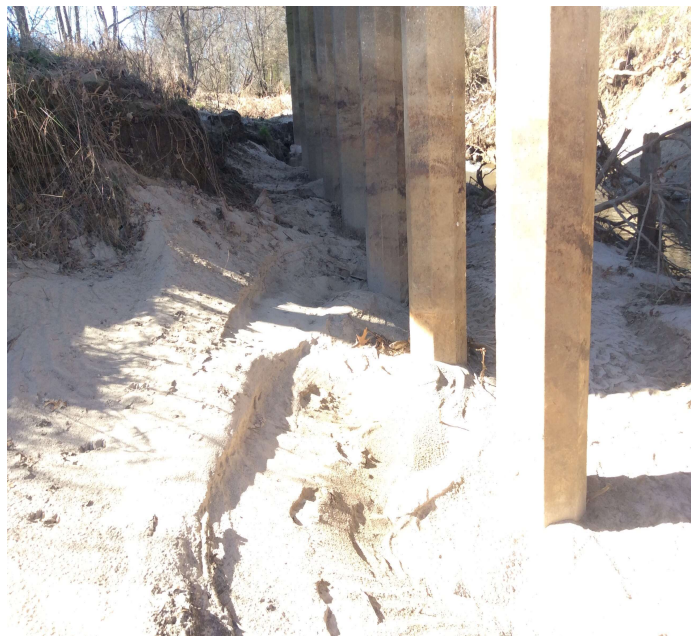
BENT 4, EROSION AROUND PILING FROM HIGH WATER EVENT

PHOTO 1 Description Erosion bent 4

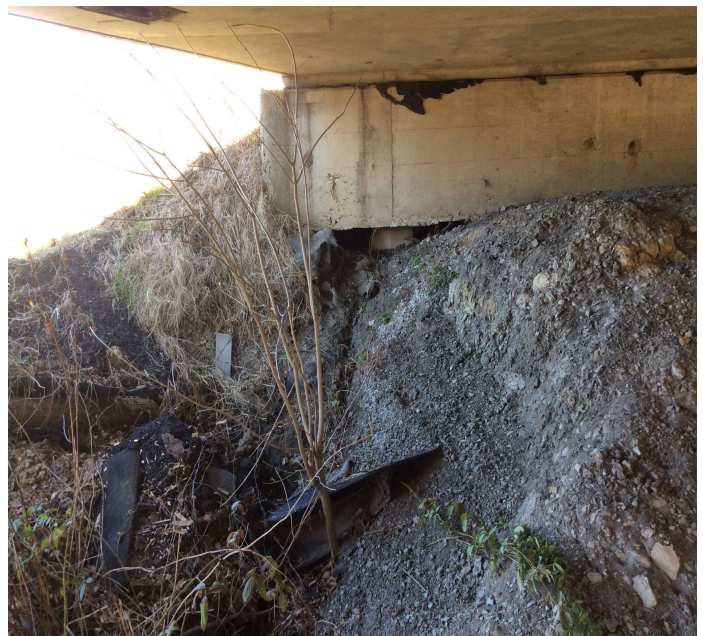
BENT 7 CAP, LEFT SIDE SOME EROSION UNDER CAP

PHOTO 2 Description Erosion under bent 7 cap left side
