Bridge Inspection Report

B5056
I-30,EB LNS-38.44
over
CARUSE CREEK

Structure Number: B5056

Facility Carried: I-30,EB LNS-38.44

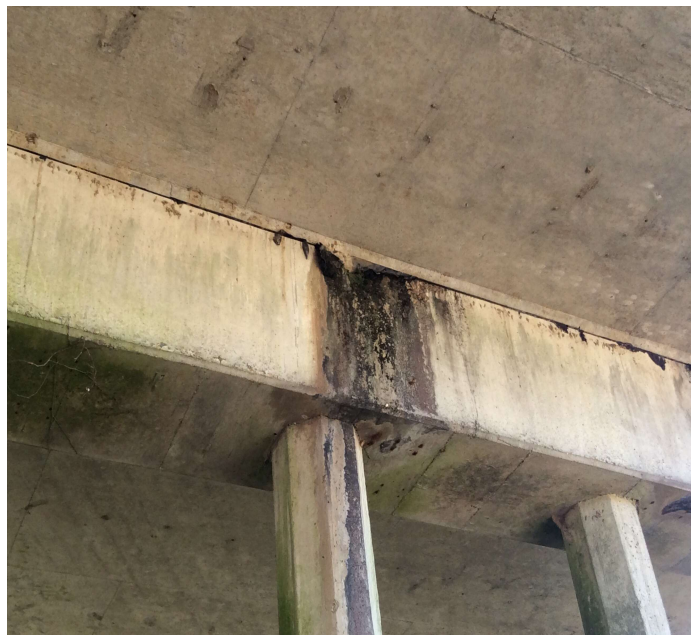
CONC. CAP

BENT #3 & 4, EAST FACE

SPALL W/ REBAR EXPOSED. NO SECTION

LOSS TO REBAR, BUT

SOME LOSS OF BEARING

AREA.

PHOTO 1 Description Bent 3 east face spall

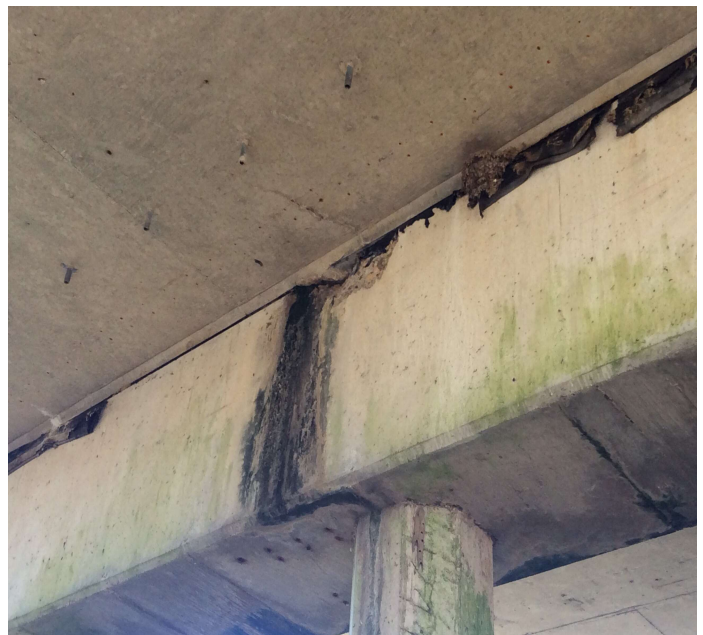
BENT #6 WEST FACE SPALL BUT NO REBAR EXPOSED

PHOTO 2 Description Bent 6 west face over pile 3

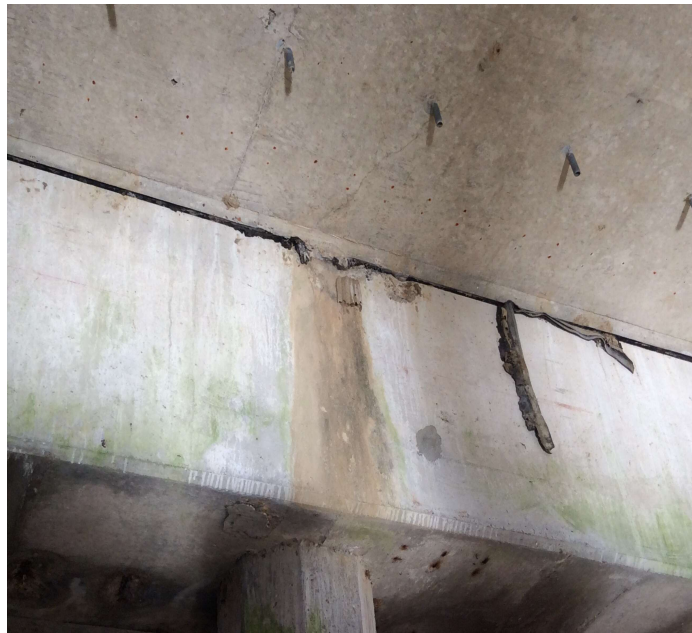
PHOTO 3 Description Bent 6 west face over pile 7

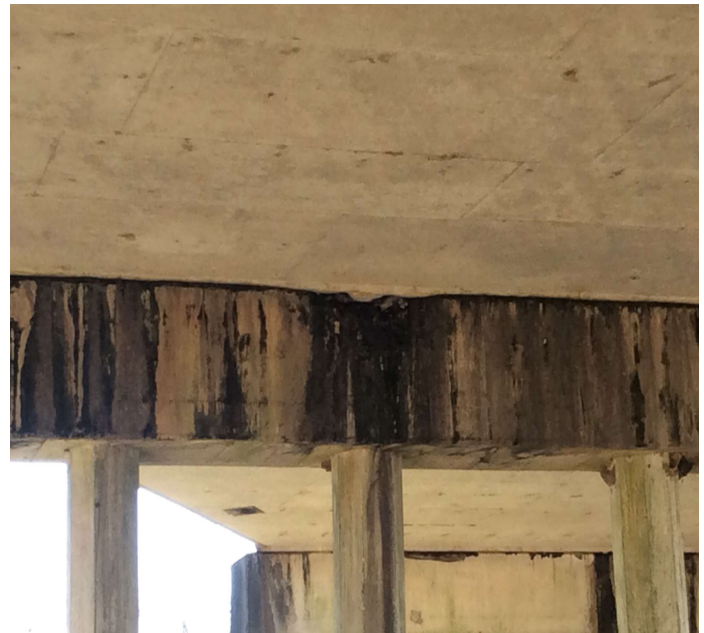
PHOTO 5 Description Bent 4 east face spall over pile 7

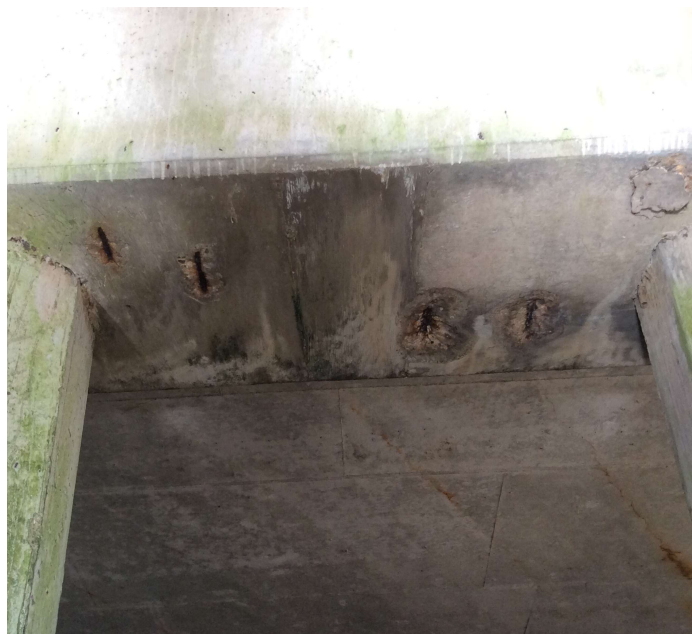
PHOTO 4 Description Bottom of bent 6 between pile 6 and 7

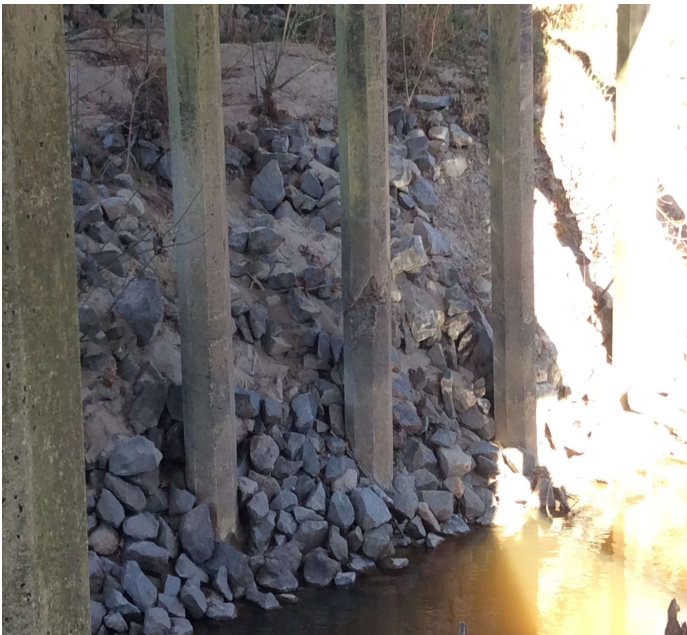
BENT #5 PILE #6
ON WEST SIDE OF PILE
NEAR GROUND LINE.

RENUMBERED PILE LT. TO RT. (IN 2007 IT WAS PILE #4)
SPALL ON PILE W/ ONE RING PARTIALLY EXPOSED, APPROX 12" X 18".

PHOTO 1 Description Bent 5 pile 6 spall near ground line

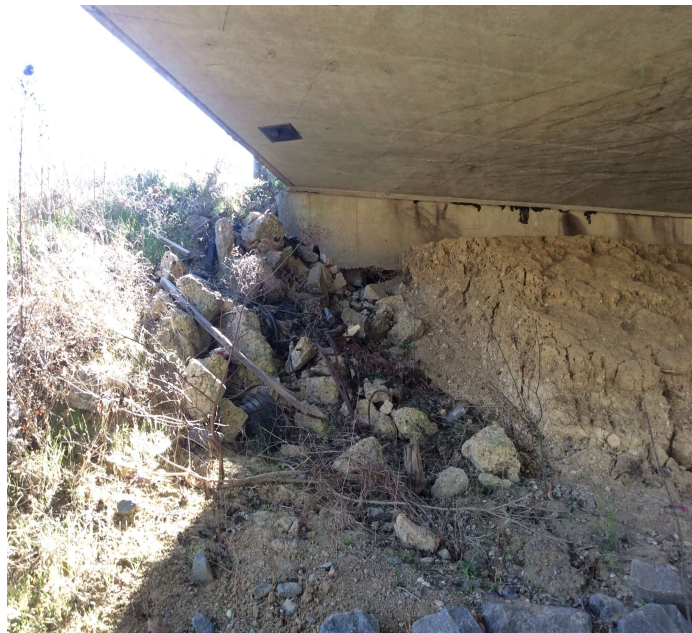
EROSION UNDER BENT 1 CAP ON LEFT AND RIGHT SIDES.

PHOTO 1 Description Erosion under bent 1 cap and in span 1 right side

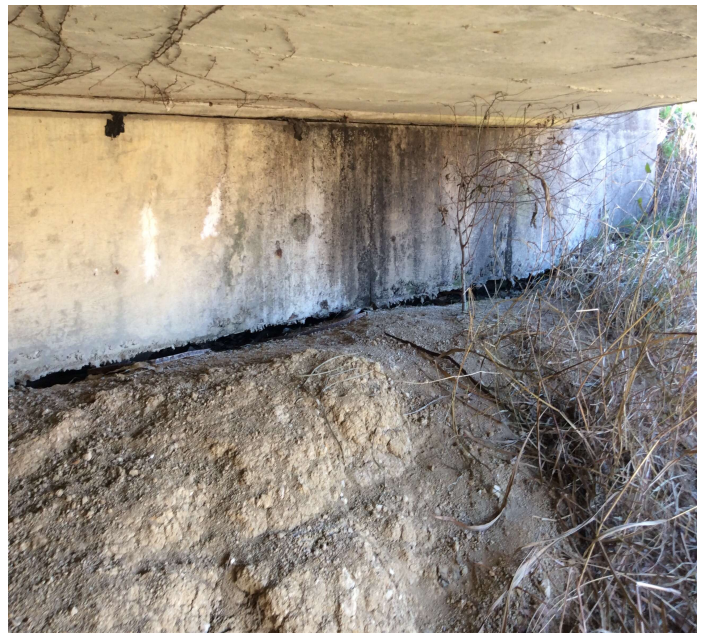
PHOTO 2 Description Erosion under bent 1 cap left side
