Bridge Inspection Report

A5058
I 30, WB LNS-39.77
over
VICKERS CREEK

Structure Number: A5058

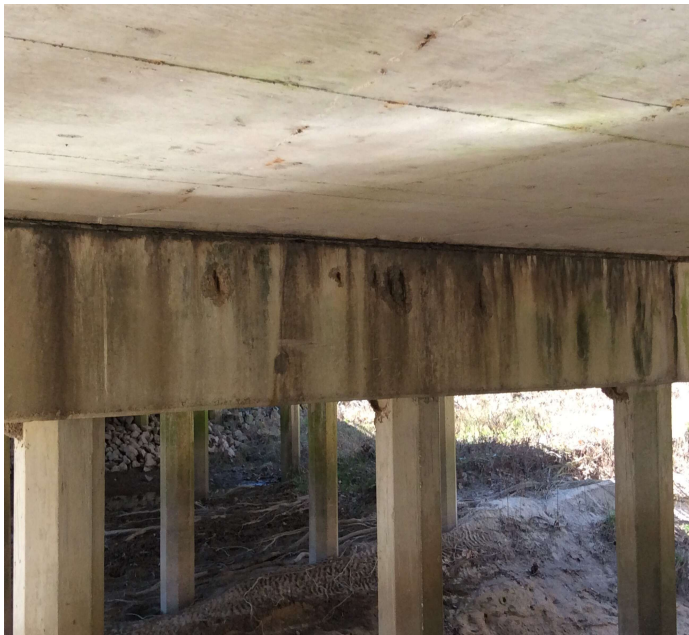
CONCRETE CAP MINOR SPALLS WITH REBAR EXPOSED

BENT 5 CAP EAST FACE

PHOTO 1 Description Rebar exposed bent 5 cap east face

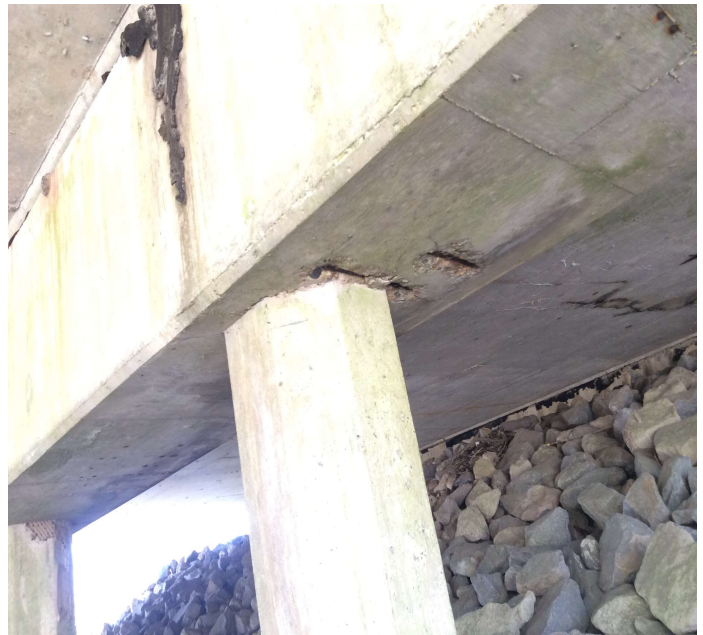
BENT 2 CAP UNDERSIDE AT PILE #2

PHOTO 2 Description Bent 2 at pile two

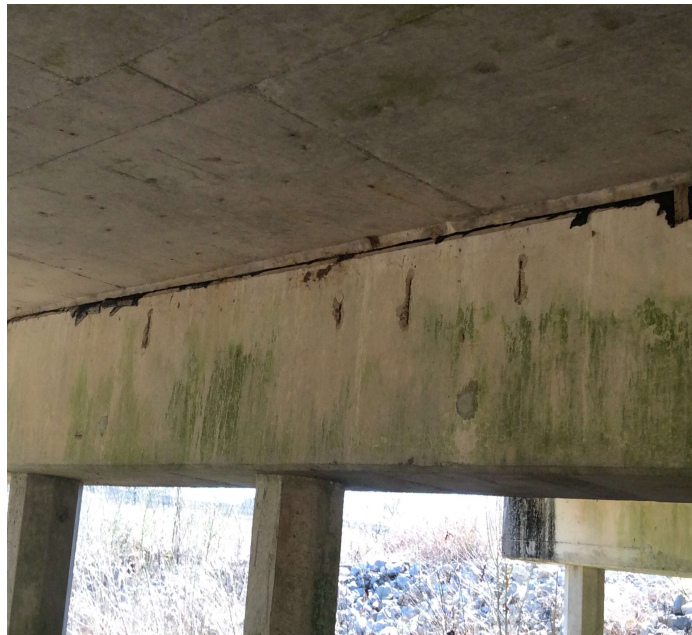
BENT 3 CAP EAST FACE

PHOTO 3 Description Bent 3 cap east face

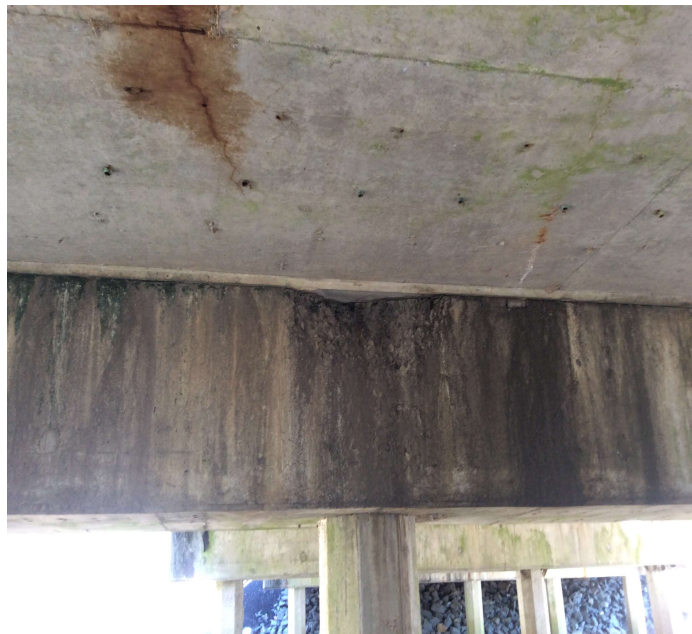
PHOTO 4 Description Bent 4 over pile 2 west face

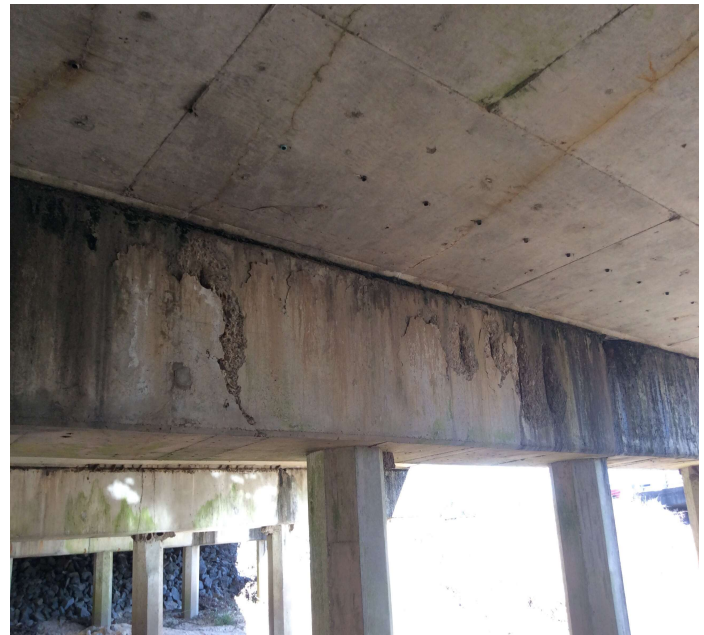
BENT 4 CAP WEST FACE

PHOTO 5 Description Bent 4 cap west face

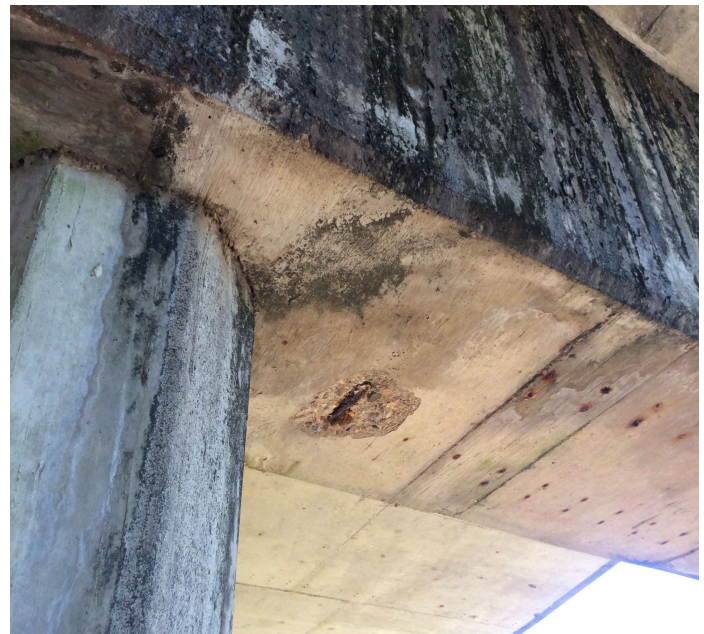
PHOTO 6 Description Bottom of bent 4 cap at pile 5

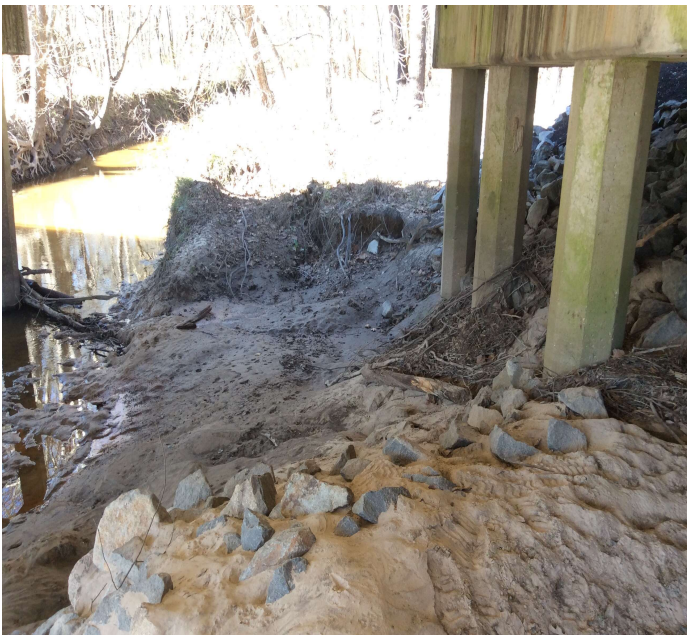
Erosion at bent 6 from pile 1 to pile 3. Approx 30'x10' area

PHOTO 1 Description Erosion at bent 6

AMS will handle.
