Bridge Inspection Report

B5058
I-30, EB LNS-39.78
over
VICKERS CREEK

Element Inspection

Maintenance Needs

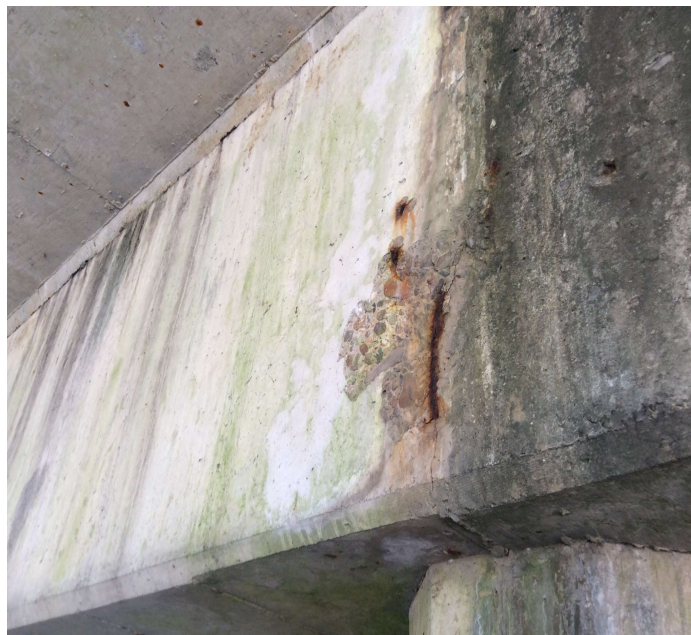
CONCRETE CAP SPALLS WITH REBAR EXPOSED
BENT 2 CAP EAST FACE
BENT 3 CAP UNDERSIDE AT PILE #2
BENT 4 CAP UNDERSIDE AT PILE #3
BENT 5 CAP UNDERSIDE BETWEEN PILES 3 AND 4.

PHOTO 1 Description Bent 2 east face over pile 2

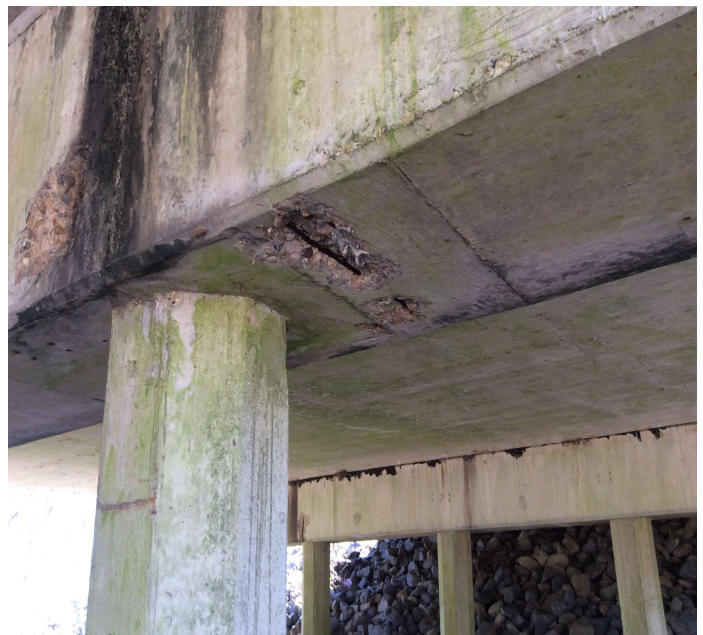
PHOTO 2 Description Bent 3 cap bottom at pile 2

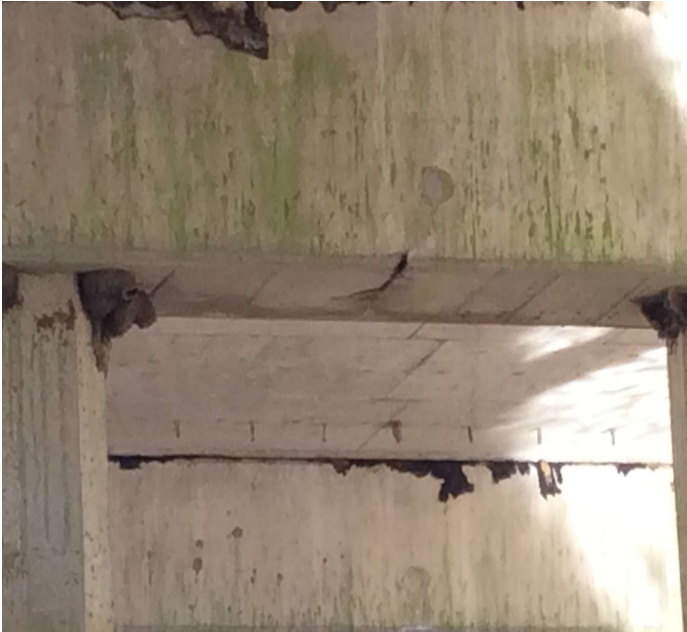
PHOTO 3 Description Bent 5 cap underside between pile 3 and 4

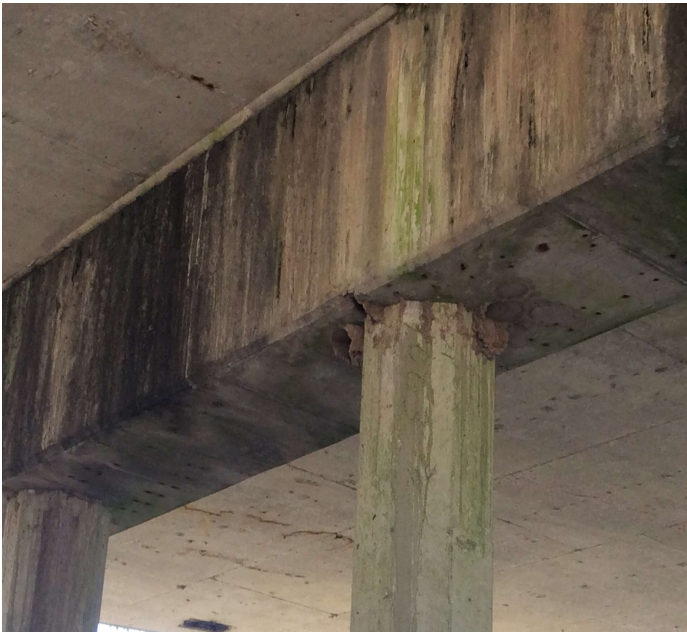
PHOTO 4 Description Bent 4 cap underside at pile 3
