Bridge Inspection Report

B5118
I-30, E.B.L-50.49
over
WILSON CREEK

Structure Number: B5118

Facility Carried: I-30, E.B.L-50.49

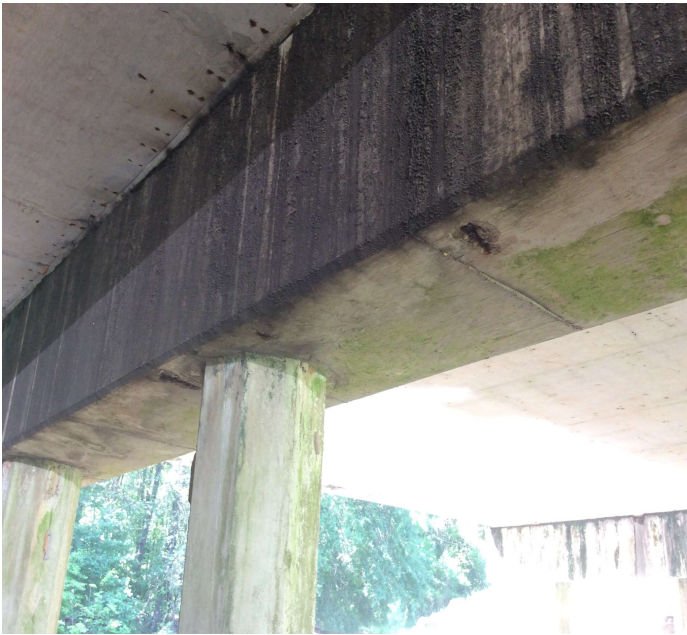
SMALL SPALL IN SPAN # 1 CLOSE TO COLUMN # 3 W/ REBAR EXPOSED AND BOTTOM OF BENT 2 CAP BETWEEN PILES 4 & 5

PHOTO 1	Description	BENT 2 & 3 small SPALLS WITH REBAR EXPOSED
---------	-------------	--

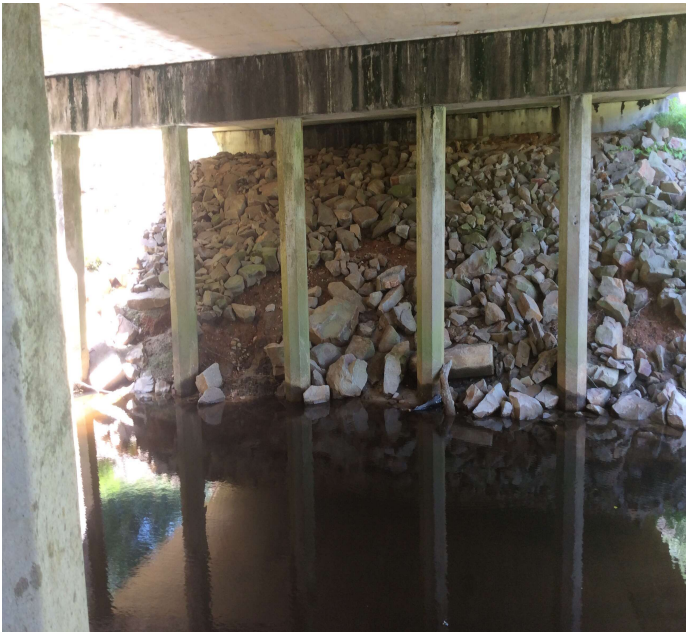
PAST FLOODS HAVE MOVED SOME OF RIPRAP FROM SLOPE UNDER SPAN 1 TO CHANNEL LEAVING DIRT BANK EXPOSED IN AREAS

PHOTO 1 Description PAST FLOODS HAVE MOVED SOME
OF RIPRAP FROM SLOPE UNDER
SPAN 1

AMS will handle

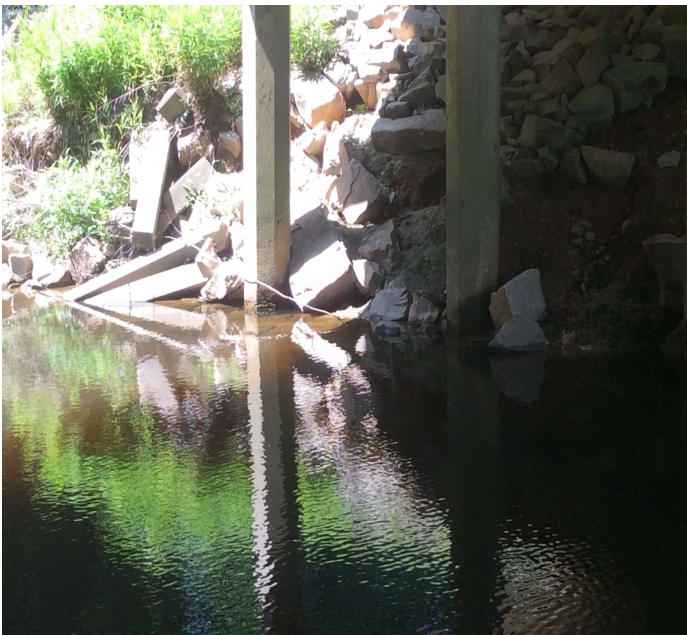
PILE 6 IS CRACK AT GROUND LINE 1/4 CRACK AROUND PILE, BENT 2 ON RIGHT SIDE OF BENT

PHOTO 1 Description PILE 6 IS CRACK AT GROUND LINE
1/4 CRACK BENT 2 RIGHT SIDE

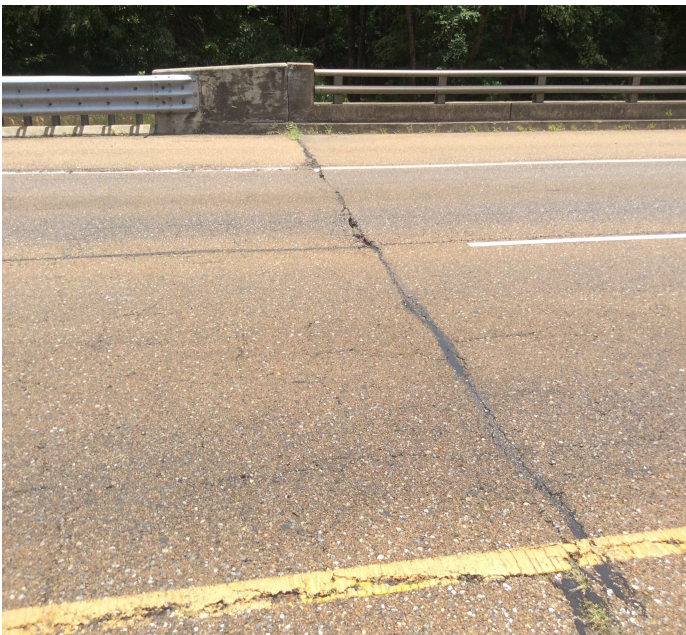
ASPHALT AT ALL JOINTS UNRAVELING AND FORMING POT HOLES

PHOTO 1 Description ASPHALT AT ALL JOINTS
UNRAVELING AND FORMING POT
HOLES
