Bridge Inspection Report

16795
County Road 42
over
Vineyard Branch Seb. Co.

Structure Number: 16795

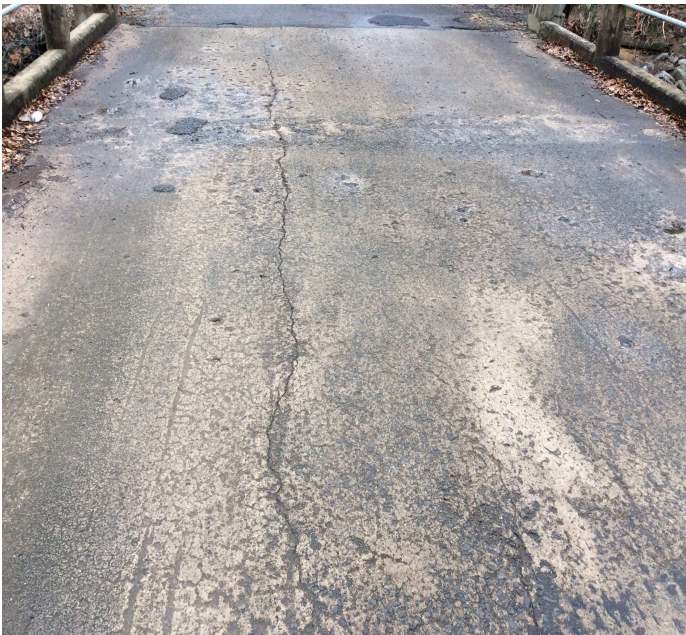
The deck has a sealable full depth longitudinal crack that spans the entire length of the deck. The longitudinal crack is visible in the driving surface and the undersurface of the deck between beams # 2 and # 3. Leakage through the full depth crack is evident on the undersurface surrounding the crack.

PHOTO 1 Description Deck crack.

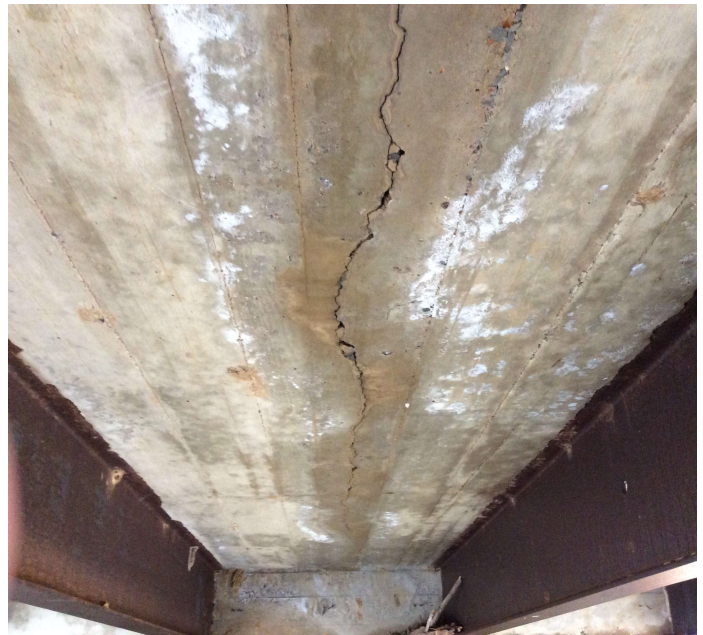
PHOTO 2 Description Deck soffit crack. Bay 2.

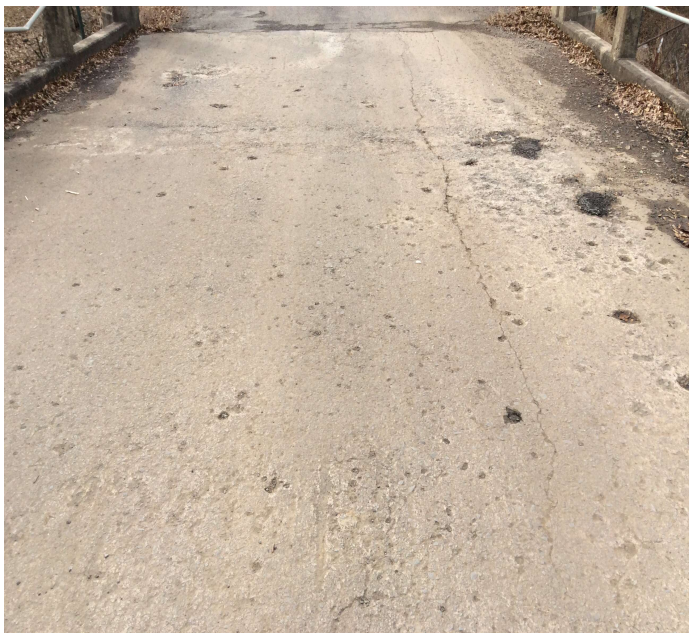
PHOTO 3 Description Deck. Typical

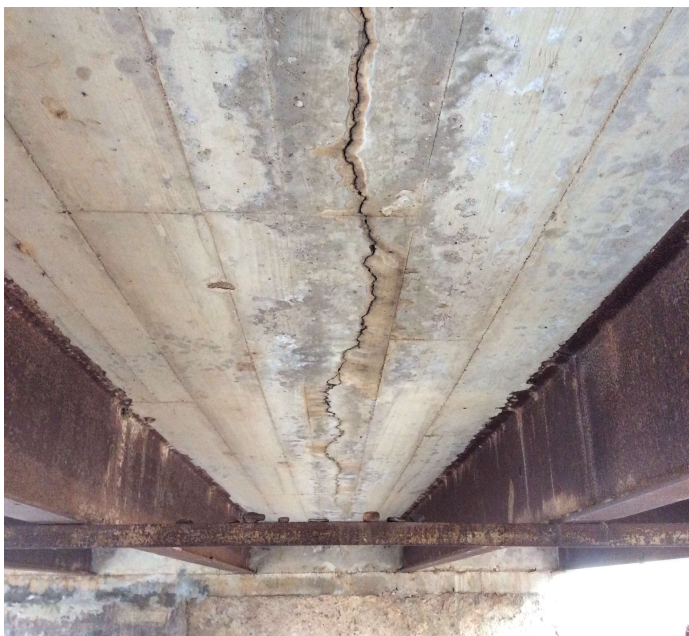
PHOTO 4 Description Bay 2 deck soffit.

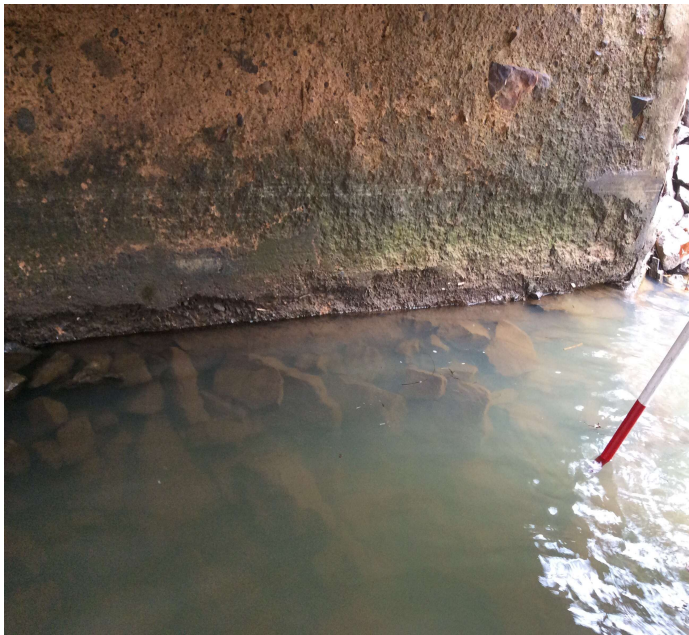
The left side of the west abutment has soft and deteriorating concrete with areas along the base of the stem wall that have approximately 2 inches of concrete section loss.

PHOTO 1 Description Bent 1. Concrete.

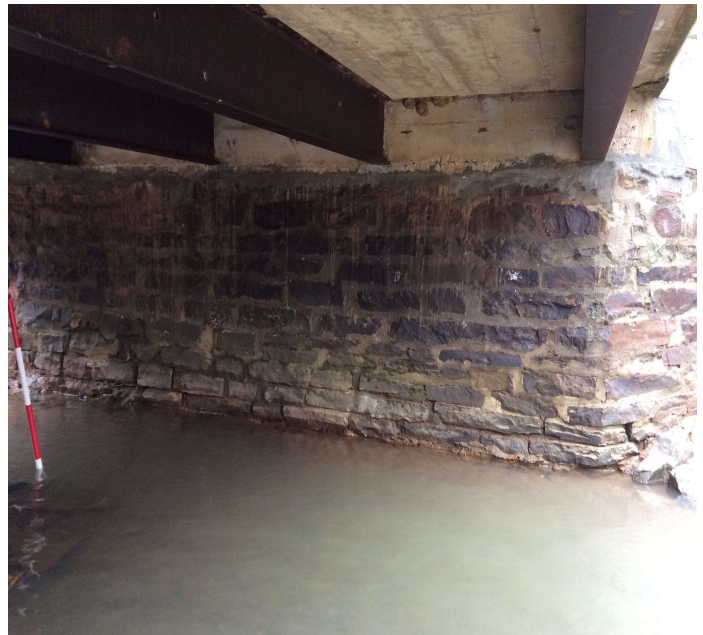
The east abutment has light grout deterioration between the stones in the lower part of the rock masonry stem wall.

PHOTO 2 Description Bent 2. Typical

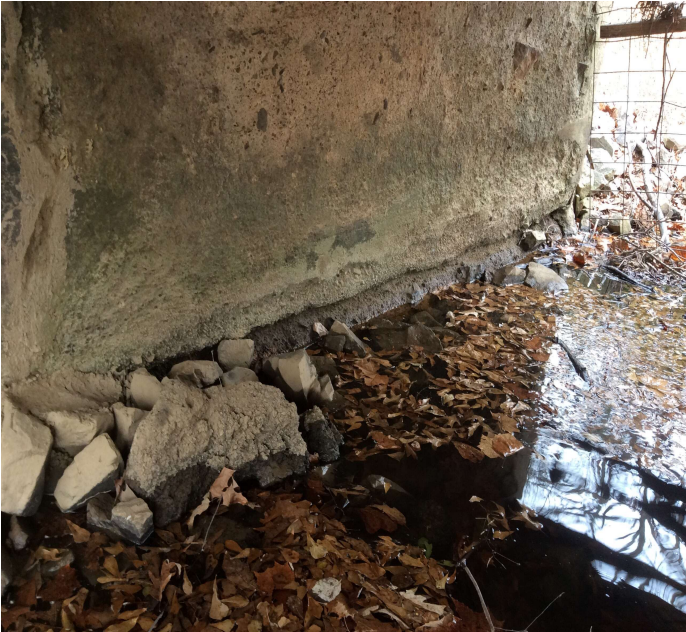
PHOTO 3 Description West abutment. Soft deteriorated concrete.

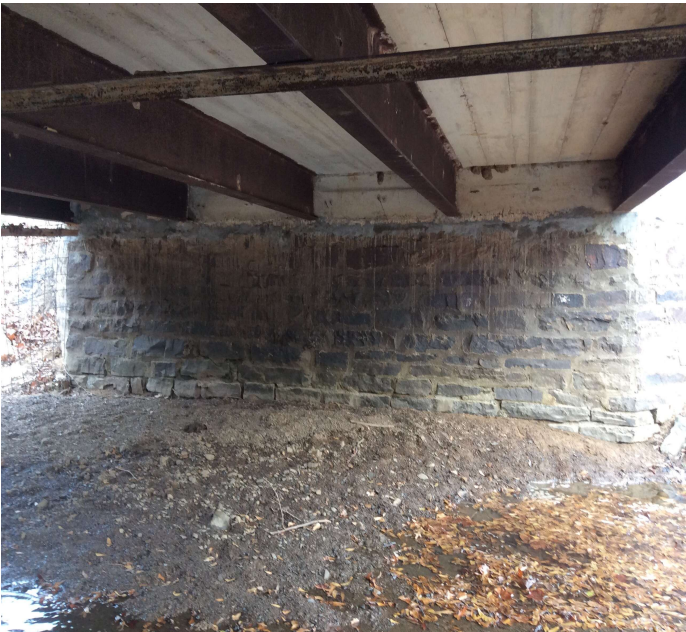
PHOTO 4 Description Bent 2. Typical

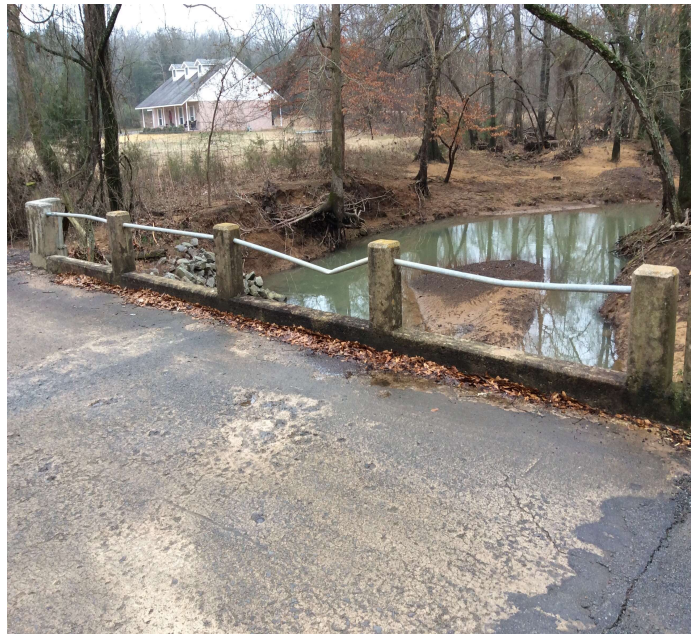
The light weight tubing used for bridge railing has collision damage.

PHOTO 1 Description Right bridge railing.

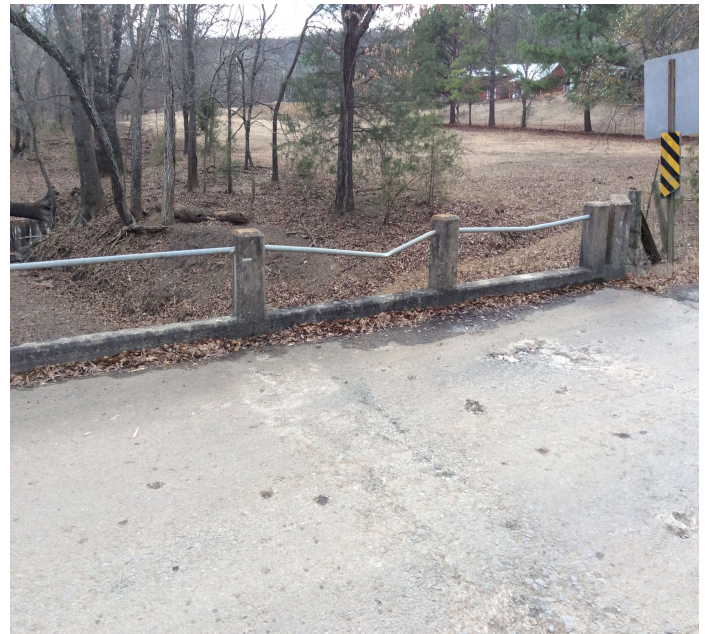
PHOTO 2 Description Right bridge railing
