**Bridge #23560(Routine)**  
**P Rdge PECK RD over SUGAR CREEK**  
**Location: 0.1 M S JCT SUGAR CREEK R**

**Team Lead: Nathan Rowland Inspection Date: May 28, 2020**

IDENTIFICATION	
(1) State Names	Arkansas
(8) Structure Number	23560
(5) Inventory Route	44602
(2) Highway Agency District	09
(3) County Code	7-Benton County, Arkansas

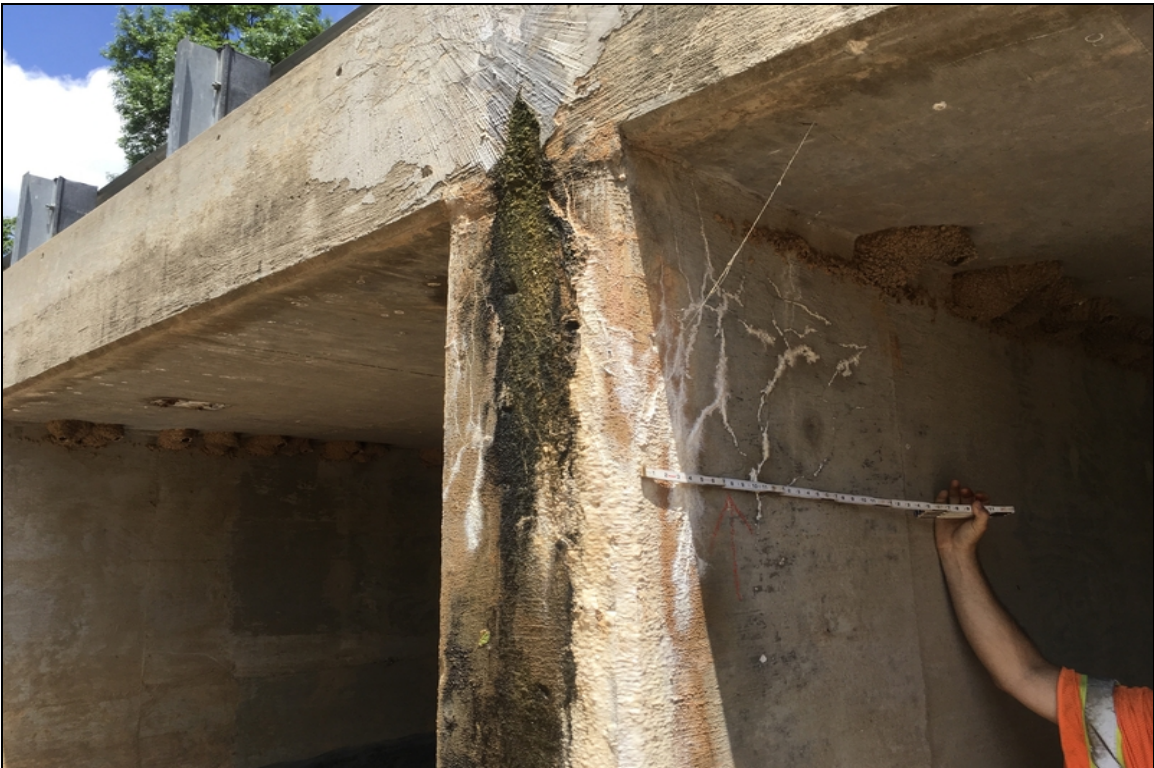
Division wall #3 has map cracking with efflorescence.

Division walls #3 and #6 on the down stream side have map cracking with efflorescence leaching.

Barrel #4- has 2 hairline transverse cracks with efflorescence in the top slab. Division wall #3 has map cracking with efflorescence at the outlet end. Minor stream bed material build up at the outlet end of the barrel floor.

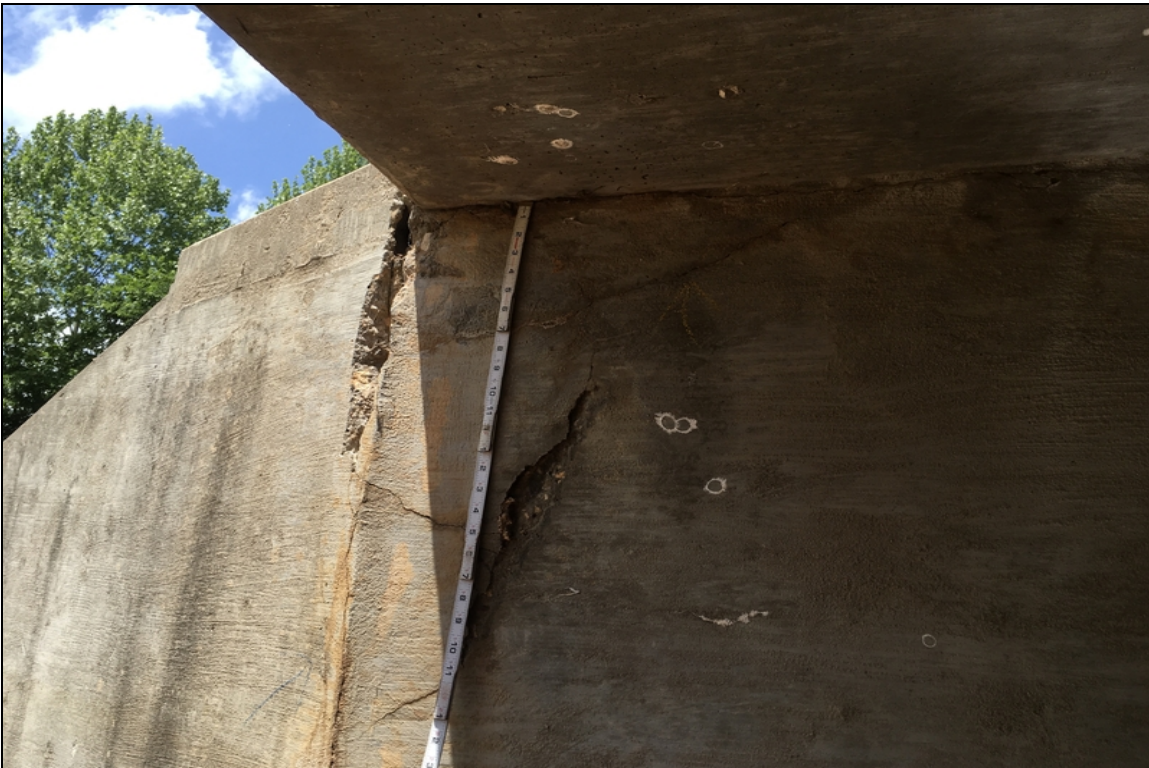
2' x 1' delamination in the backwall of barrel #1 at the outlet end.

Barrel #1 has a delamination at the top right corner at the outlet end.

Driving surface- no deficiencies noted.The entire left bridge railing, and the beginning and end sections of the right railing have been replaced due to flooding.The ending approach slab has a transverse crack.Barrel #1- has a 2' x 1' delamination in the backwall at the outlet end. The top slab has 2 hairline transverse cracks of which one has efflorescence. The backwall and division wall have one hairline vertical crack each. Minor stream bed material build up at the outlet end of the barrel floor. Bridge railing left has collision damage due to a high water event.

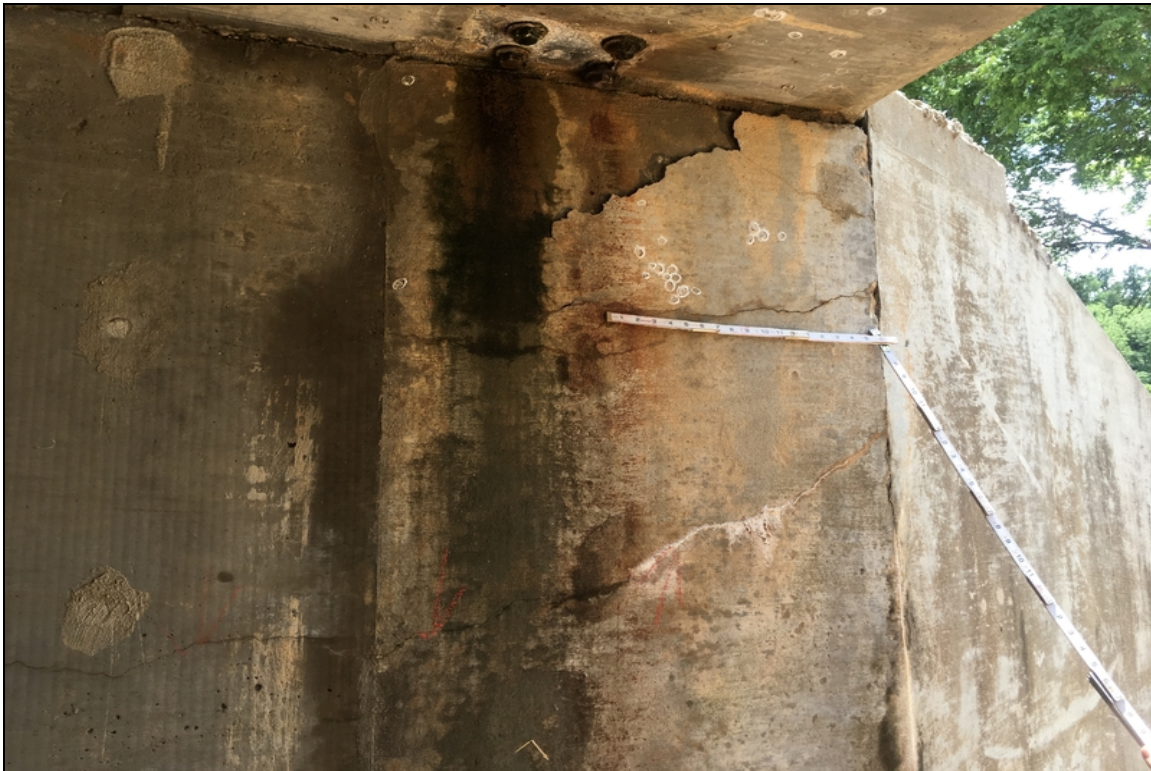
2'x 1' delamination at inlet and outlet end of barrel #12 backwall.

Barrel #12 has a delamination at the top corners at the inlet and outlet ends.

Barrel #12- has a 2' x 1' delamination at the inlet and outlet end in the backwall. The backwall has 21' of hairline horizontal cracking. The top slab has 1 hairline transverse crack with light efflorescence. Minor stream bed material build up at the outlet end of the barrel floor.

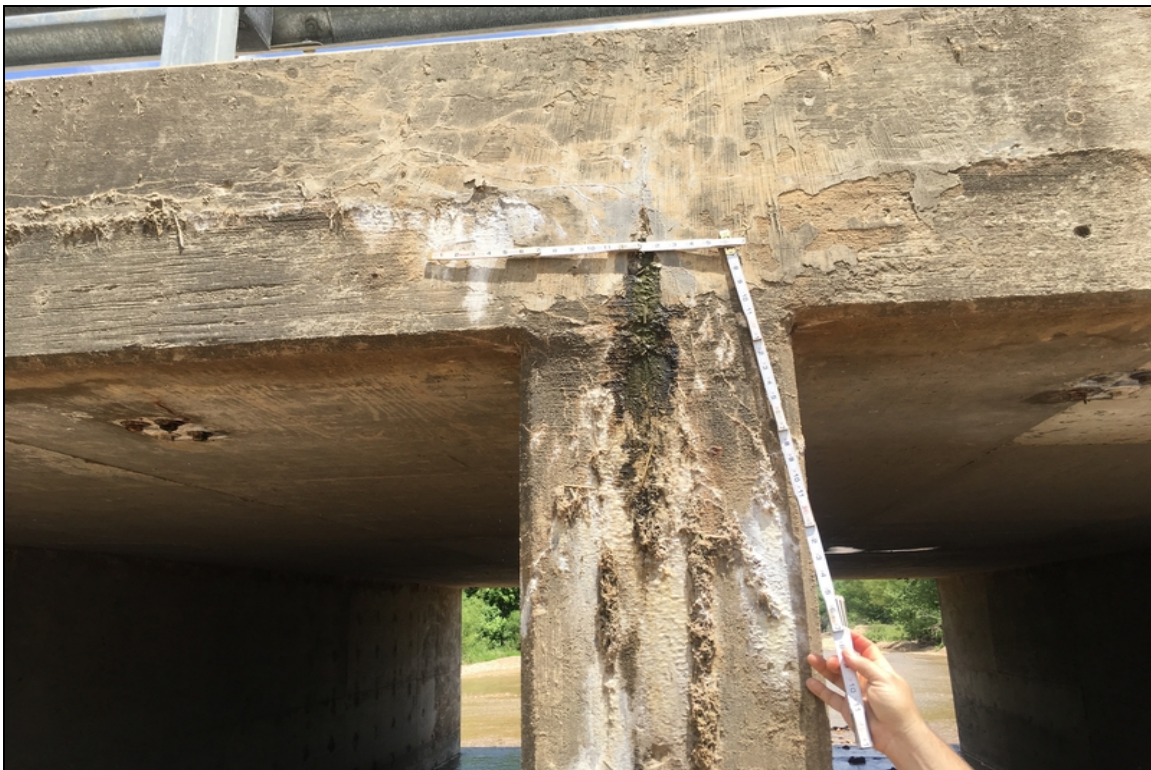
Division wall #6 has map cracking with efflorescence at the outlet end.

Barrel #7- has 2 hairline transverse cracks with efflorescence in the top slab. Division wall #6 has map cracking with efflorescence at the outlet end. Minor stream bed material build up at the outlet end of the barrel floor.

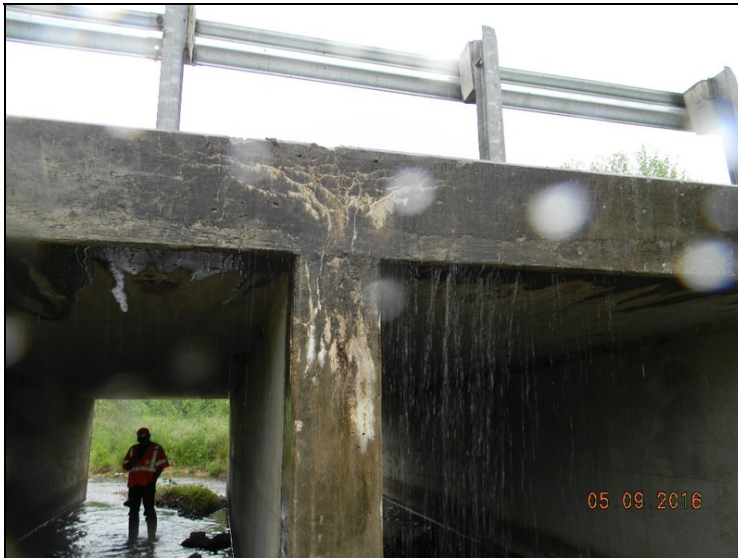
Headwall between barrels 5 & 6 - Cracking and leaching.

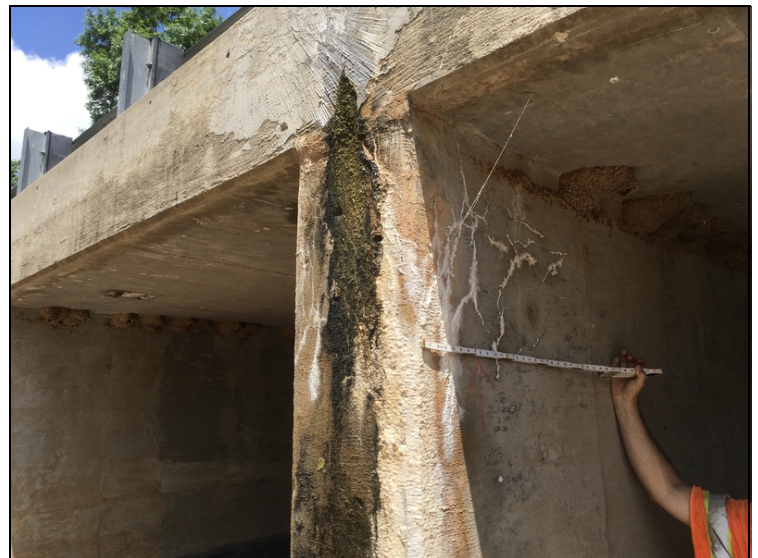
Division walls #3 on the down stream side have map cracking with efflorescence leaching.

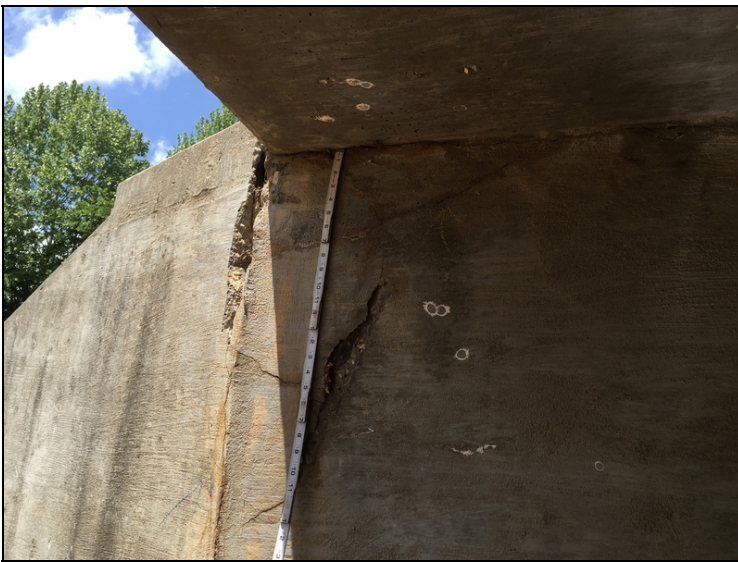
Barrel #12 has a delamination at the top corners at the inlet and outlet ends.

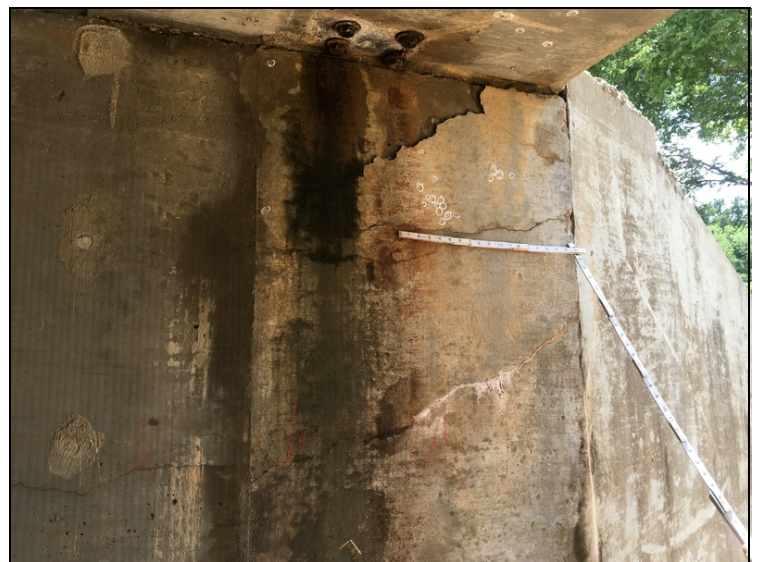
Barrel #1 has a delamination at the top right corner at the outlet end.

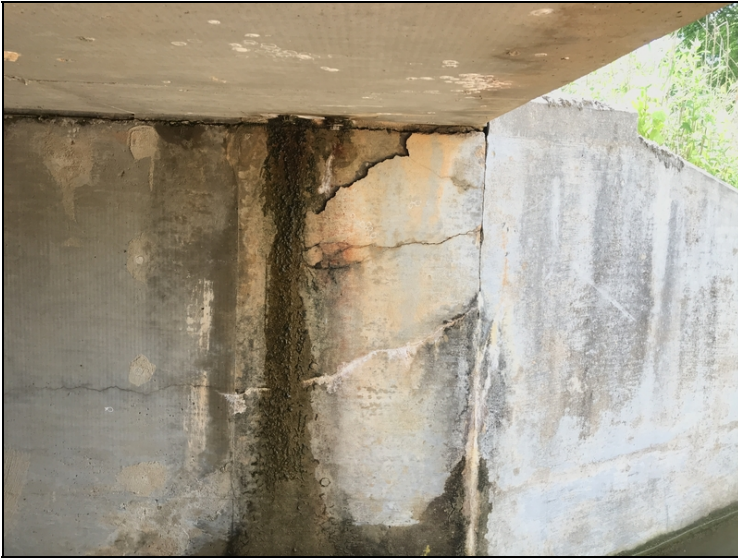
Barrel #12 wall #13 right side at the southwest wingwall juncture large eliminated area.

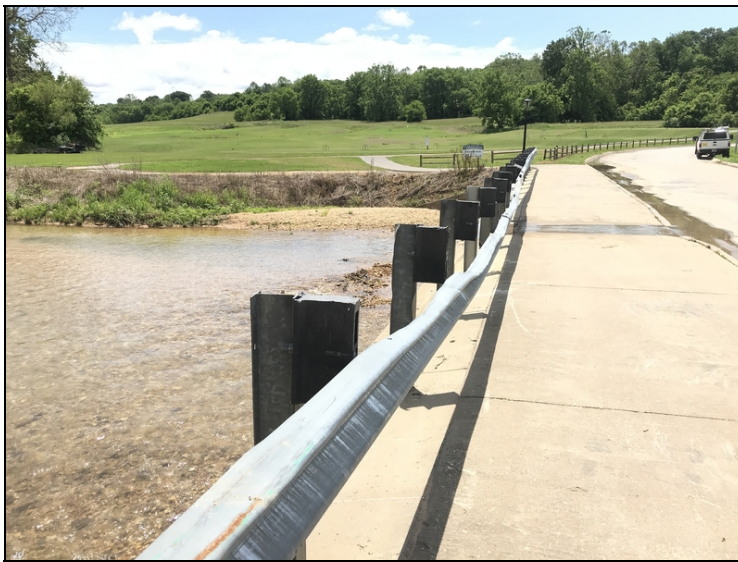
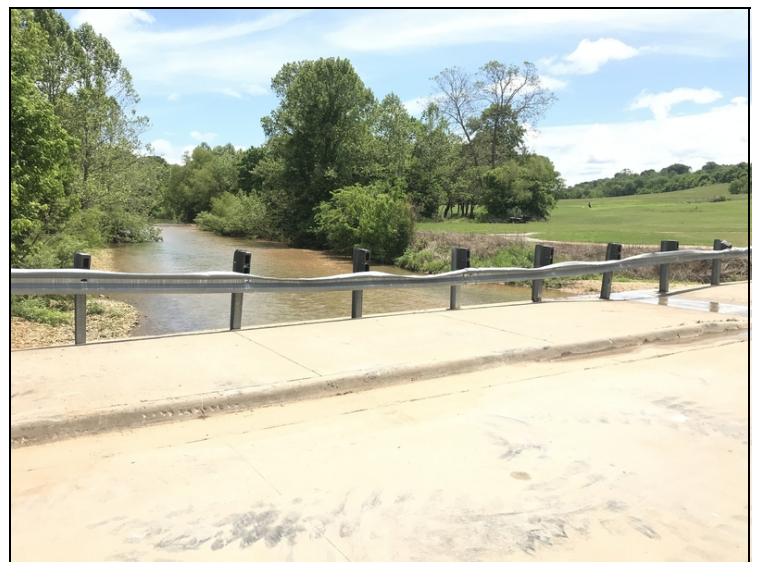
Bridge railing:  
-The left bridge railing has collision damage due to a high water event.

Railing left collision damage

Date Reported: 05/29/2020  
Priority: C - Important  
Type of Work: Repair  
Status: Open  
Inspection Direction N to S  
Component: Miscellaneous
