**Asset #04531** (Routine, Underwater type 2)

**New Hope Rd Rogers over OSAGE CREEK**

**Location: .14 M. E I-49**

**Team Lead: Nathan Rowland, Inspection Date: 06/08/2022**

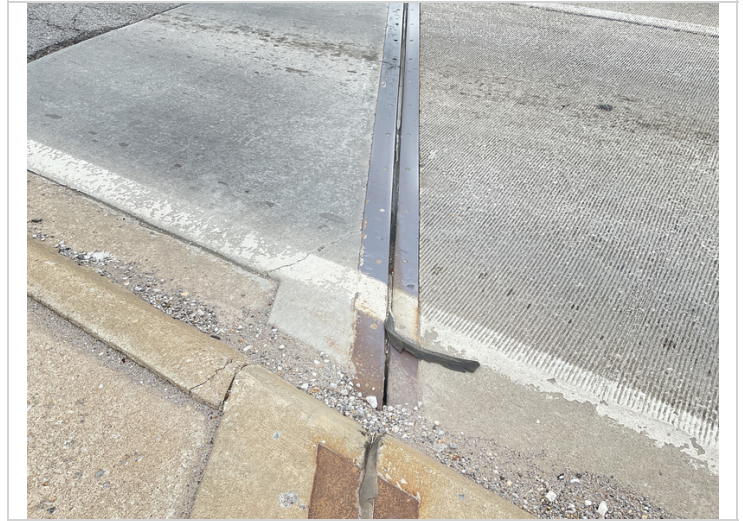
- Abutment #2 The left side of abutment has approximately 3' of pourable joint material that has been displaced.

-The left side of abutment has approximately 3' of pourable joint material that has been displaced.

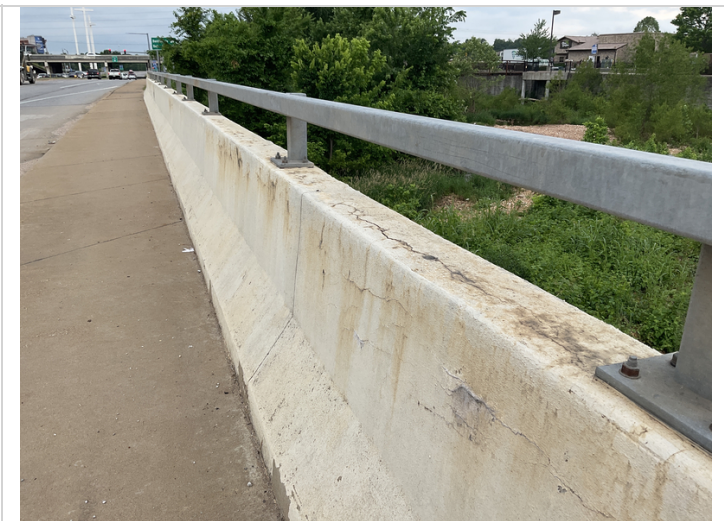
- has areas of map cracking along the top edge.
- The top of parapet has areas of delamination and cracking in random locations.

Cracking and delamination on top of parapet wall.

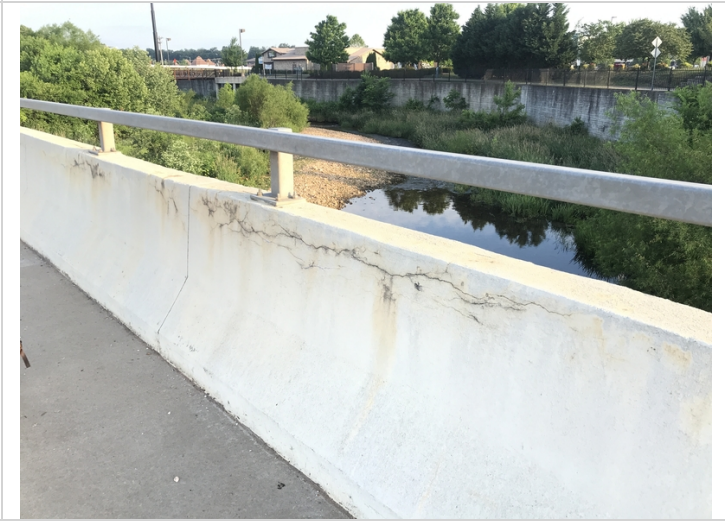
Horizontal cracking in the right parapet.

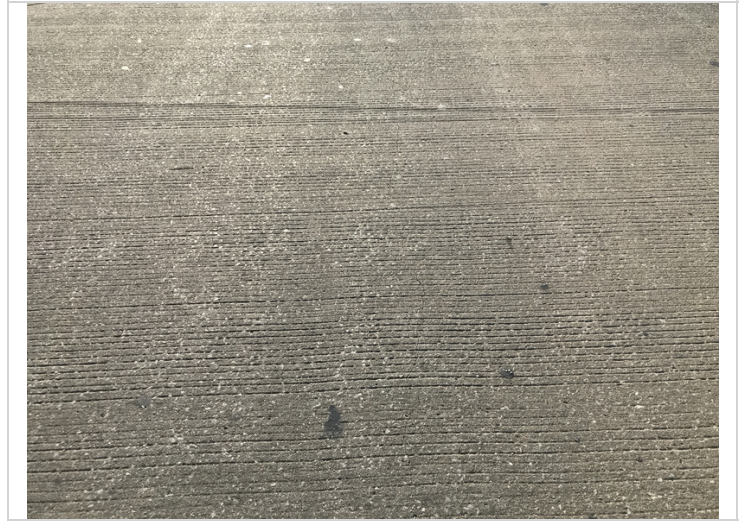
- has a tined finish that is showing very little wear.
- The driving surface has long duration hairline cracking in the driving lanes with intermittent transverse cracks.
- The top of the back wall at the left ending of the bridge has deep spalling for 4' and is cracking, the concrete is loose at this location.
- The pourable construction joint seals are beginning to lose adhesion.
- The right sidewalk has map cracking at the edge near the curb over span #5.

Typical longitudinal cracking in deck surface.

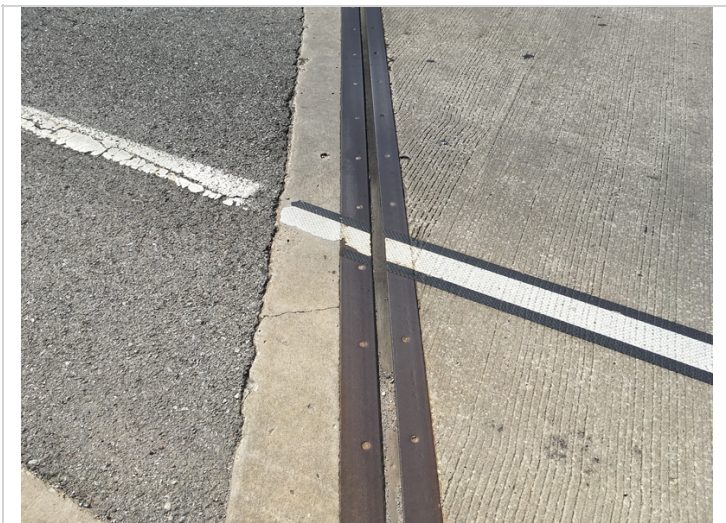
Typical joint seal condition at the abutments.

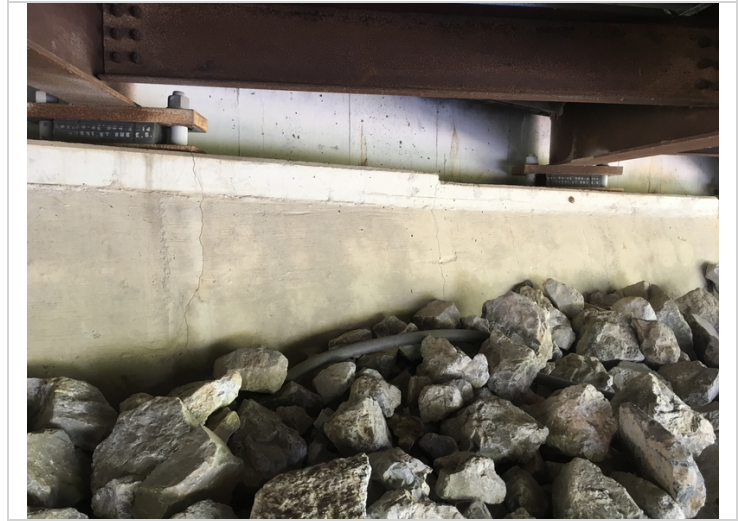
- has vertical and horizontal hairline cracking in the bridge seat and back wall for most of its length on the original portion of the abutment, the added section has water staining due to leaking joint seals.
- The elastomeric bearings at abutment #1 are in good condition, the masonry plates are showing minor corrosion due to leaking seals.
- The abutment has a small MSE retaining wall to facilitate the bike path. The rip rap is in place and functioning as intended.

Cracking in the vertical face of the bridge seat in the original portion of the abutment.

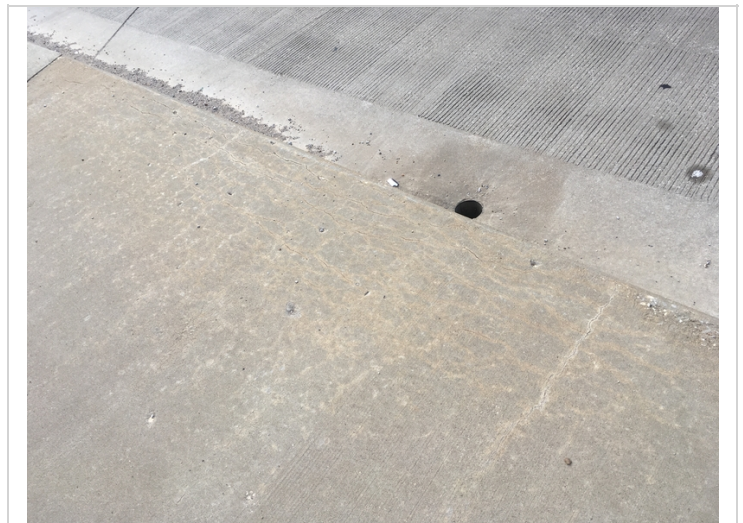
Map cracking in the edge of the right sidewalk over span #5.

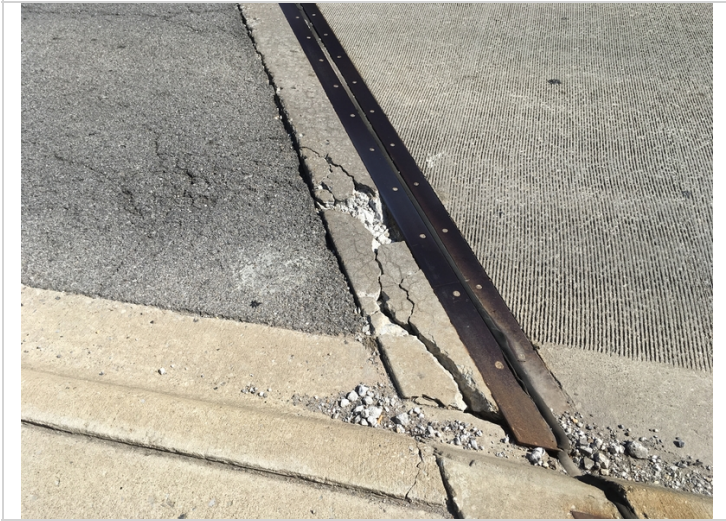
The top of the back wall at the left ending of the structure has deep spalling and is loose.

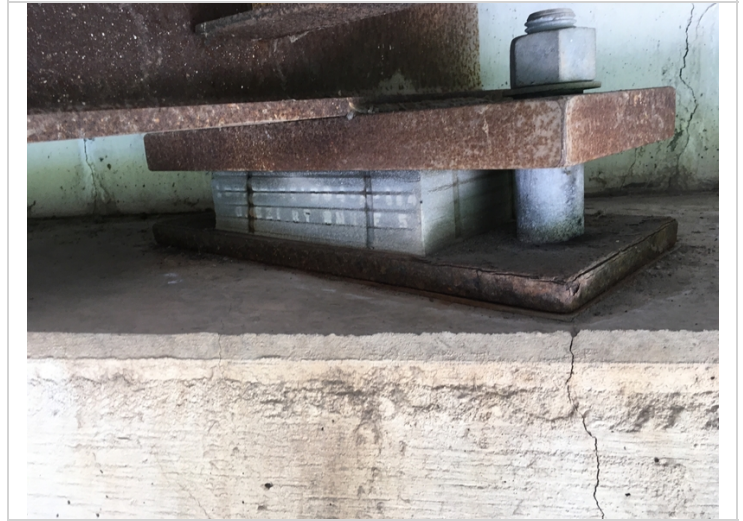
Bearing condition at abutment #1. Typical of all 10 at this location. Showing minor corrosion on the masonry plate.

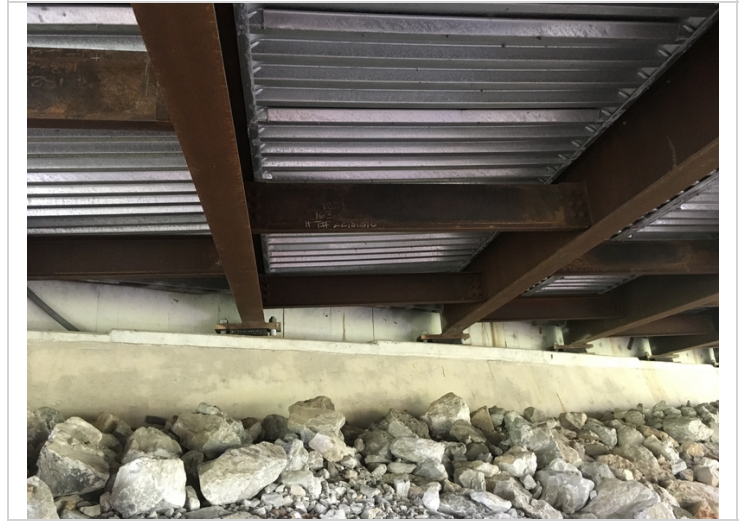
span #7- The beams are not centered on the bearings over abutment #2 at all the beams, the condition worsens as the beams continue to the right.

The beams are not centered on the bearings at abutment #2 at all the beams, the condition worsens as the beams continue to the right.

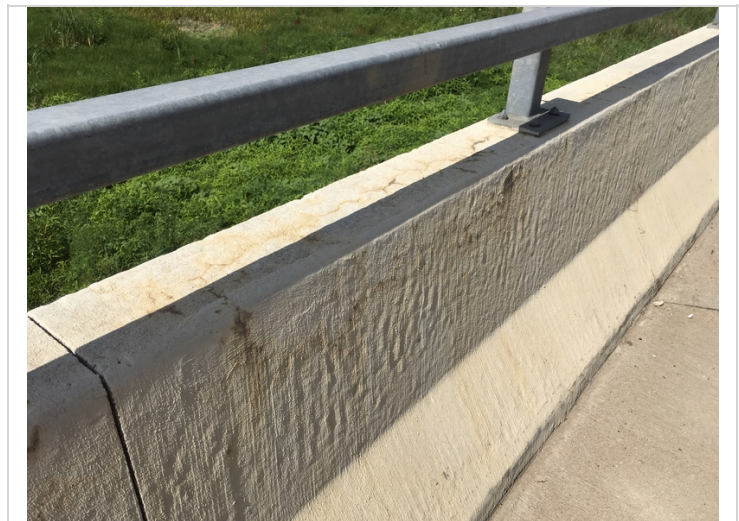
- The parapet wall has a square metal tubing attached to the top.
- Left parapet wall- has areas of map cracking along the top edge.

Map cracking in the bridge parapet. Typical of several locations.
