Bridge Inspection Report

19039
S. 10TH ST.
over
CREEK

Structure Number: 19039

Facility Carried: S. 10TH ST.

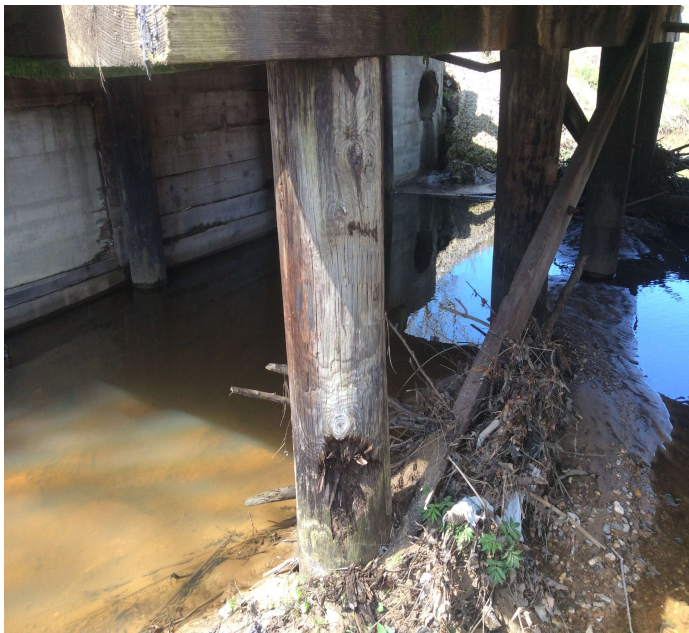
PHOTO 1 Description

Pile 1 bent 2 rotten with large hole. Pile 3 bent 3 rotten area.

Work Code: Repair

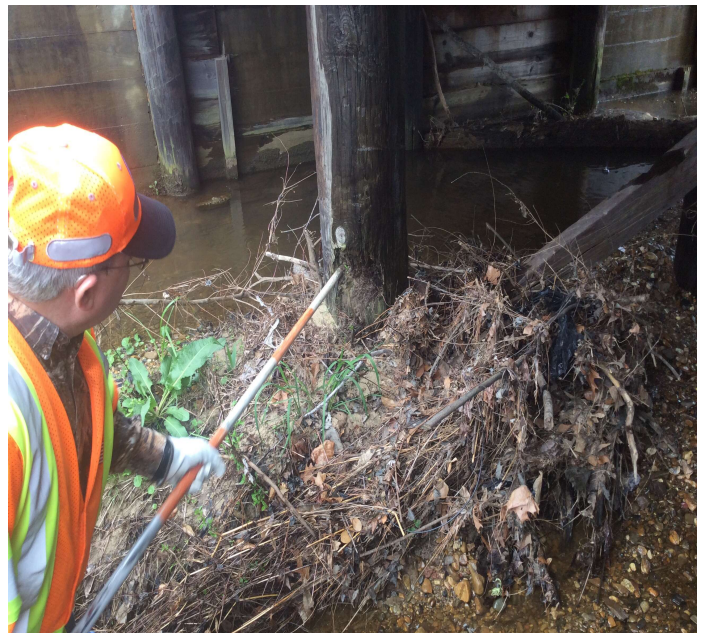
PHOTO 2 Description Bent 2 pile 1 rotten

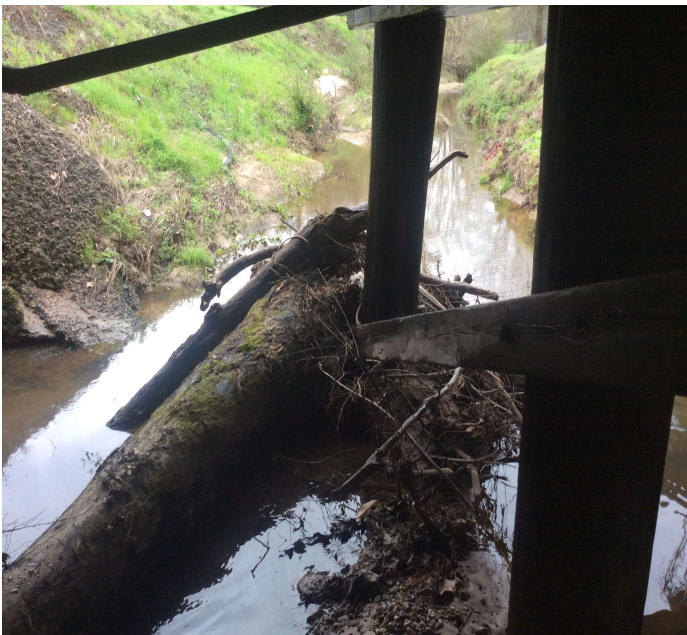
Heavy drift pile lodge against pile 4 bent 2. 03/06/2017 JPR -- Bent 2 @ Pile 4 there is a large log that is against pile 4.

PHOTO 1 Description Bent 2 drift right side, against Pile 4.
