Bridge Inspection Report

20892
C W POST RD
over
LITTLE BAY DITCH

Structure Number: 20892

Facility Carried: C W POST RD

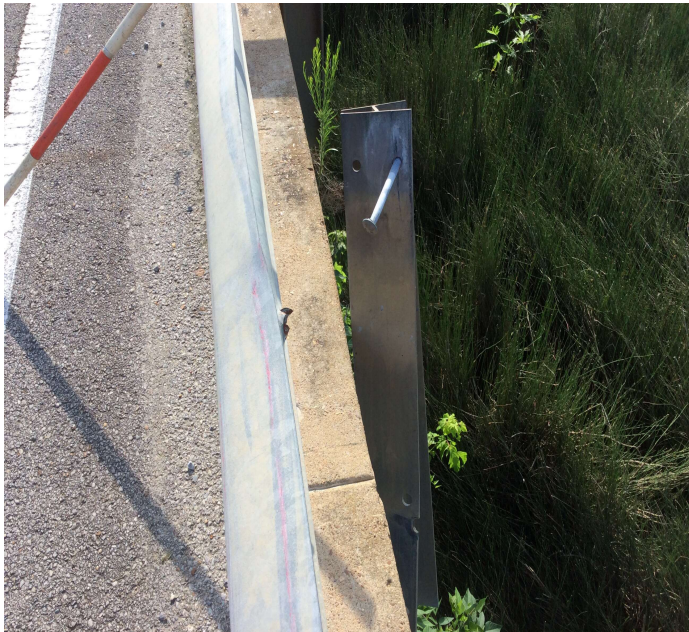
PHOTO 1 Description

20 ft. of right approach rail at bent 1 is damaged.
Right rail has 1 post and 10 ft. of damage. See 2016 photos.
