## Bridge 14772 Inspection Report

**Richie Road over Ashley Creek Logan Co.**

**Location: 0.54 MI S SH 10**

**Team Lead: Rhett Franks Inspection Date: 09/26/2024**

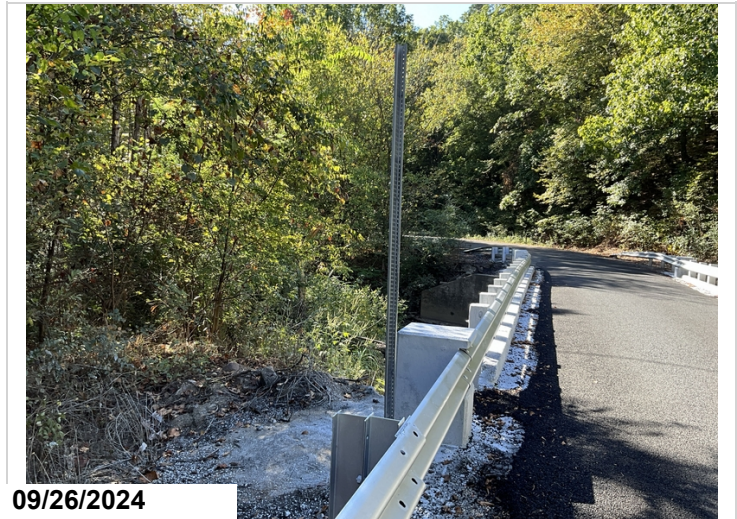
Span 1, bent 1, left side approach is missing flare panel.

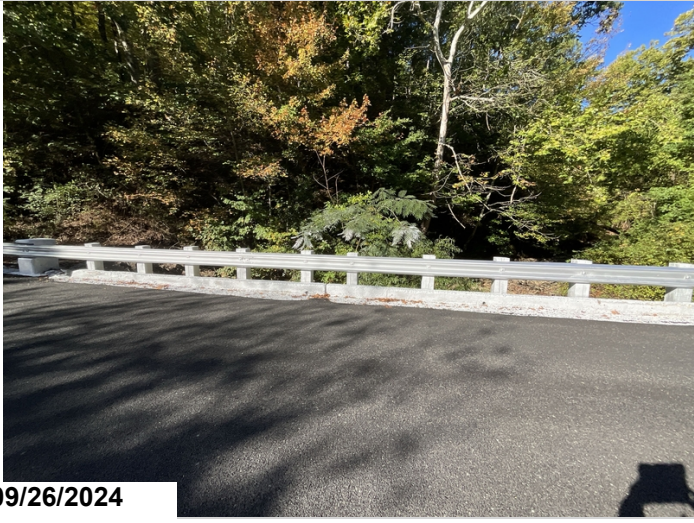
Rail has new paint.

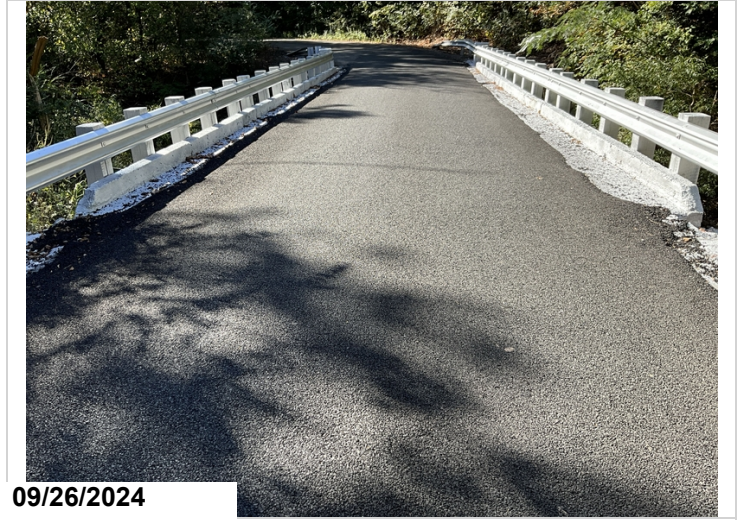
Deck has new asphalt wearing surface . 3"

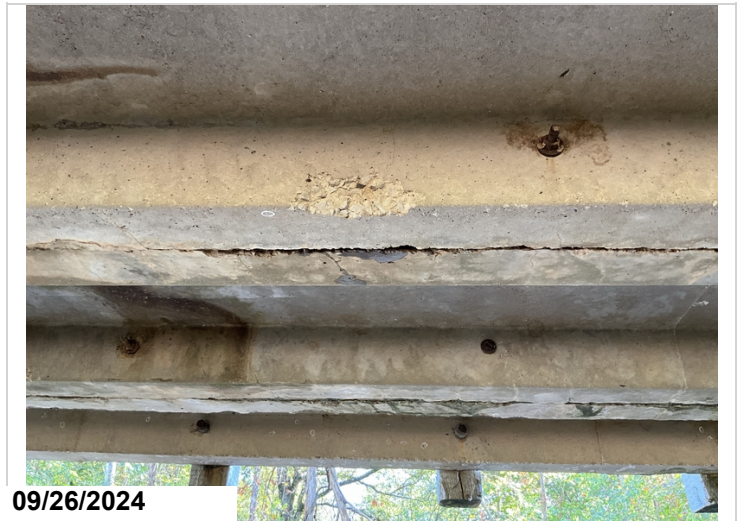
Span 3, bent 3, unit 3 left leg has spalling. CS2

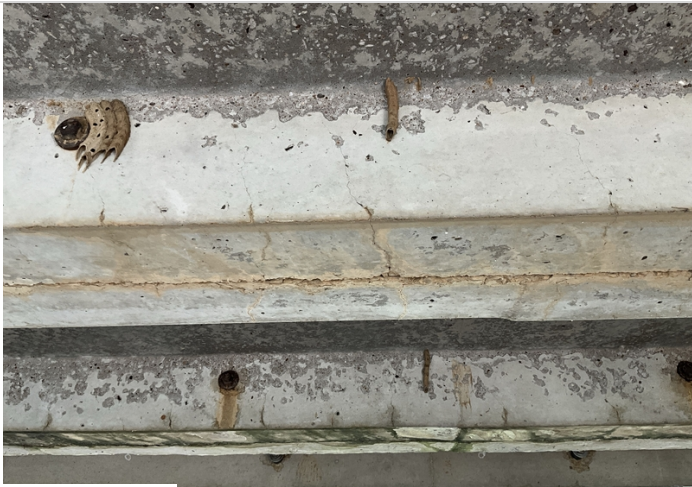
Span 1, bent 1, unit 4, right leg has flexure cracking. CS2

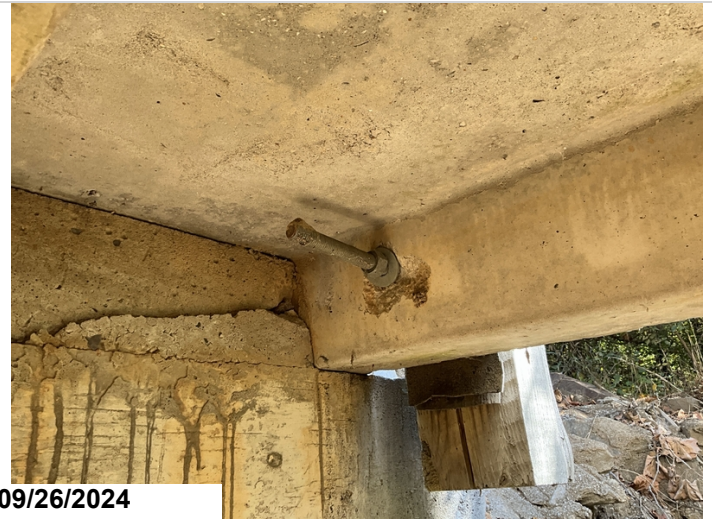
Exterior channel beams have shallow spalling in the exterior stems around the bolts that attach the bridge railing posts.

Span 1, bent 1, unit 1 left leg has spalling at lag bolt. CS3

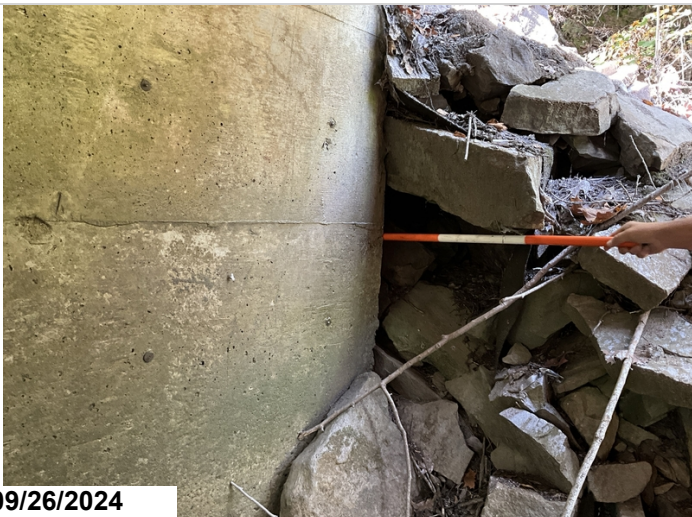
Span 3, bent 4, right side has erosion approximately 1'.

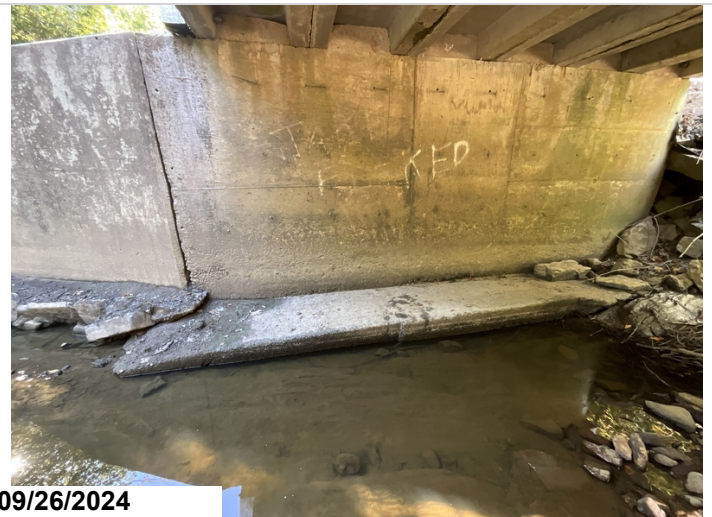
Span 3 Bent 3, Portions of the top footings are exposed at this inspection. Approximately 14" of the vertical face of Bent 4 footing is exposed with minor voids under the footing near centerline. bent 4 left wing wall has a non-uniform footing with voids that penetrate up to approximately 12" under the edge of the footing. Voids do not reach the face of the wing wall during this inspection.

Span 3, bent 4, footing is exposed.

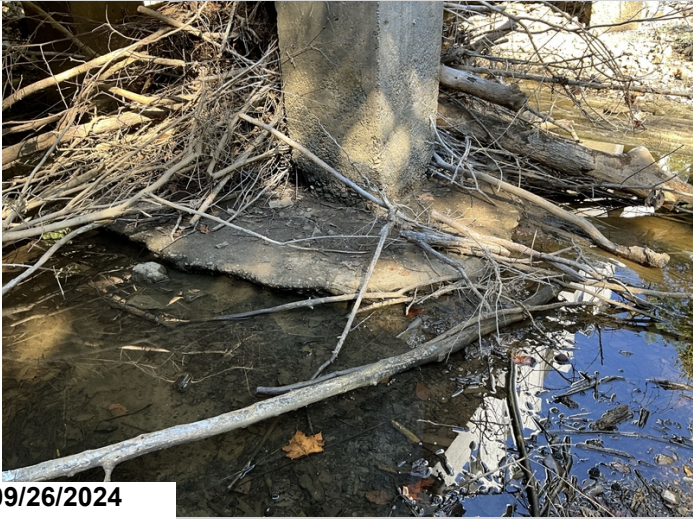
Span 3, bent 3, column 1, has spalling. CS3

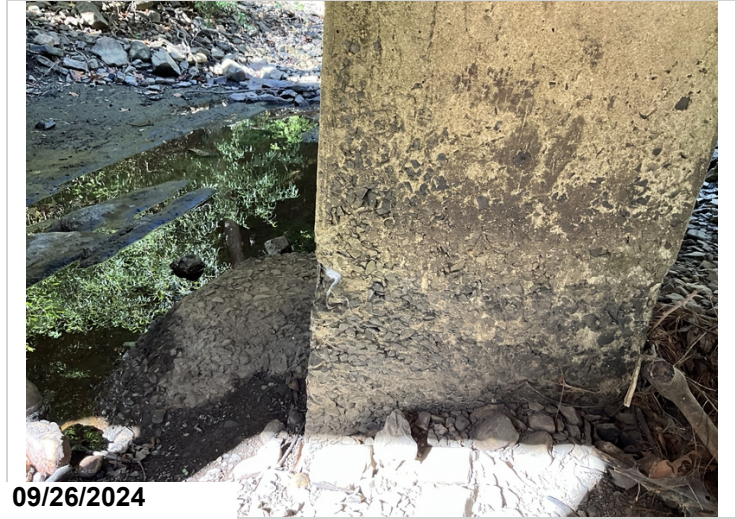
Span 1, bent 2, column 2, has spalling. CS3

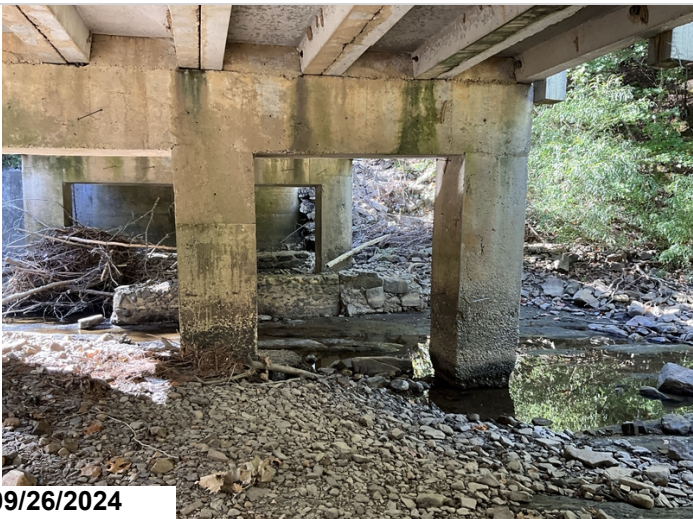
Span 1, bent 2, column 3, has concrete deterioration. CS3

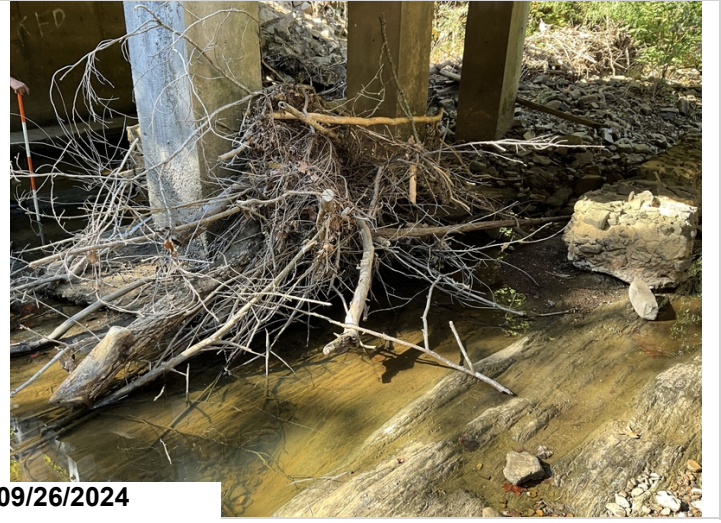
Span 2, bent 3, has drift build up in between the columns.

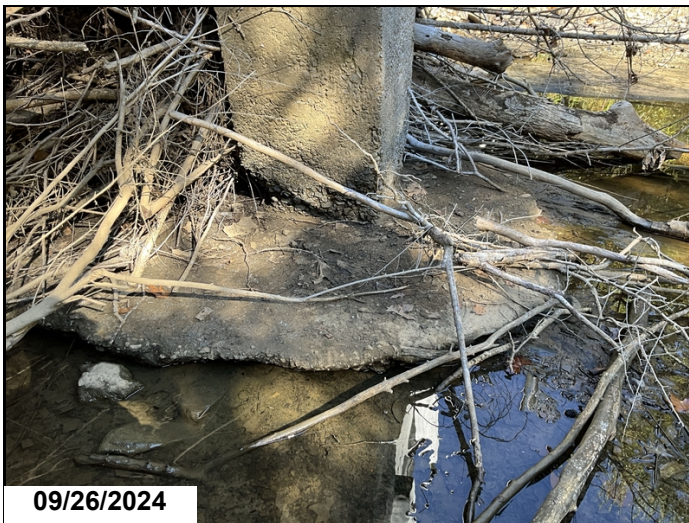
The bases of columns have concrete section loss due to abrasion and deteriorated concrete. Bent # 3, column # 1 has concrete deterioration at the base with concrete section loss approximately 6" high and 4" deep that extends across the entire width of column.

Concrete deterioration and section loss in the base of the columns at the footing juncture exists below the water elevation.

Span 3, bent 3, column 1, has section loss.

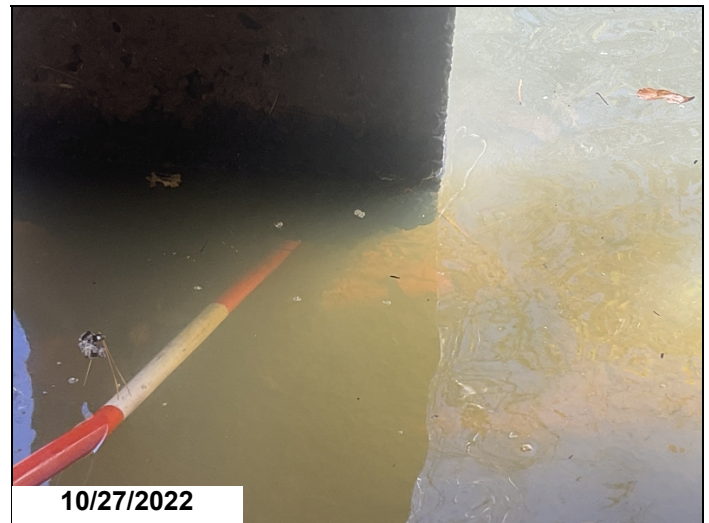
Bent 3, column 1-Concrete section loss at base of column

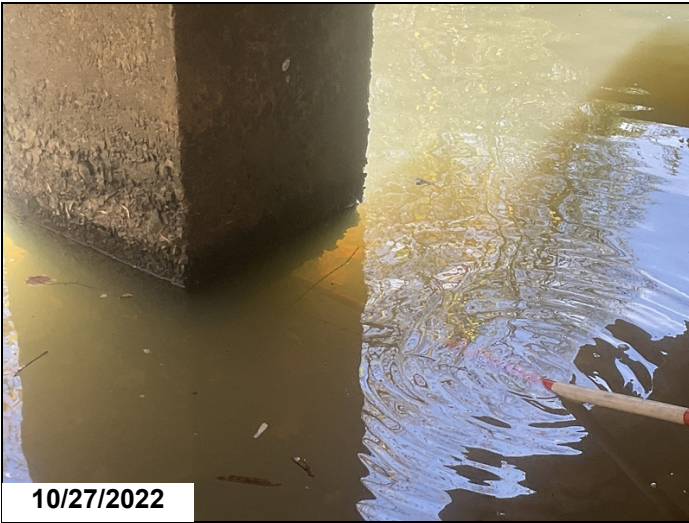
Bent 3, column 1-Concrete section loss at base of column

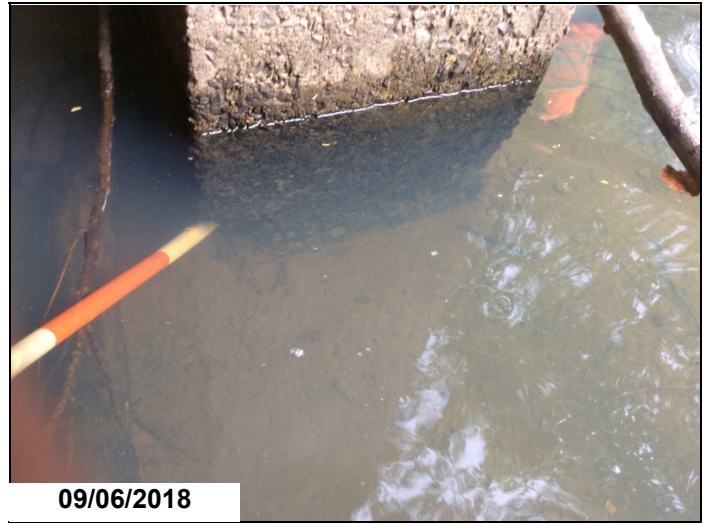
Bent # 3 Lt column concrete deterioration with section loss.

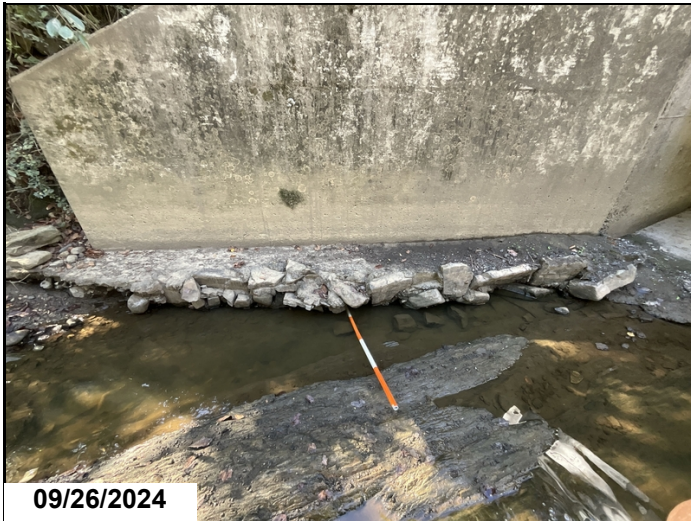
The Southeast wing wall has a non uniform footing with voids that penetrate approximately 12" under the edge of the footing. Voids do not reach the face of the wing wall during this inspection.

Span 3, bent 4, left side wing wall undermining.

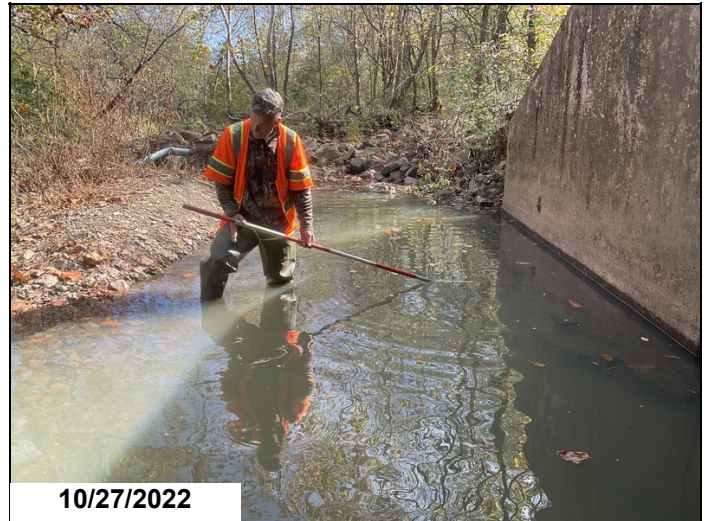
The Southeast wing wall has a non uniform footing with voids that penetrate approximately 12" under the edge of the footing. Voids do not reach the face of the wing wall during this inspection.

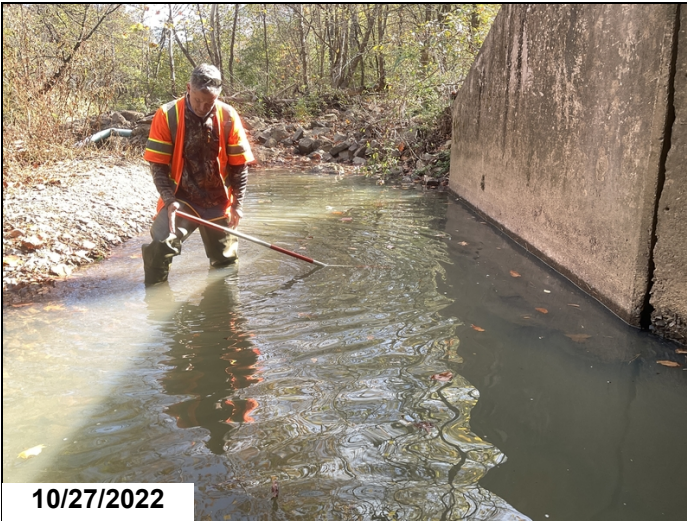
The Southeast wing wall has a non uniform footing with voids that penetrate approximately 12" under the edge of the footing. Voids do not reach the face of the wing wall during this inspection.

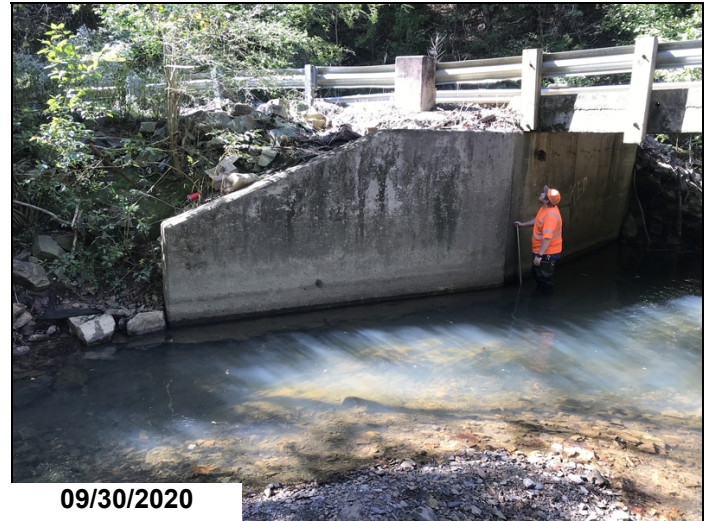
The Southeast wing wall has a non uniform footing with voids that penetrate approximately 12" under the edge of the footing. Voids do not reach the face of the wing wall during this inspection.

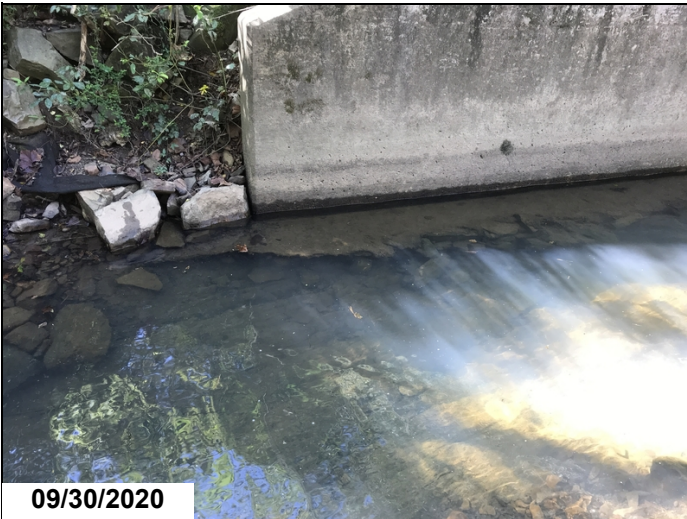
The Southeast wing wall has a non uniform footing with voids that penetrate approximately 12" under the edge of the footing. Voids do not reach the face of the wing wall during this inspection.

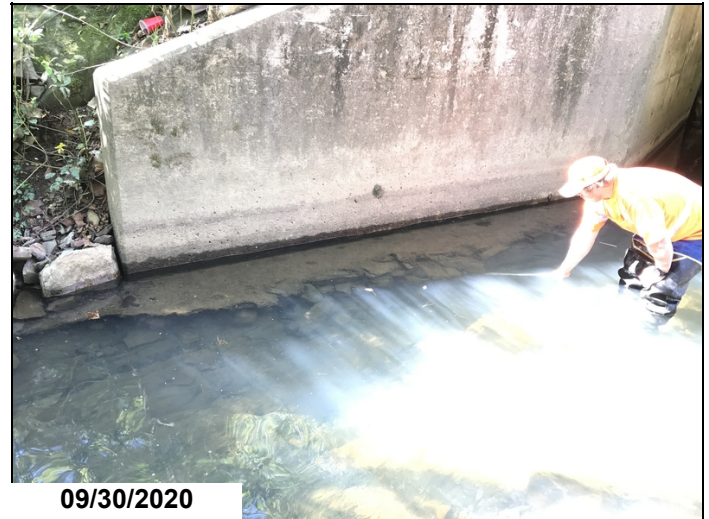
The Southeast wing wall has a non uniform footing with voids that penetrate approximately 12" under the edge of the footing. Voids do not reach the face of the wing wall during this inspection.

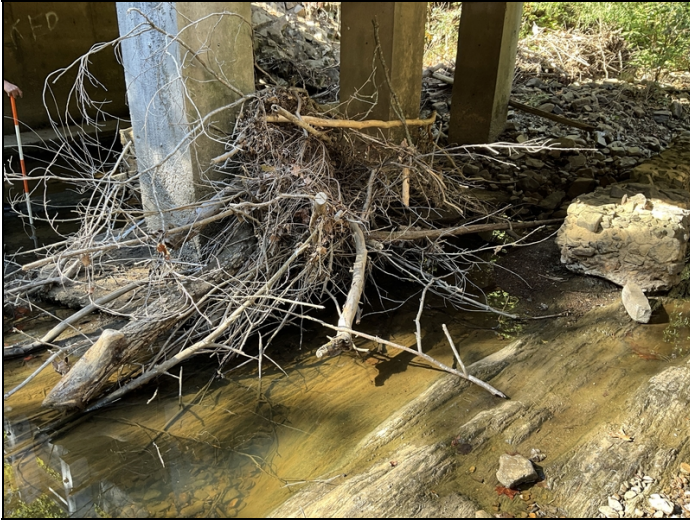
Span 2, bent 3, has drift build up in between the columns.
