Bridge 20409 Inspection Report

Arnold Road ID:42xRICHIERDx1xA, Arnold Log mile:0.432

District 08, 83 - Logan County

Team Lead: Rhett Franks, Inspection Date: 03/11/2024

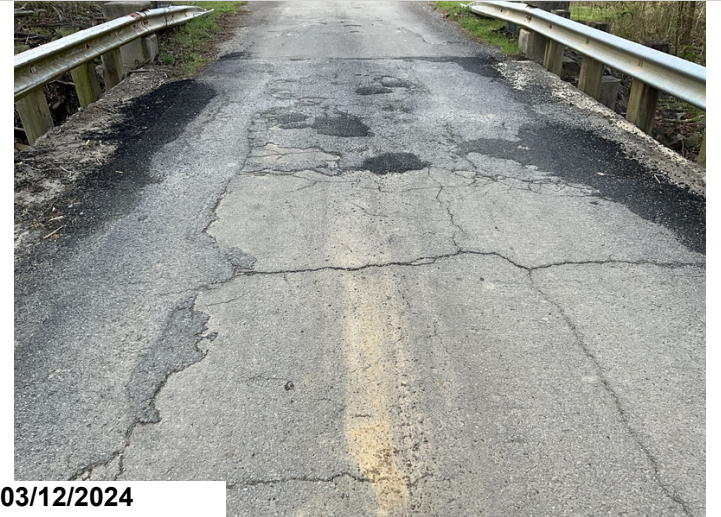
Vertical and horizontal cracking in the overlay full length of deck. CS3 Cracking

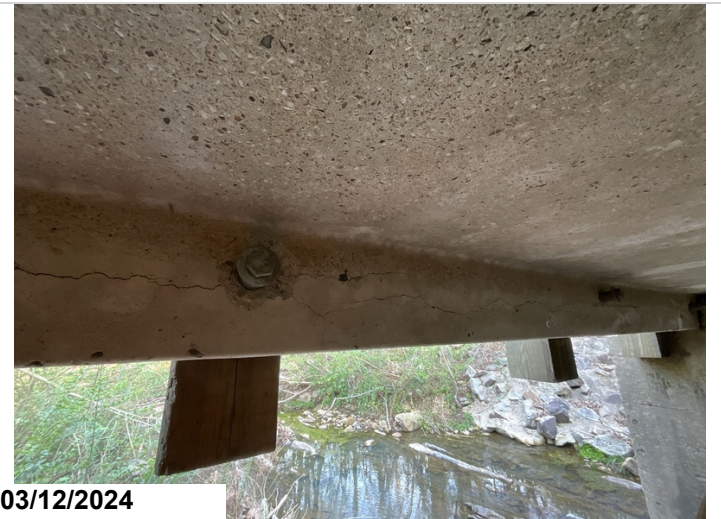
Span 2, unit 5, right leg, has cracking along the bolted guard rail. CS3 15 LF.

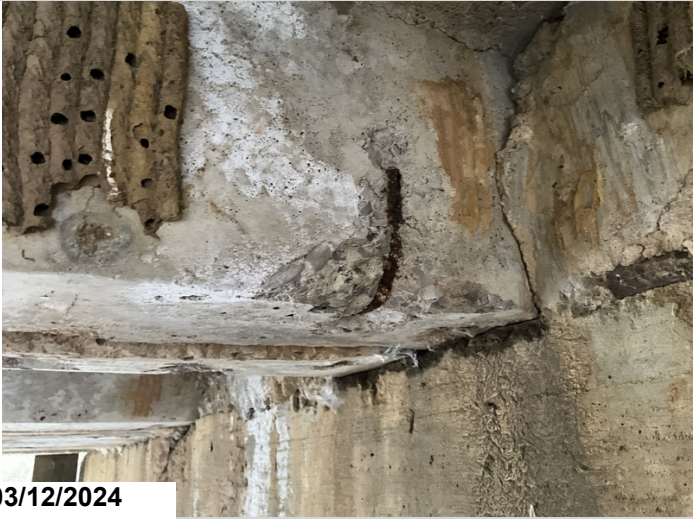
Span 2, unit 3, right leg, has spalling with exposed reinforcing steel. CS3

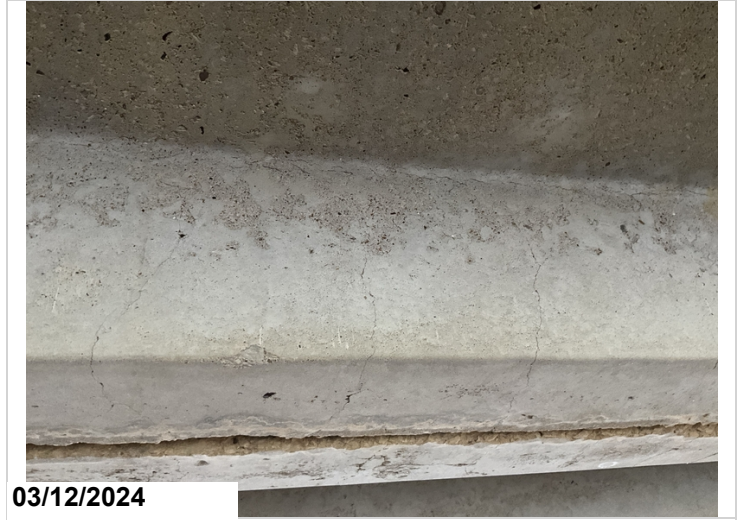
Precast concrete channels with flexural cracking in the stems of channels at approximately 4" to 6" centers.CS2

Typical flexure cracks in all units. CS2

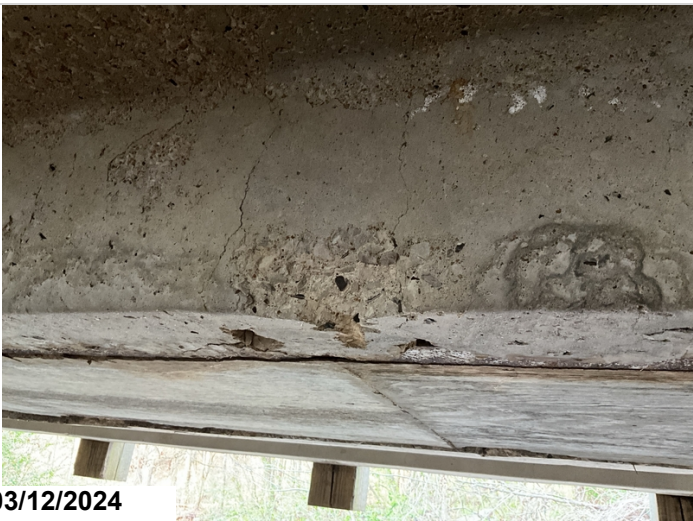
Span 1, unit 4, right leg has spalling. CS3 1LF

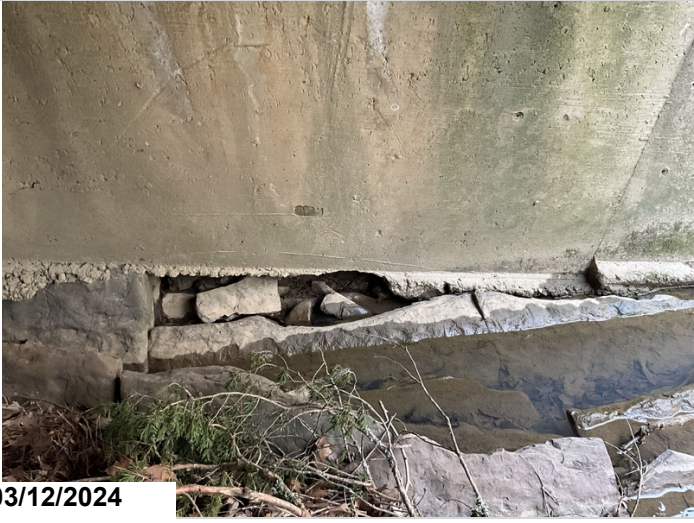
Bent 3, has irregular void under the footing. CS2 1LF

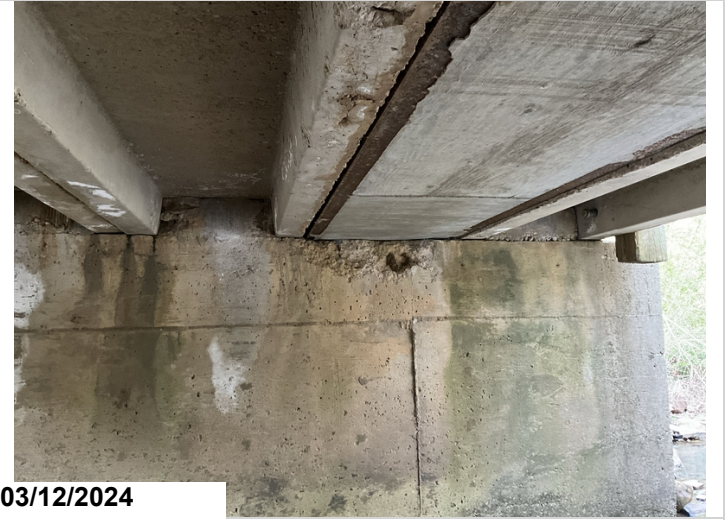
Bent 2 pier wall has a 36" x 10" x 4" deep spall in the back face in the bearing area of unit 5.

Pier 2, back side in the bearing area has large spall. CS3 2LF

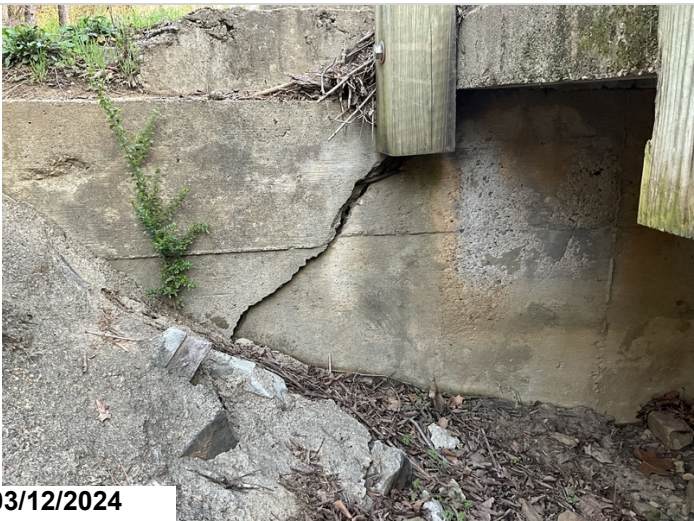
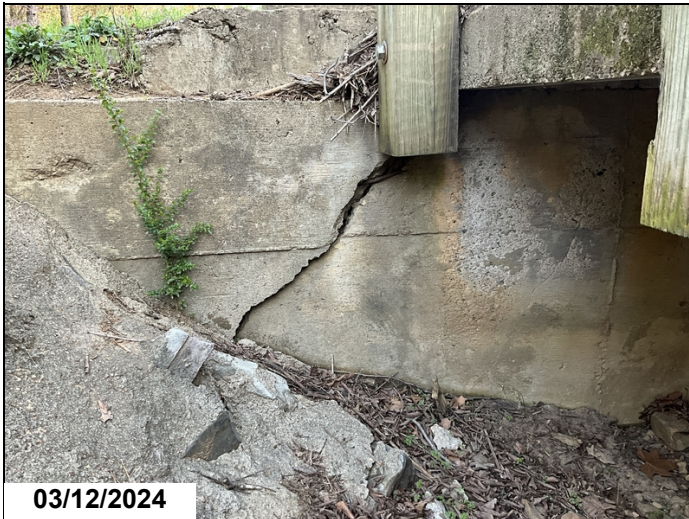
Bent 1 right is fractured with exposed exposed reinforcing steel. The fractured portion of the stem wall extends under the right stem of unit 6 on the exterior side of the structure.CS3

Abutment 1 on the right side has large crack. CS3

The right side of abutment # 1 stem wall is fractured and has exposed reinforcing steel. The fractured portion of the stem wall extends under the right stem of unit # 6 on the exterior side of the structure.

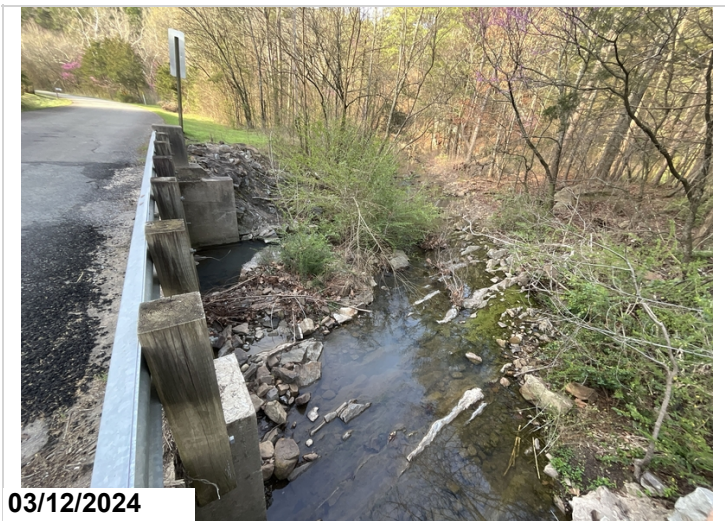
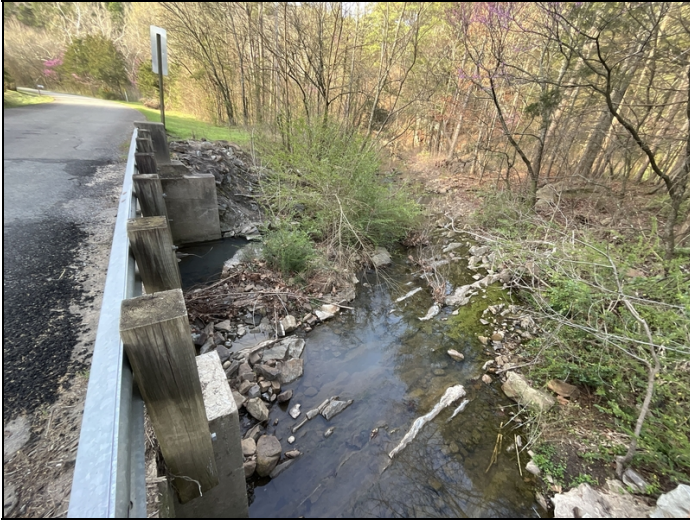
Vegetation in channel restricting flow on the right down stream side.

Vegetation in channel restricting flow.

A-64 - Vegetation Removal Requested (Yes)

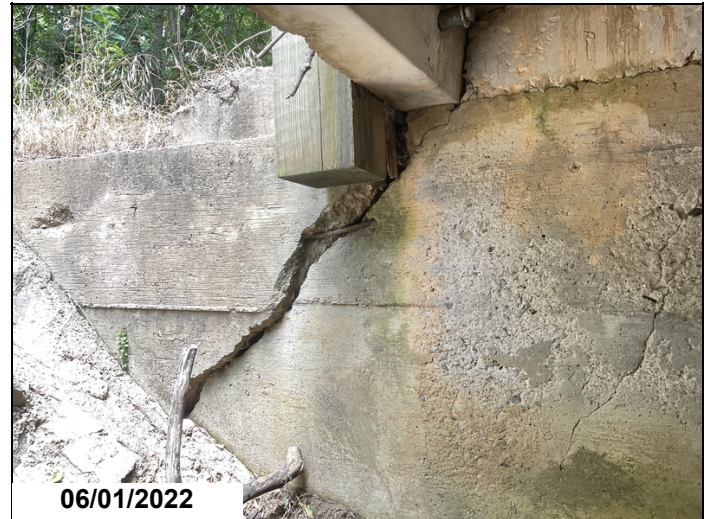
Abutment # 1, right side-Fractured under right stem of unit # 6.

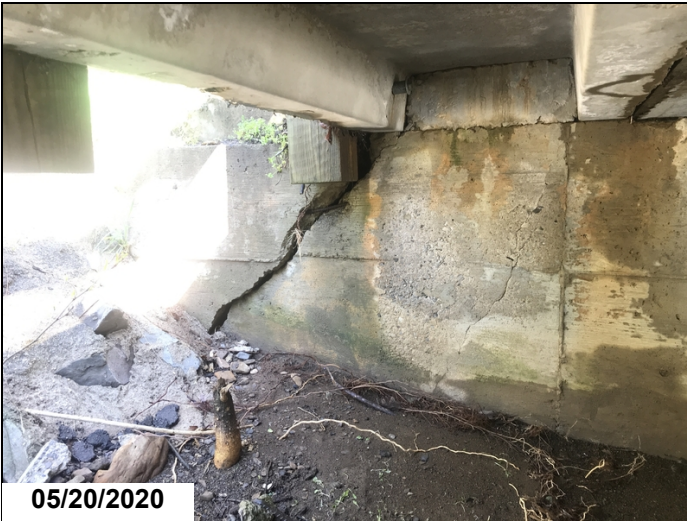
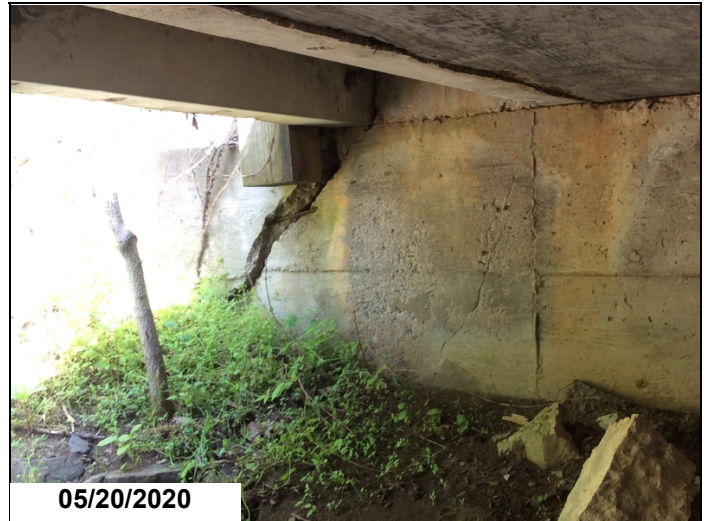
The right side of abutment # 1 stem wall is fractured and has exposed reinforcing steel. The fractured portion of the stem wall extends under the right stem of unit # 6 on the exterior side of the structure.

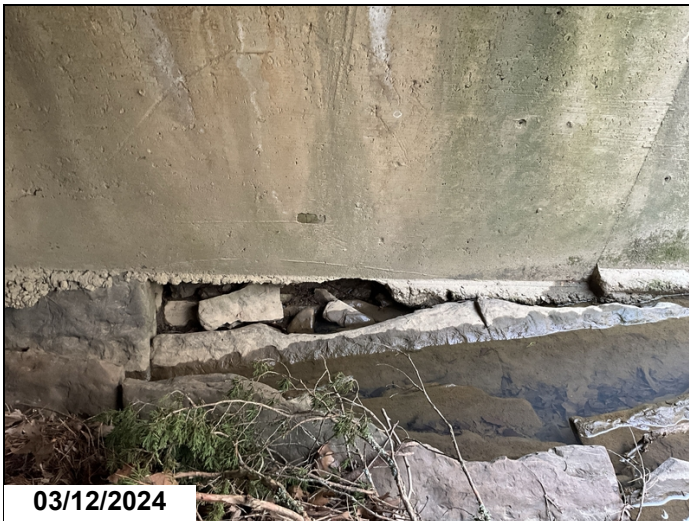
Bent 3, has irregular void under the footing. 1LF

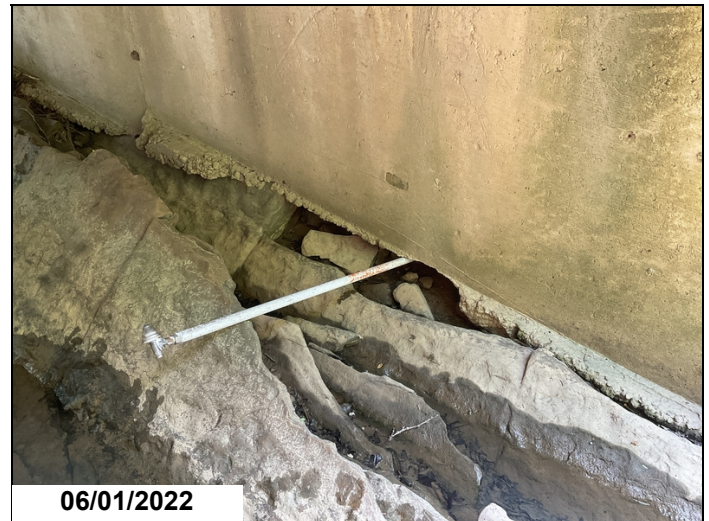
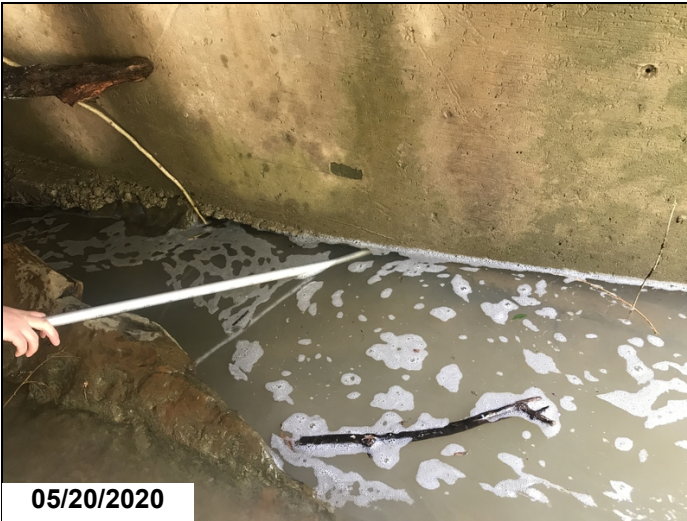
Abutment # 2 stem wall has a 3' long x 5" high void that penetrates up to 16" under the base of the abutment located under channel unit # 5. Abutment appears to be constructed on non-uniform solid rock channel with no apparent scour problems during this inspection.

Abutment # 2 has a 3' long x 5" tall void that penetrates up to 16" under the base of the abutment that is located under Unit # 5. Bent appears to be constructed on non-uniform solid rock channel with no apparent scour problems during this inspection.

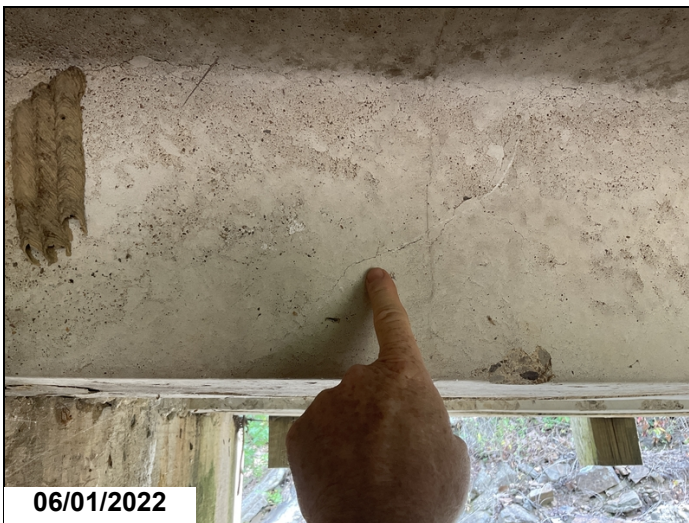
Span # 1, units # 1, 2, & 4 and span # 2, units 2, 3, 4, & 6 have shear type cracking adjacent to the bents.

Span # 2, unit # 3, left stem-Shear type crack.

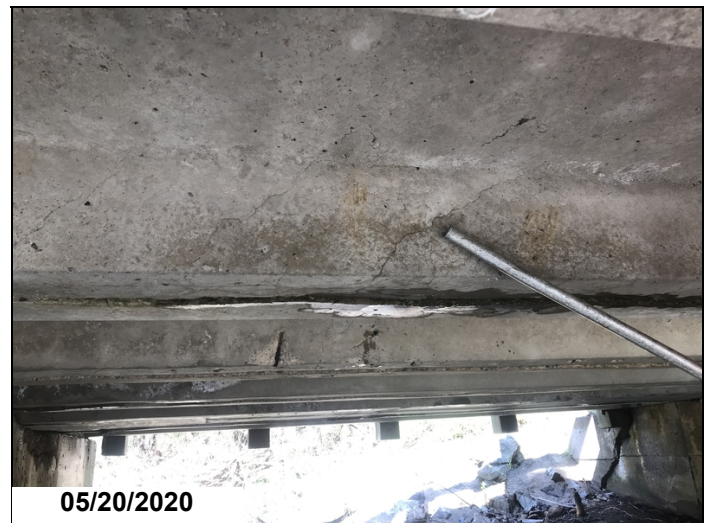
Span # 1 shear cracks in the Right stem of Channel # 1.

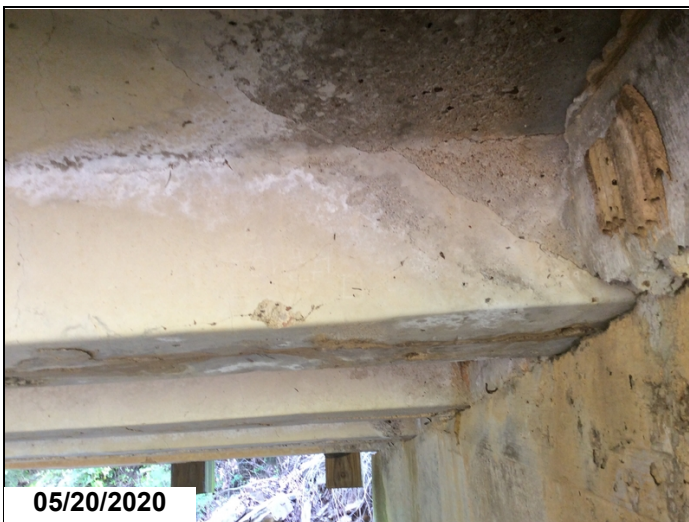
Bent # 3 Unit # 4 shear crack that extends into the deck.

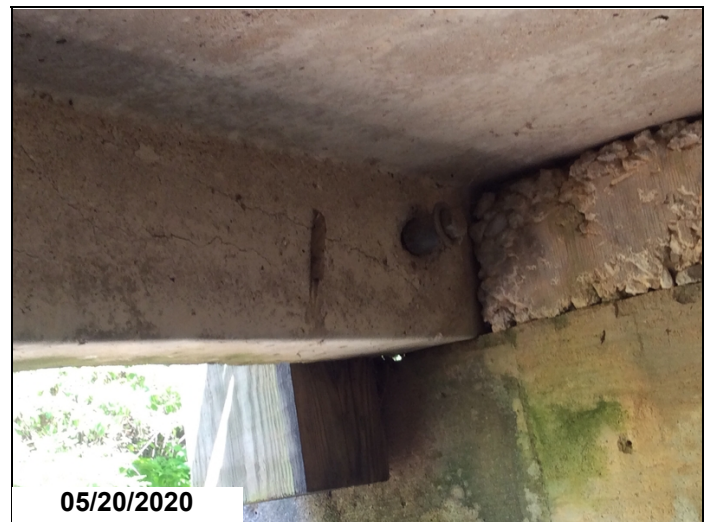
Span # 2 Unit # 6 shear type crack in the RT stem.

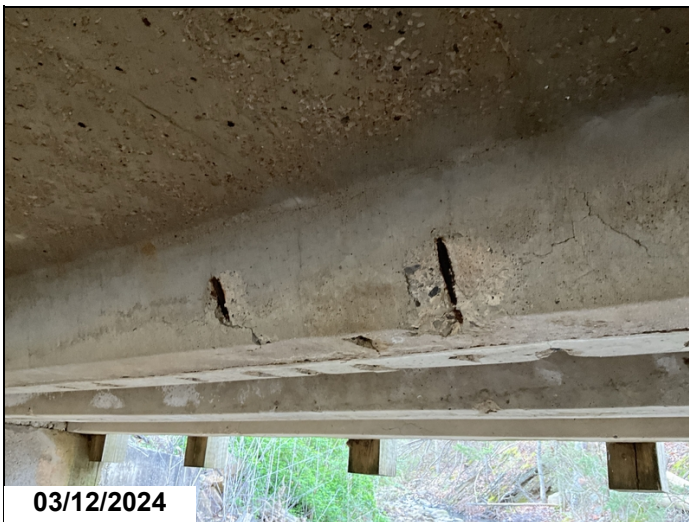
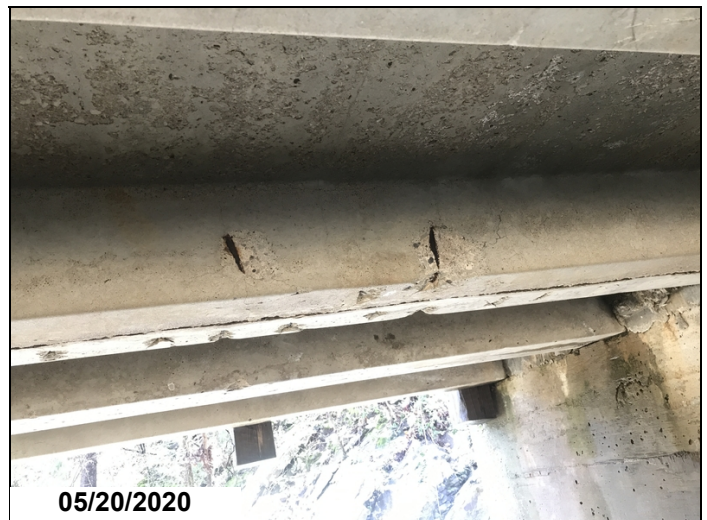
Span # 1, Left stem of Unit # 3.

Span # 1, units # 2, 3, 4, & 6 and span # 2, unit # 3 have areas of shallow spalling with exposed reinforcing steel along the bottom of the stems.

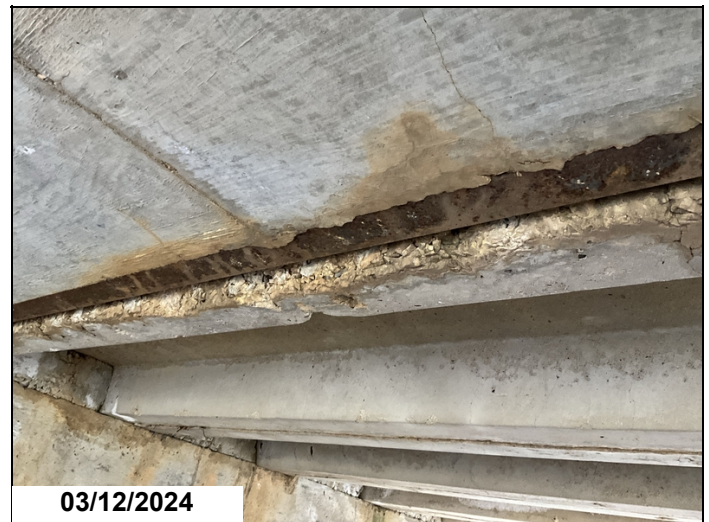
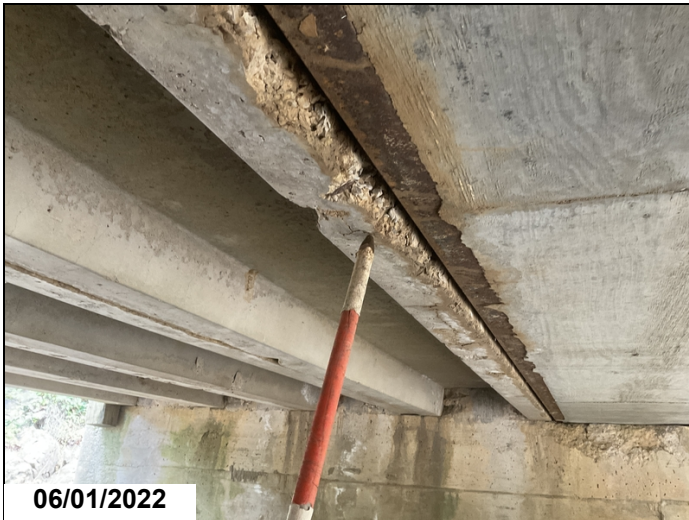
Span # 1, unit # 4, right stem-Spalling

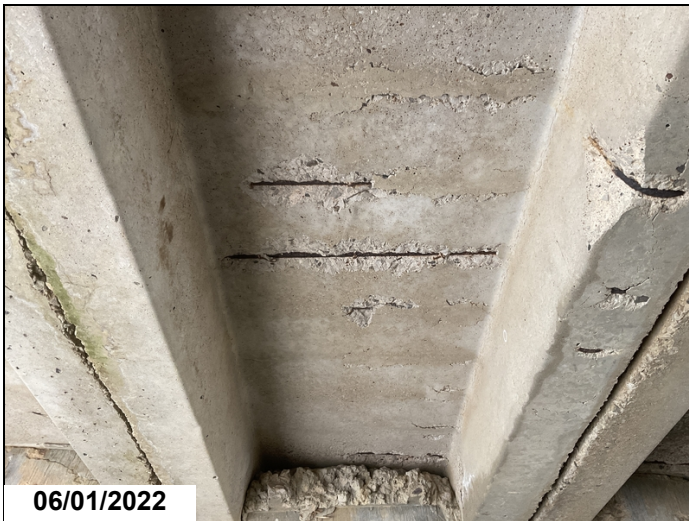
Span # 1, unit # 2-Spalling with exposed reinforcing steel in deck undersurface.

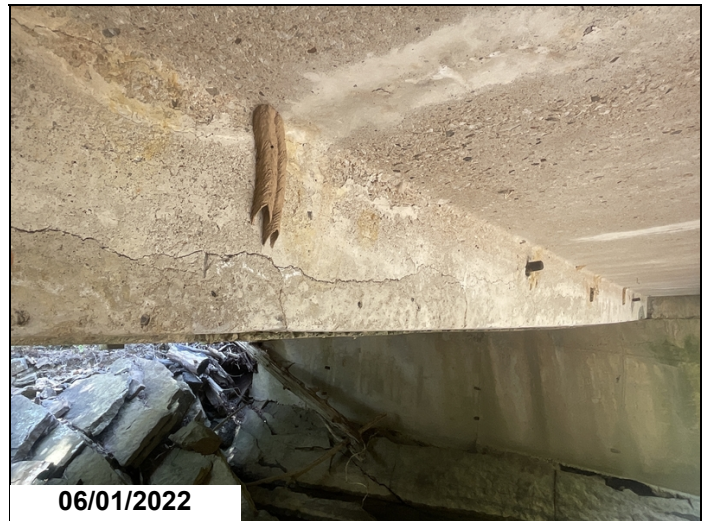
Span # 2, unit # 6 has longitudinal cracks in the left and right stems that extends for the majority of the length of the beam.

Span # 2, unit # 6, left stem has longitudinal cracking.

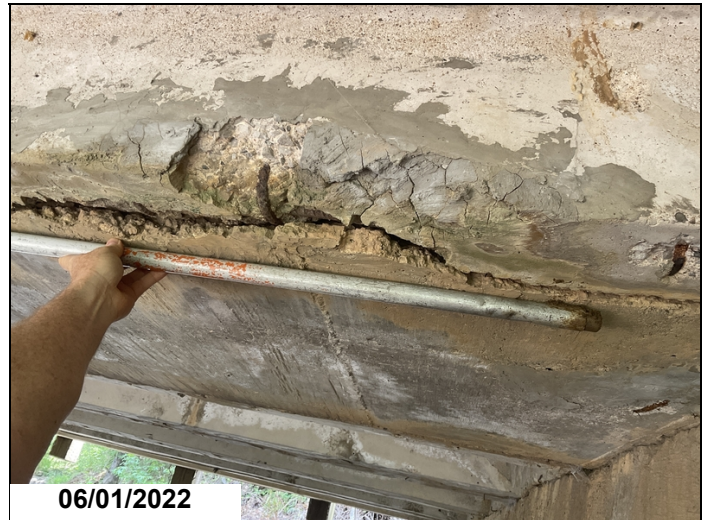
Span # 2, unit # 6 has a failed grouted repair in the left stem near abutment # 2 with the reinforcing steel exposed.

Span # 2, unit # 6, left stem near abutment 2-Failing grout repair.

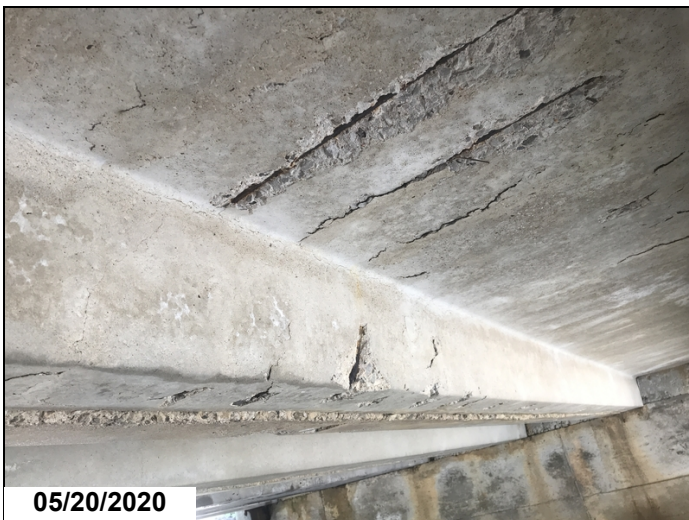
Span # 1. Channel Unit # 2. Spalls with exposed reinforcing steel.

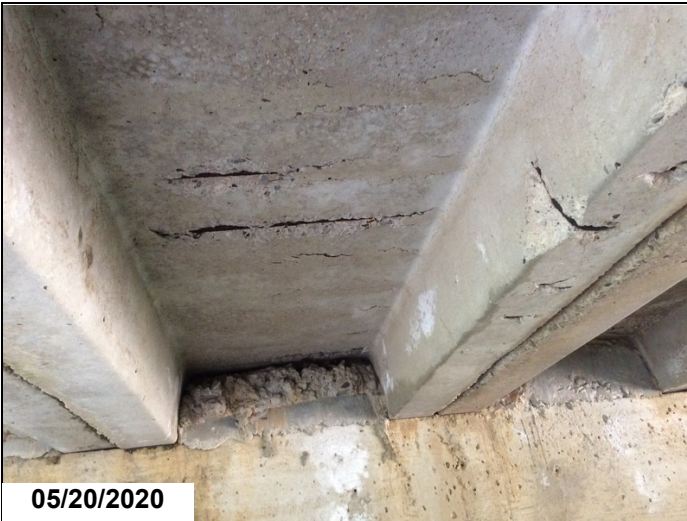
Span # 1 Unit # 2 with spalling that exposes reinforcing steel in the stem and on the undersurface of the units deck.

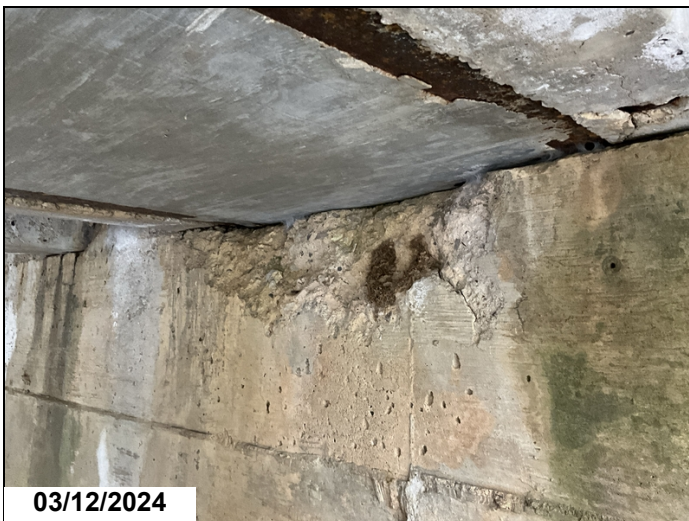
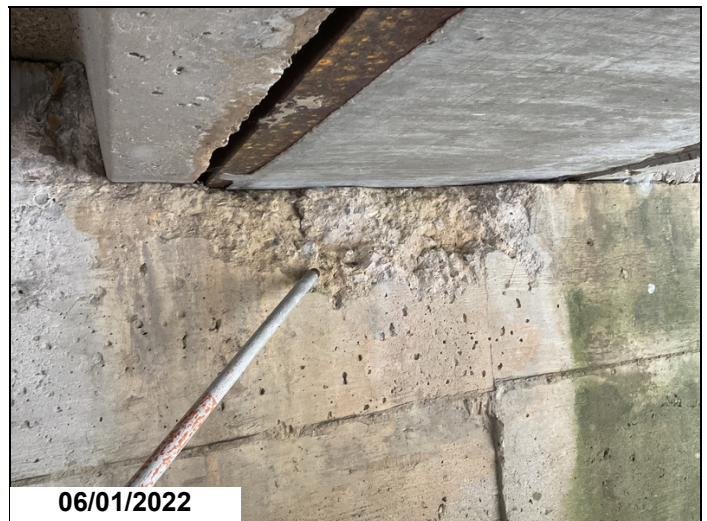
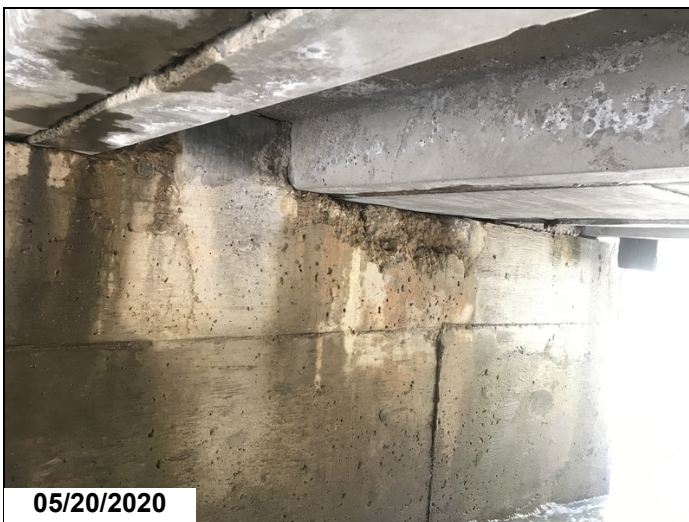
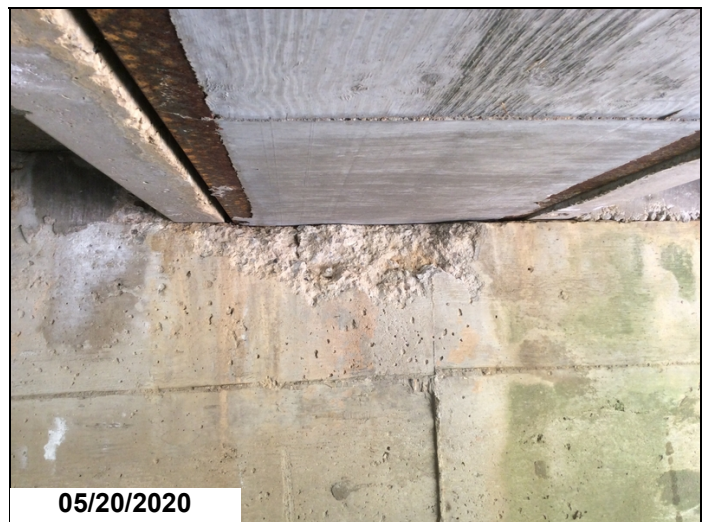
Substructure -
Bent # 2 pier wall has spalling in the bearing area of the channel units.

Span # 1, bent # 2-Spalling in bearing area under channel unit # 5.

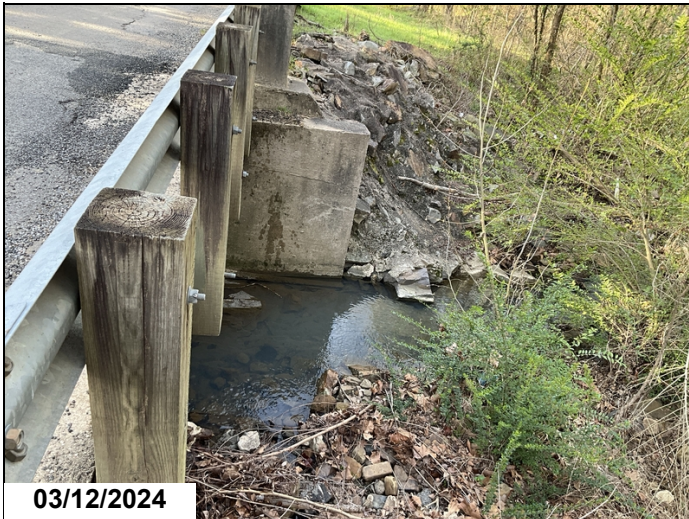
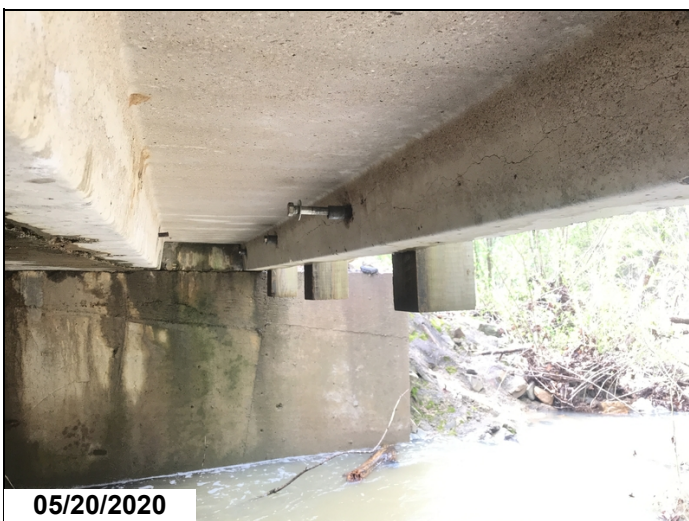
The bridge rail on the right side of the structure is loosely bolted to the exterior stem of channel units.

Loosely bolted rail on right side of bridge.

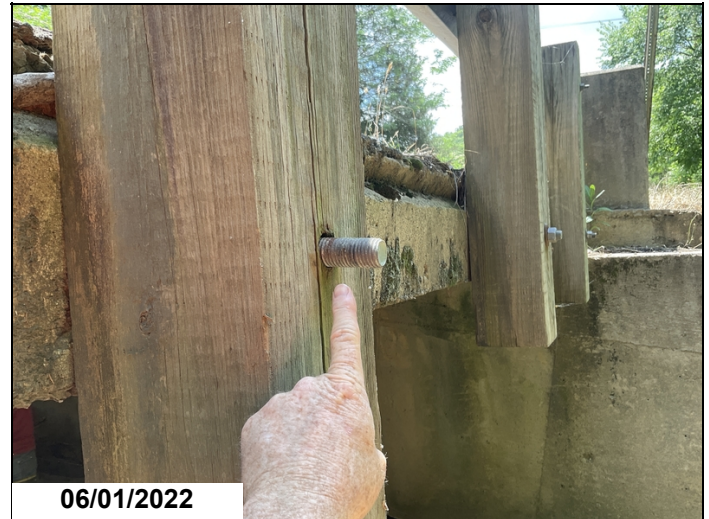
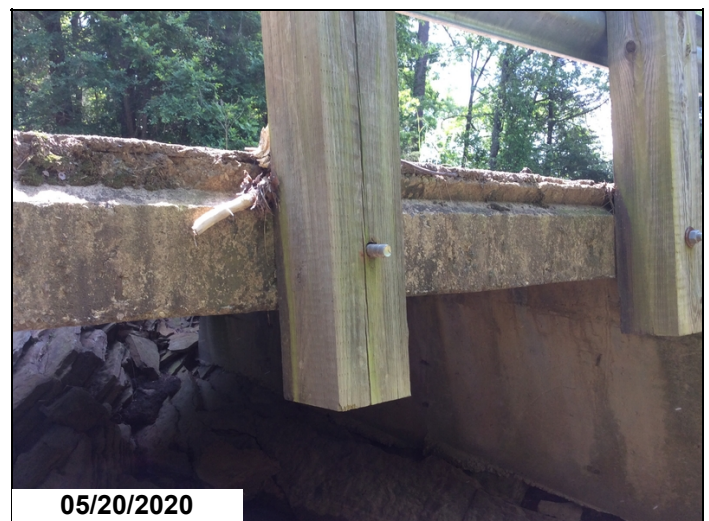
Post # 3 on the right side of span # 2 is missing a nut on the lower anchorage bolt.

Span # 2, post # 3, right side-Missing nut on bolt that secures post to channel beam
