Asset #21758(Routine)

Trammel Rd over FIVE MILE CREEK

Location: .30 MI E OF US 67/I-6

Team Lead: Keith Harris, Inspection Date: 05/22/2023

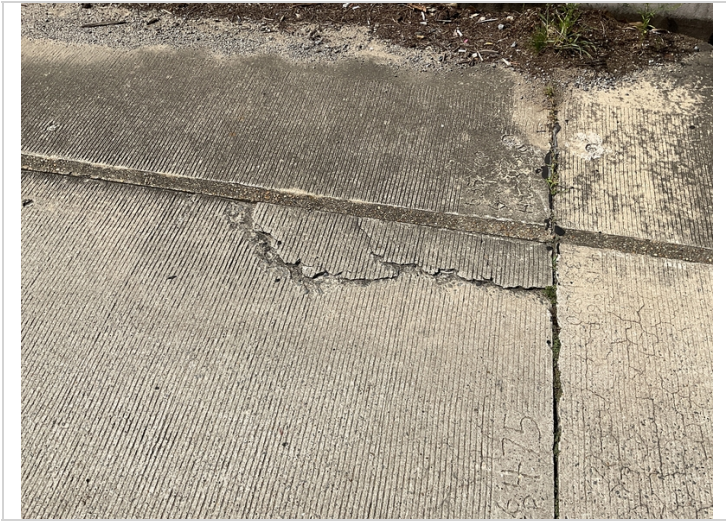
Span 3 units 2,3,4,&5 small spall in units at grouted key ways, and delam mat channel unit 7.

Span 3, channel unit 7 delam

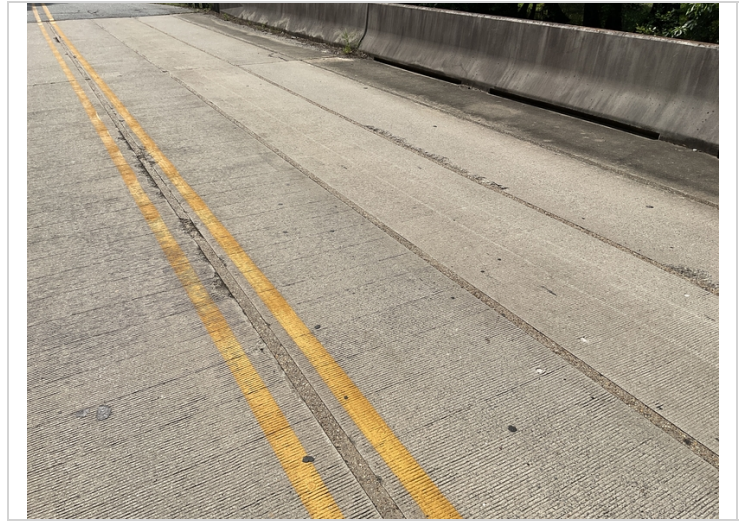
Span 2 units 3,4,5,&7 small spalls in units at grouted key ways.

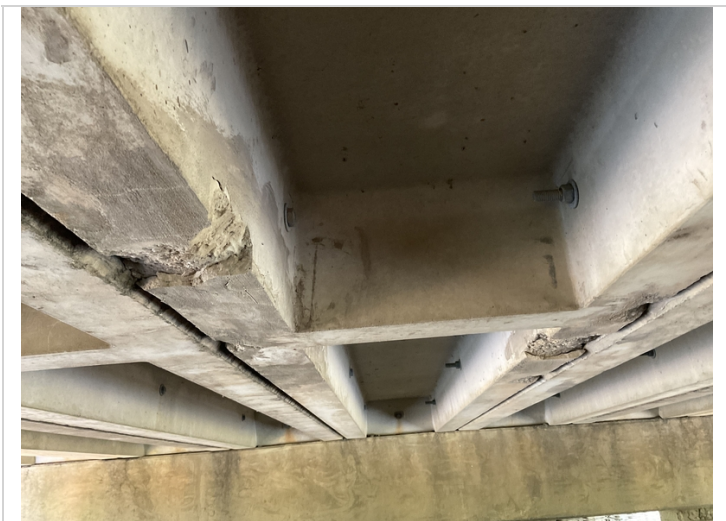
Span 2 unit 5 spalls on channel legs.

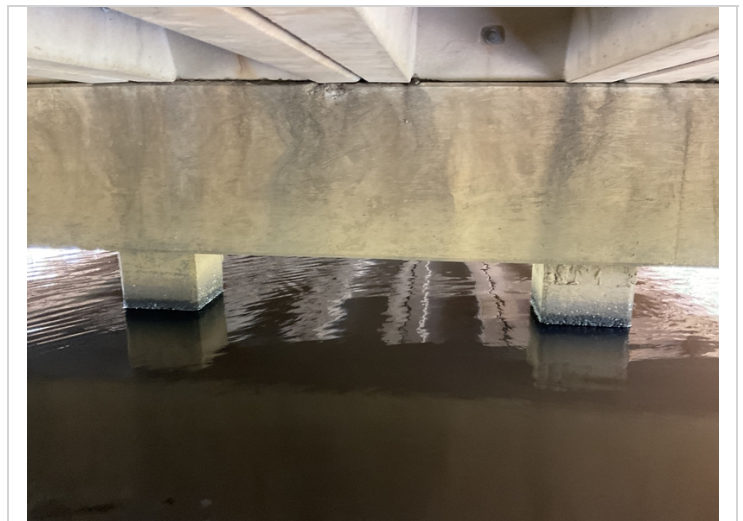
Bent 3 cap small spall on ahead face.

All pile have abrasion at waterline

Bent 3 spall on cap and abrasion on columns

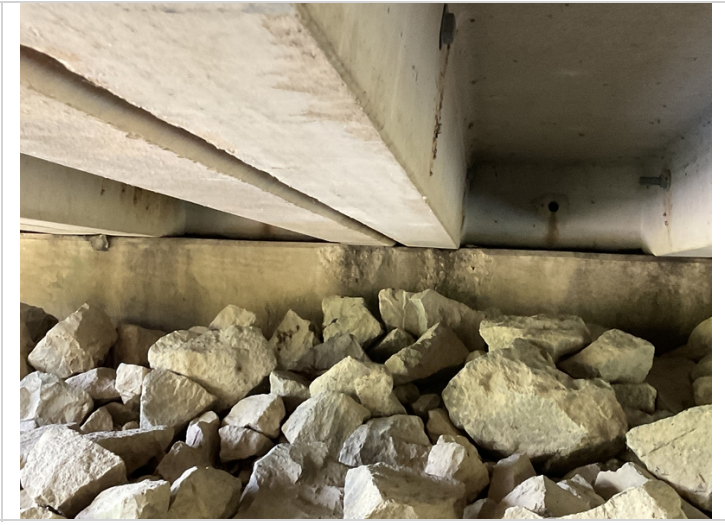
Bent 1 spalls under units 4,6&7

Bent 1 spalls under units 6&7

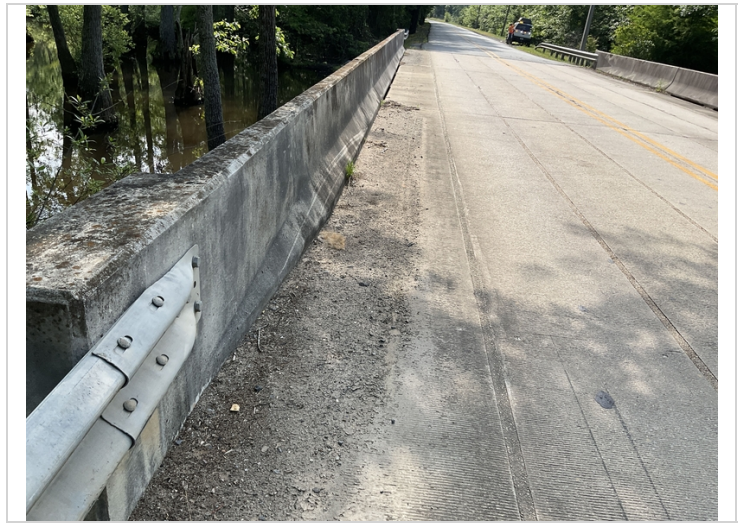
Debris in both gutters

A-55 - Deck Washing Needed (Yes)

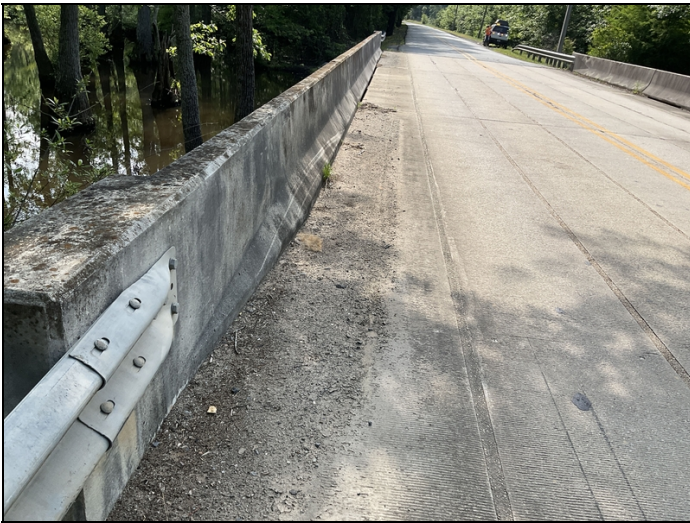
Debris in both gutters
