# **Bridge Inspection Report**

**04201**

**Blue Springs Road  
over  
Mill Branch-Goshen**

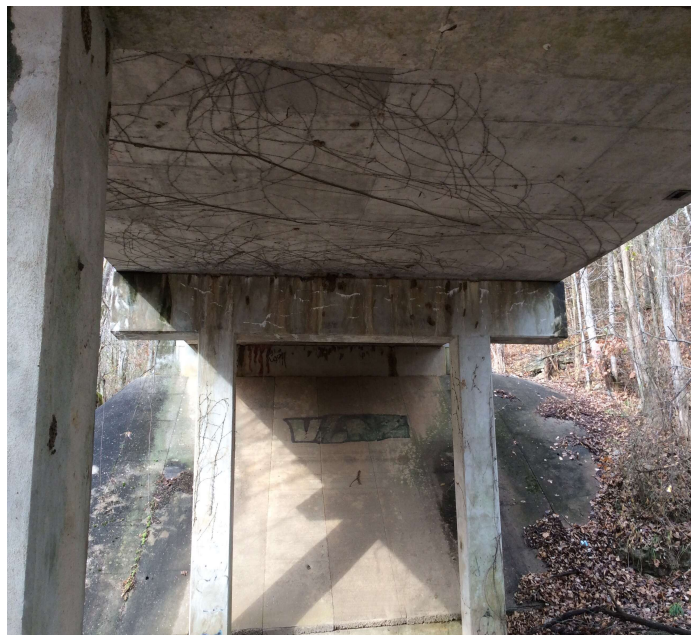
Bent # 3 cap has areas of shallow spalling with exposed reinforcing steel in the right side of the cap on the span # 3 side. Both ends of the cap have heavy map cracking with efflorescence. Both sides of the cap have numerous random cracks with efflorescence along the length of the cap. The north abutment has shallow spalling in the top of the stem wall on the left and right sides.

PHOTO 1 Description Bent # 3 Span # 2 cracking with efflorescence.

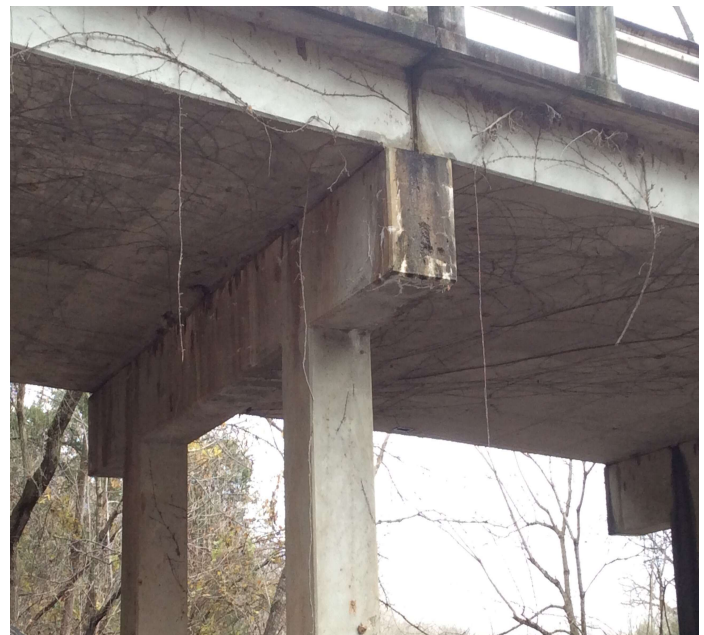
PHOTO 2 Description Bent # 3 left edge of the cap cracking with efflorescence.

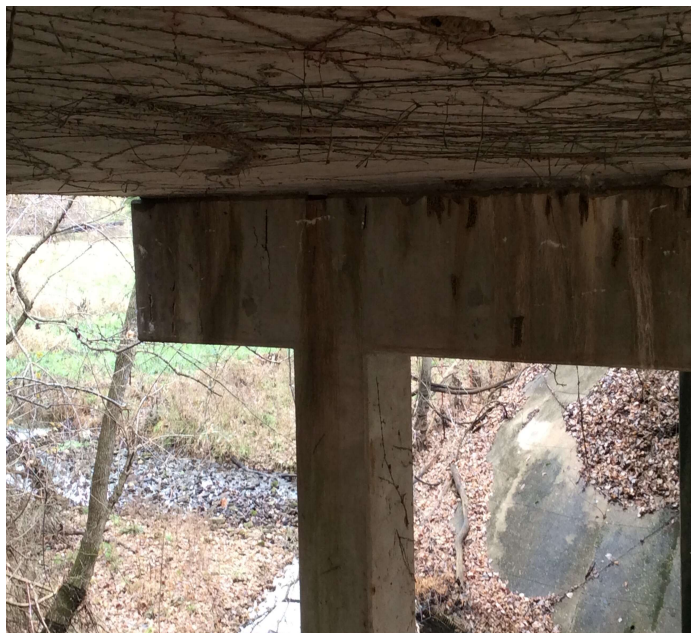
PHOTO 3      Description      Bent # 3 Span # 3 vertical spalls with exposed reinforcing steel.

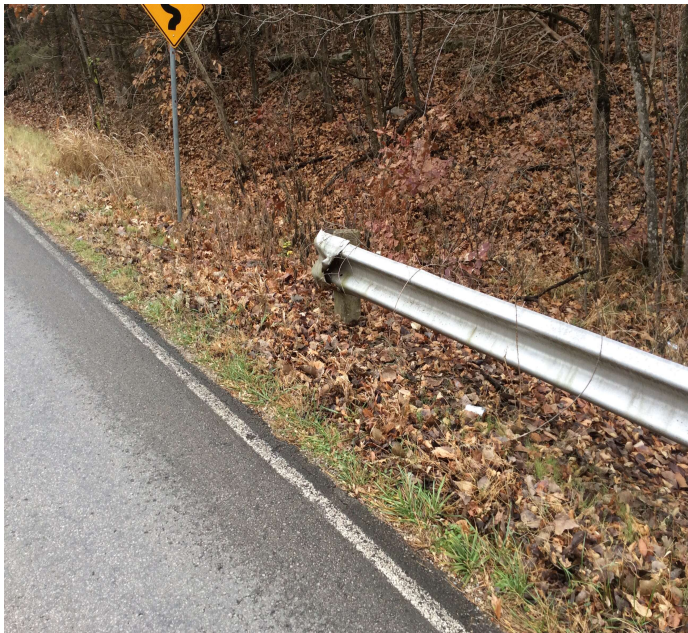
The Southwest and Northeast approach railing has collision damage. The Southwest approach railing has out of plane bending in several locations. The end terminators of the Southwest and Northeast approach railing have collision damage that has created tears and out of plane bending to the terminators.

PHOTO 1      Description      North east approach rail damage.

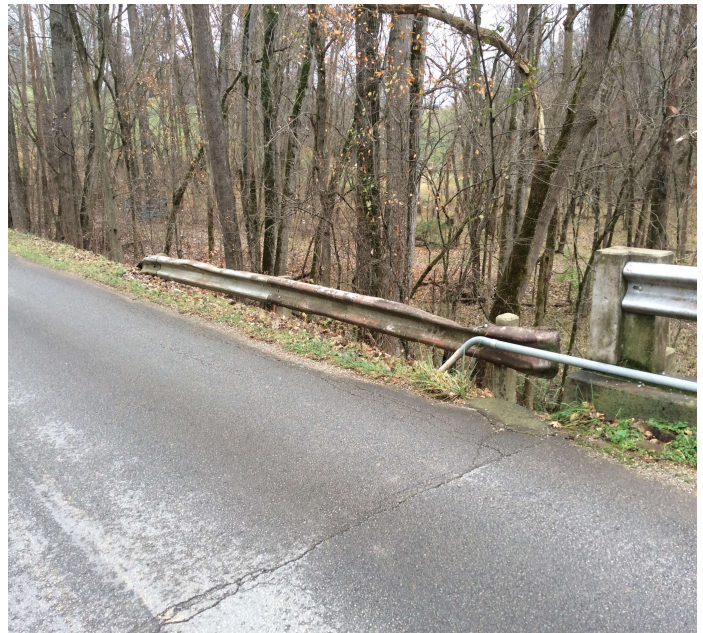
PHOTO 2      Description      South west approach rail damage.

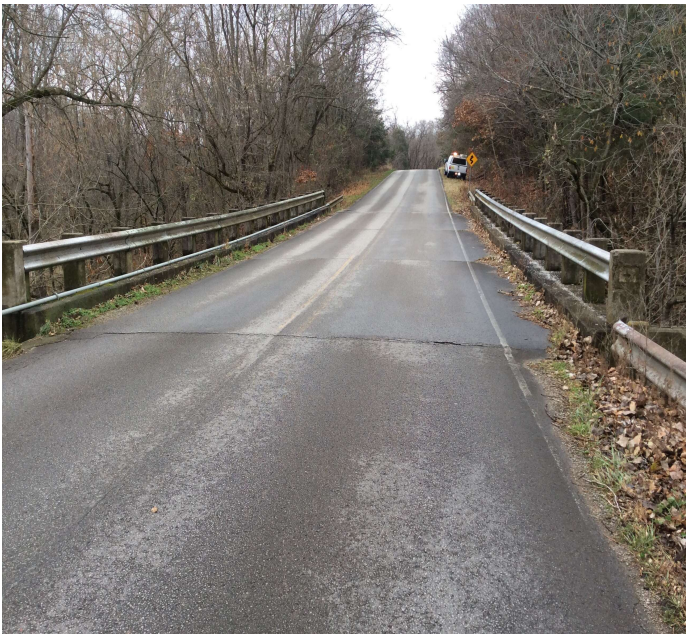
The gutters on the left and right sides of the structure have dirt and gravel accumulation with vegetation growing.

PHOTO 1      Description      Vegetation and debris in the deck gutters.
