# Bridge Inspection Report

**A3092**  
**I -30 Log 113.64**  
**over**  
**US 67-9 Log 7.61**

Structure Number: A3092

Facility Carried: I-30 Log 113.64

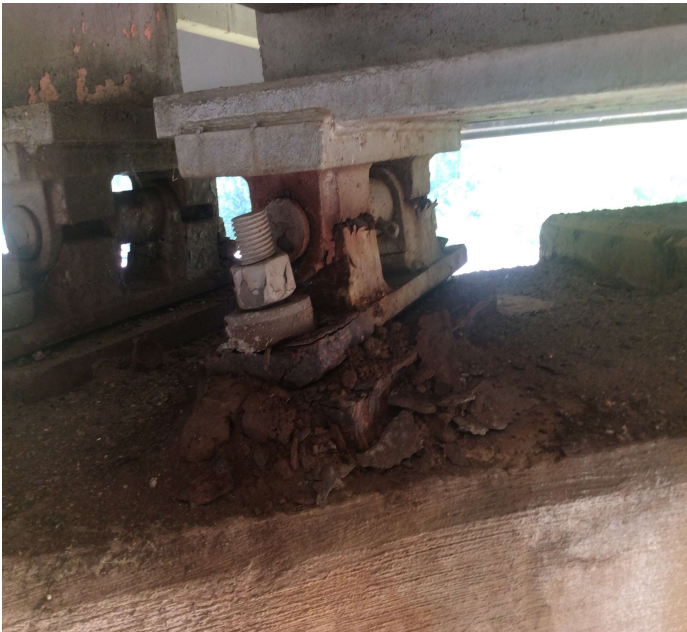
Bearings at bents 1 & 4 have heavy laminating rust, Added 5/14/2018 - Bearings at bent have laminating/pack rust. Photo attached.

PHOTO 1      Description      Bent 3 girder 6 bearing has laminating/pack rust.

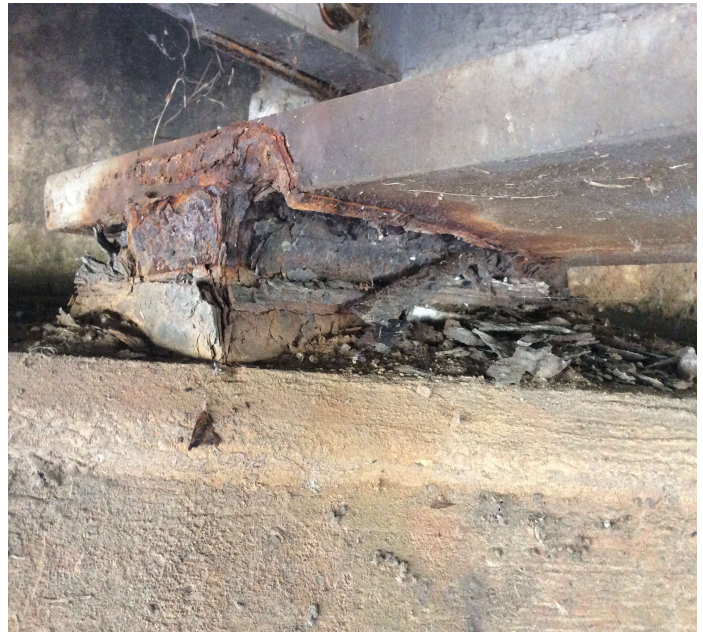
PHOTO 2      Description      Bent 4 bearing 2, laminating/pack rust.

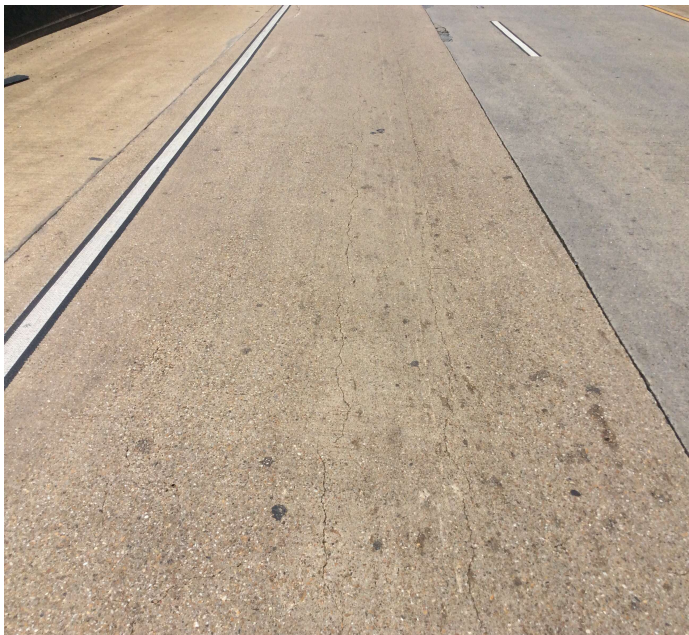
Deck all spans large unsealed cracks.

PHOTO 1 Description Span 3 longitudinal cracking in deck.

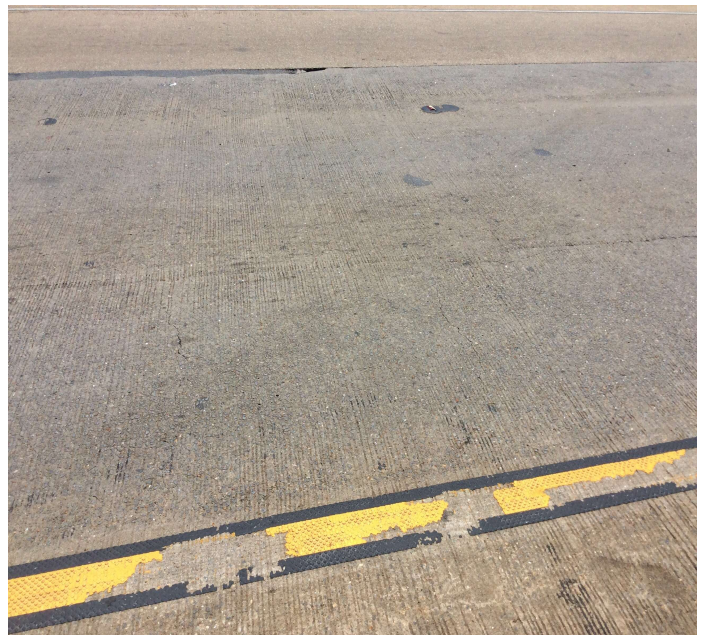
PHOTO 2 Description Transverse cracking span 3.

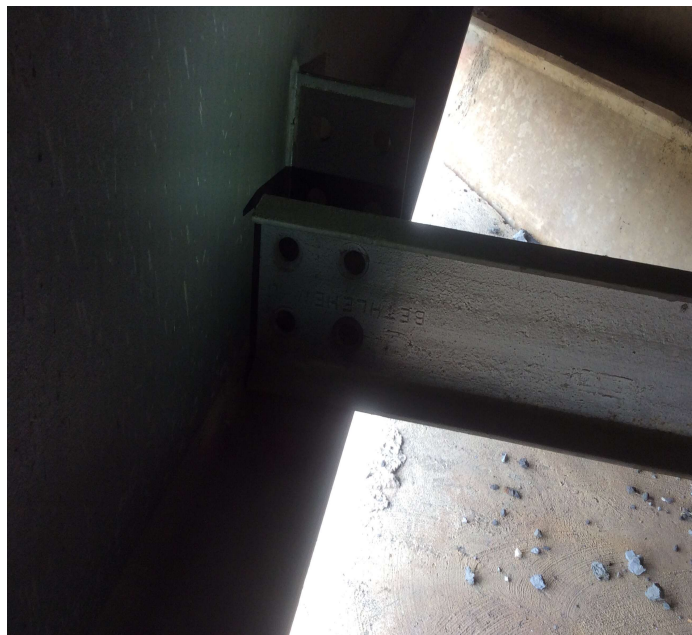
Span 1 between beams 6 and 7. The first diaphragm has missing and loose bolts and diaphragm is not attached to beam 7 and diaphragm is laying on flange.

PHOTO 1      Description      First diaphragm at bent 1 between girders 6 and 7 has loose and missing bolts.

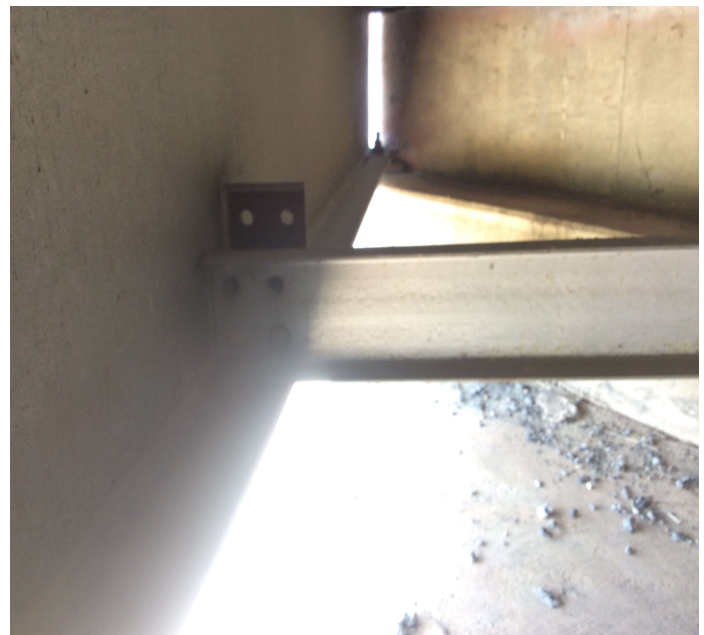
PHOTO 2      Description      Span 1 girder 7 diaphragm 1 is sitting on bottom flange, all 4 bolts are loose on girder 6.

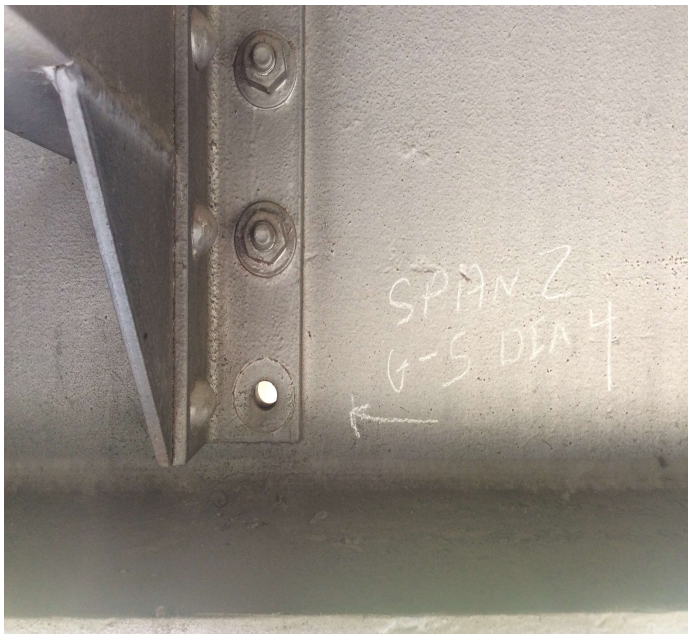
Missing bolts - Span 2 girder 5 diaphragm 4.

PHOTO 1      Description      Span 2 girder 5 has a missing bolt in bottom of diaphragm connection.

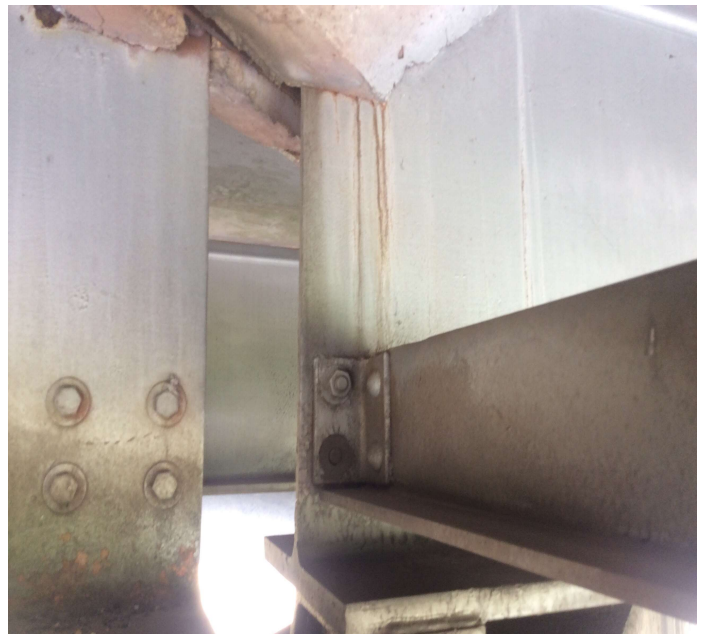
Added 5/14/2018 - Sheared bolts in diaphragm connection at the following locations, Bent 1 girder 3, Bent 2 girder 3, Bent 3 girder 2, 3, 5 and 6.

PHOTO 2      Description      Bent 2 girder 3 has 2 sheared bolts.

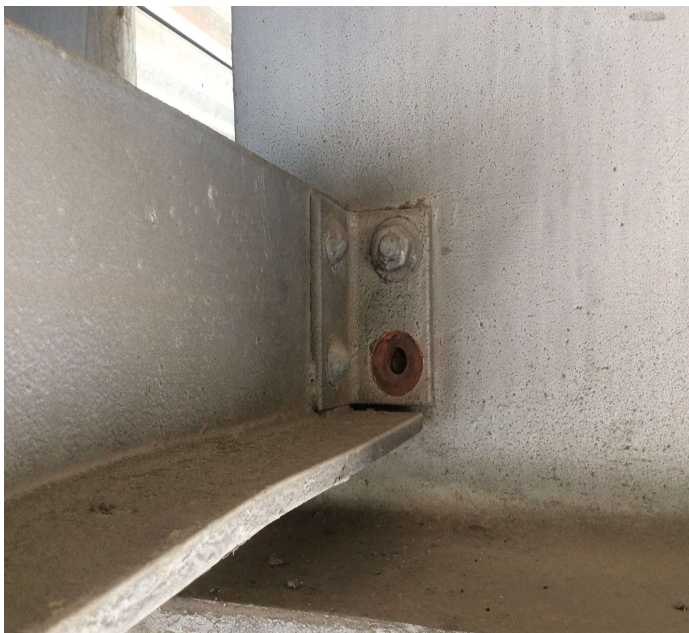
PHOTO 3	Description	Bent 3 girder 6 sheared bolt in diaphragm connection.
---------	-------------	---

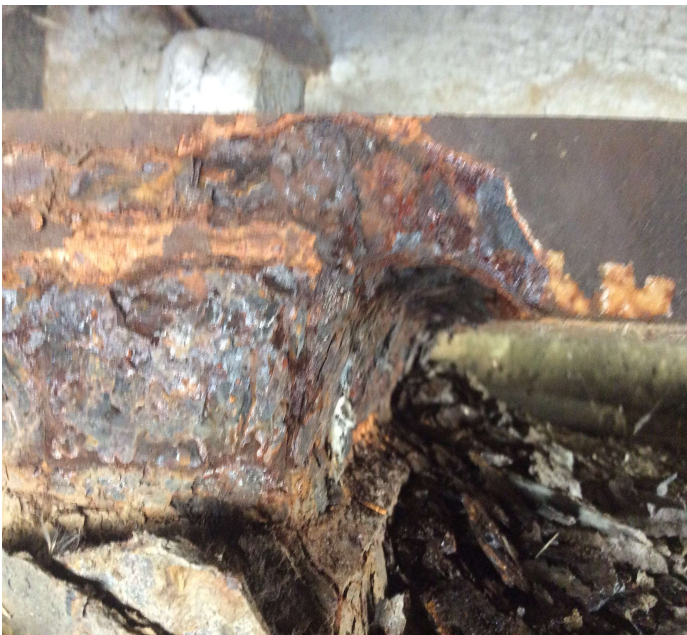
Girders 2-5 at bent 4 have up to 3/8" section loss to bottom of bottom flange at the bearing.

PHOTO 1      Description      Bent 4 girder 2 has 5/16" section loss to bottom of bottom flange.
