Bridge Inspection Report

B3092
I -30-SEC 22 WB
over
US 67-9 Log 7.61

Job # 60247, drawing # 24664

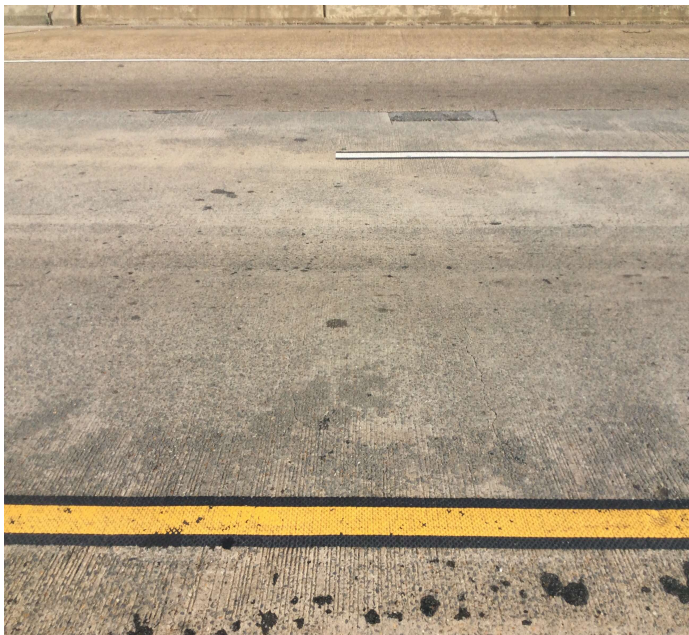
Deck all spans large unsealed cracks and spalls filled with asphalt.

PHOTO 1 Description Transverse cracks in span 1 left lane.

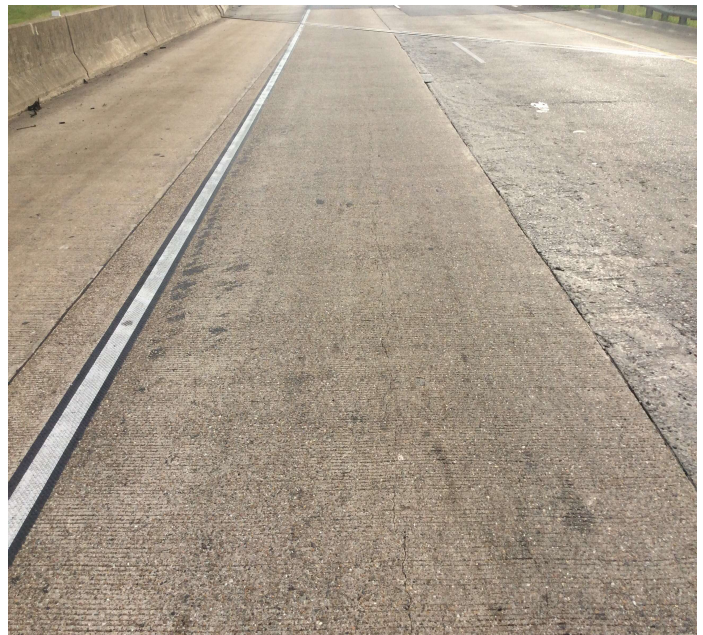
PHOTO 2 Description Longitudinal cracks in span 3.

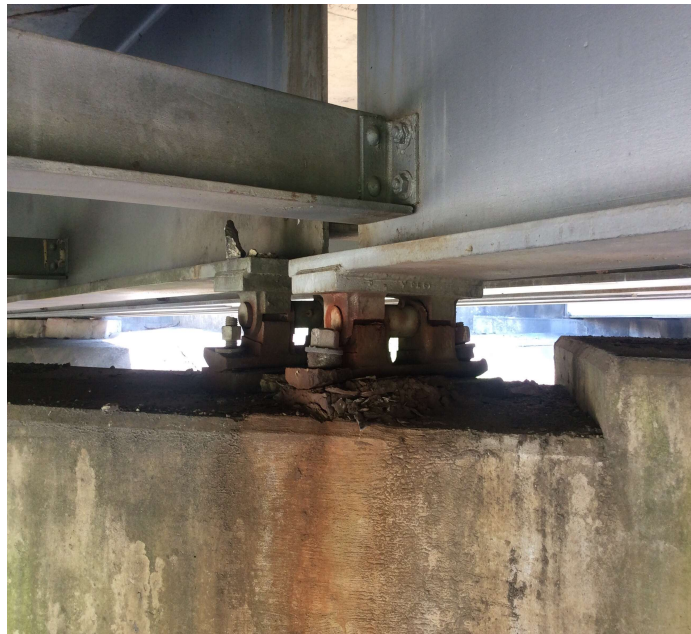
Bents 1 & 4 bearing have heavy laminating rust. Added 5/14/2018 – Bent 3 all bearings have pack rust. Bent 4 bearings 3 and 4 are floating.

PHOTO 1 Description Bent 3 bearing 4 pack rust.

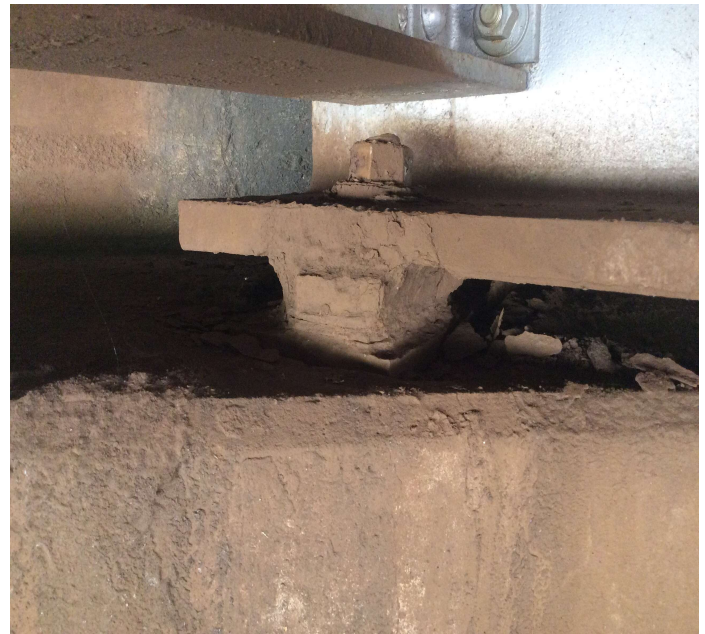
PHOTO 2 Description Bent 4 girder 3 and 4 have floating bearings.

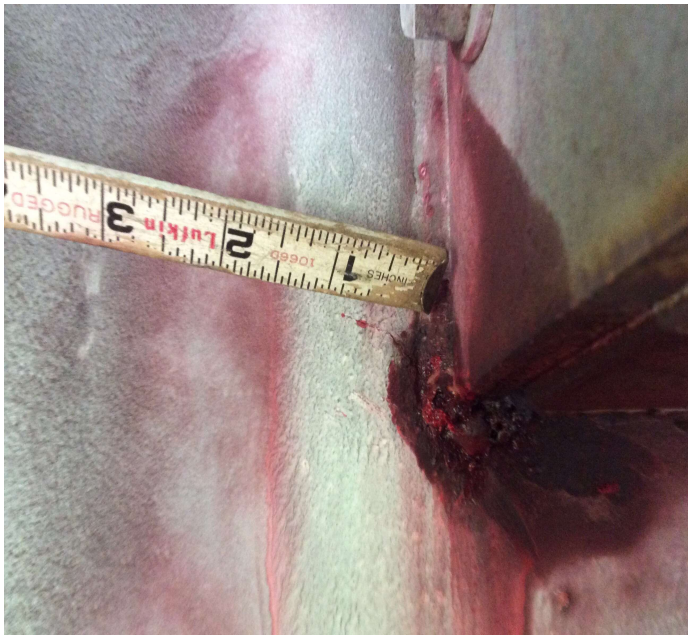
PHOTO 1 Description

Span 3 girder 7, diaphragms 2, 3 and 4 , cracks in weld propagating into web. Span 2 girder 7 diaphragm 3 crack running from hole drilled by state forces.

Added 5/14/2018 –Cracks propagated into web at the following locations, Span 1 girder 1 diaphragm 3 and span 1 girder 7 diaphragm 2. Cracks in toe of welds at the following locations, Span 1 girder 1 Diaphragm 2, Span 2 girder 1 diaphragm 3 and Span 2 girder 7 diaphragm 4.

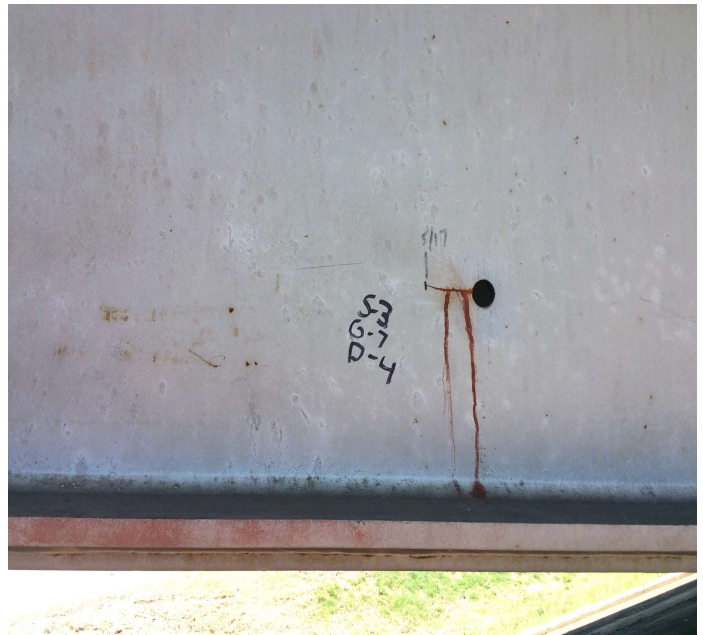
PHOTO 2 Description Span 3 girder 7 diaphragm 4 crack in web.

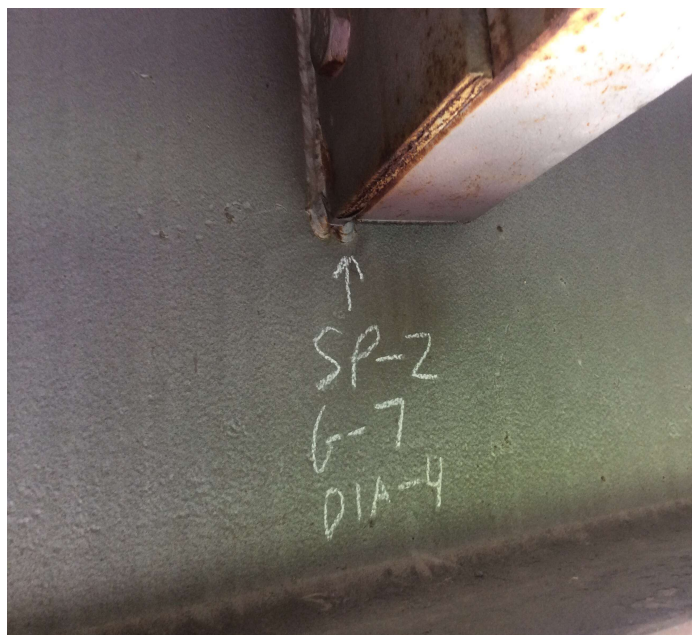
PHOTO 3 Description Span 2 girder 7 diaphragm 4 crack in toe of weld.

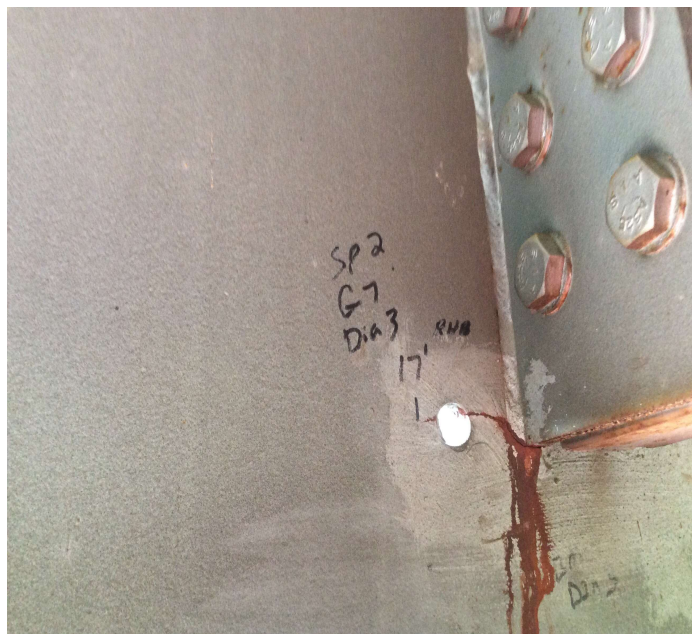
PHOTO 4 Description Span 2 girder 7 diaphragm 3 crack has propagated out of arrest hole into web.

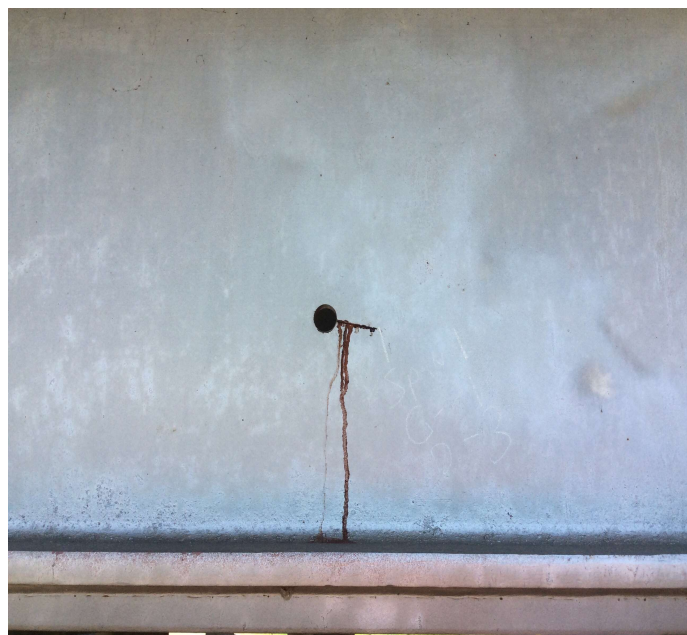
PHOTO 5 Description Span 1 girder 1 diaphragm 3 crack in web.

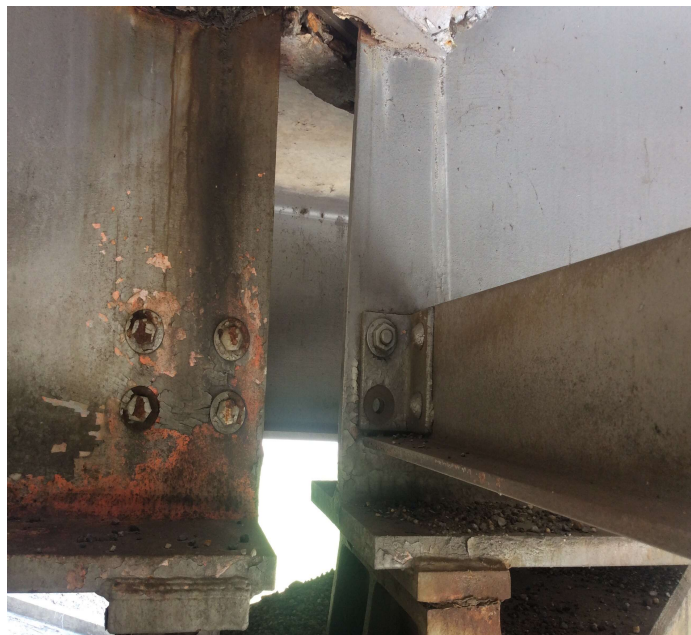
Sheared bolts in diaphragm connections at the following locations, Span 1, Girder 5, diaphragm 1 and Bent 2 girders 4 and 5.

PHOTO 1 Description Bent 2 girder 4 has 2 missing bolts in bottom of diaphragm connection.

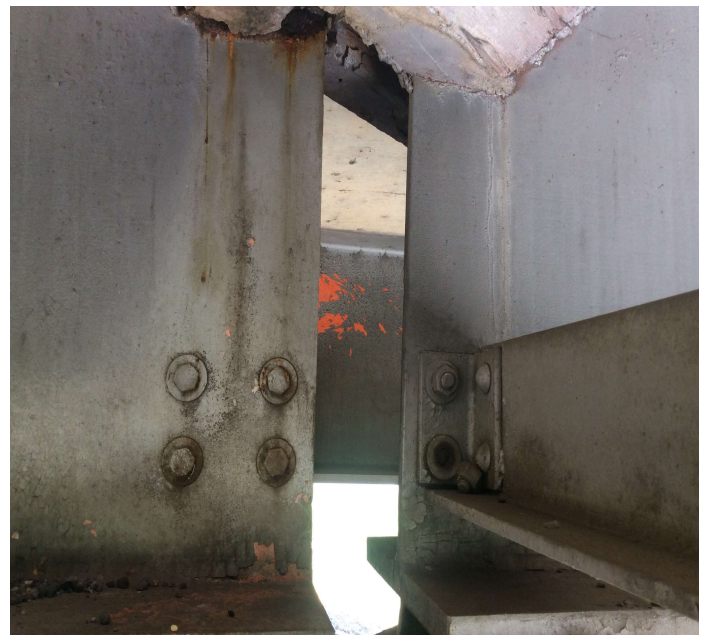
PHOTO 2 Description Bent 2 girder 5 has 1 sheared bolt in diaphragm connection.
