# Bridge Inspection Report

**A3093**  
**I-30 EB Log 113.96**  
**over**  
**SALINE RIVER RELIEF**

Structure Number: A3093

Facility Carried: I-30 EB Log 113.96

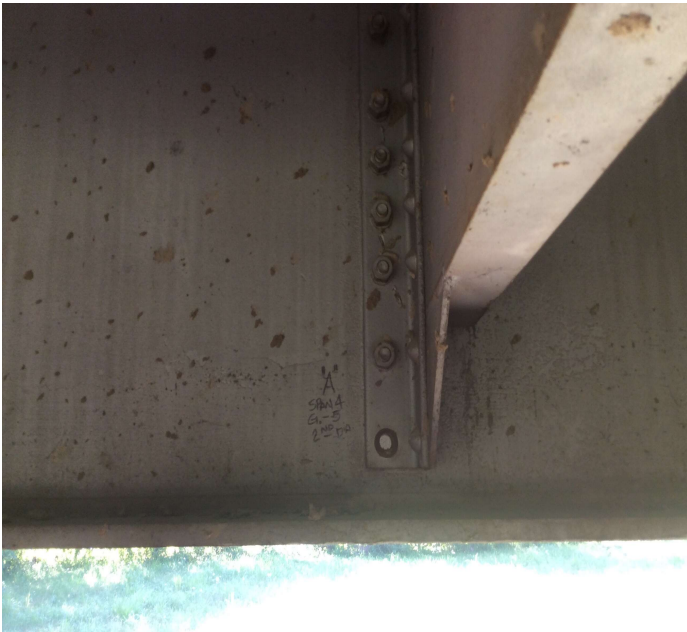
Span 4 beam 5 at the 2nd diaphragm has a bolt missing at the bottom of the connection. 6/5/2018 Changed priority from C to D

PHOTO 1      Description      Span 4 girder 5 missing bolt.

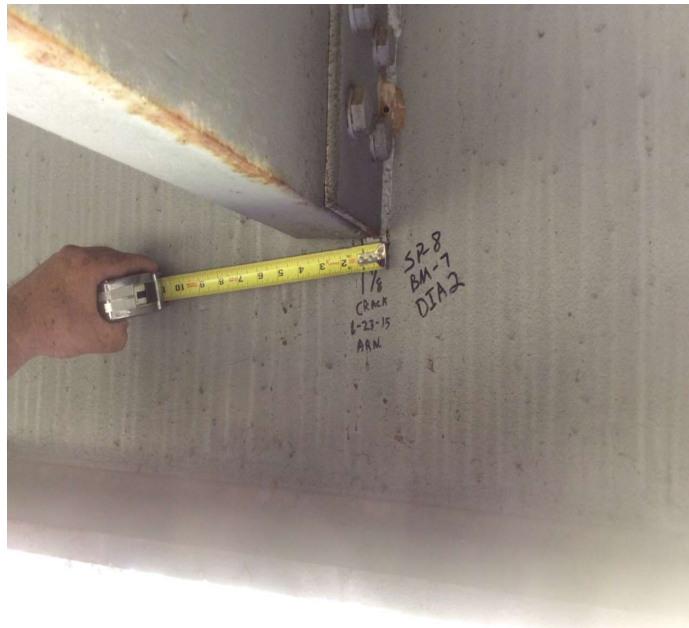
Span 8 beam 7 at diaphragm 2 crack in the weld.

PHOTO 1 Description Span 8 beam 7 diaphragm 2 has a 7/8 inch crack in the web

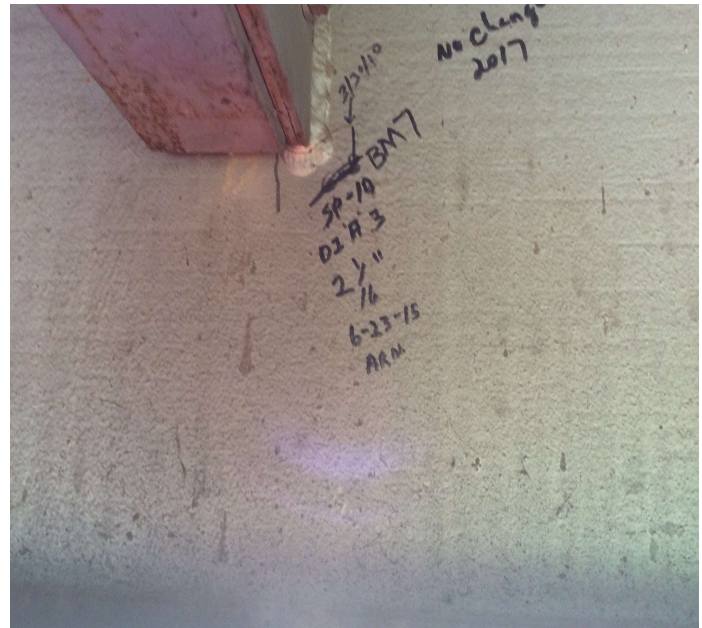
Span 10 beam 7 at diaphragm 3 crack in the web.

PHOTO 2 Description Span 10 girder 7 diaphragm 3 crack in web. No change since last inspection.

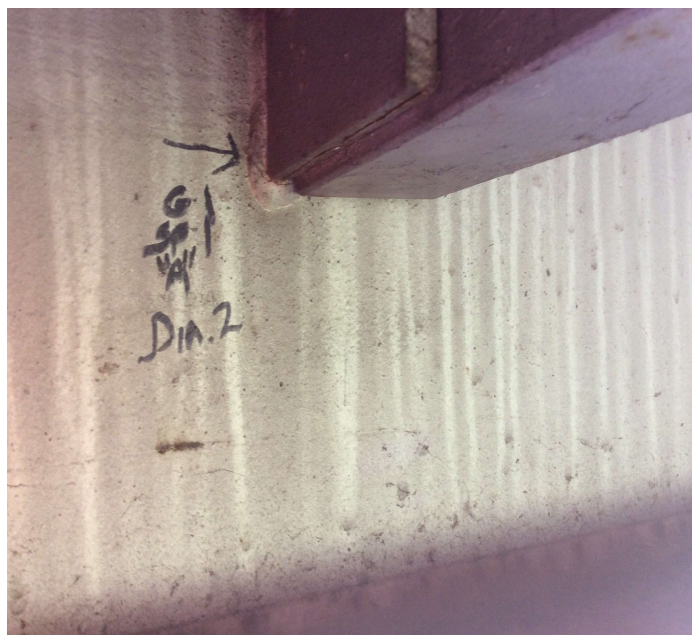
Span 1 beam 1 at diaphragm 2 crack in the bottom weld.

PHOTO 3 Description Span 1 girder 1 diaphragm 2 crack in toe of weld

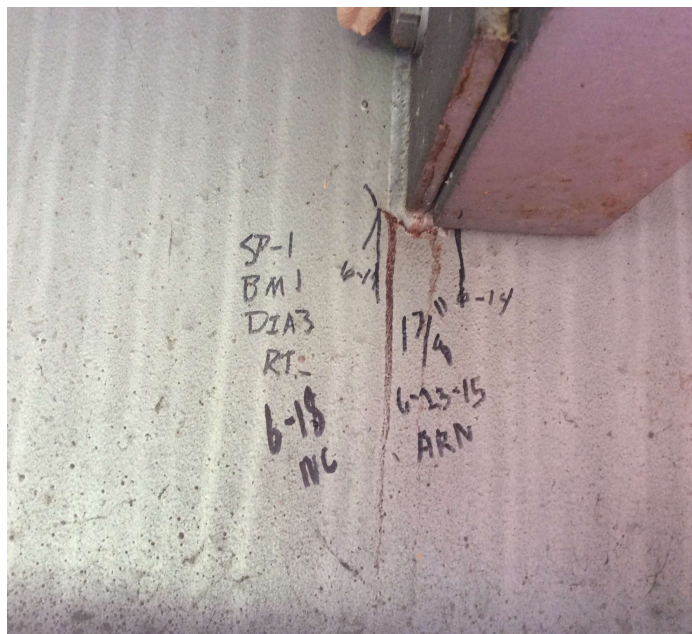
Span 1 beam 1 at diaphragm 3 crack in the web.

PHOTO 4 Description Span 1 girder 1 diaphragm 3 crack in web.

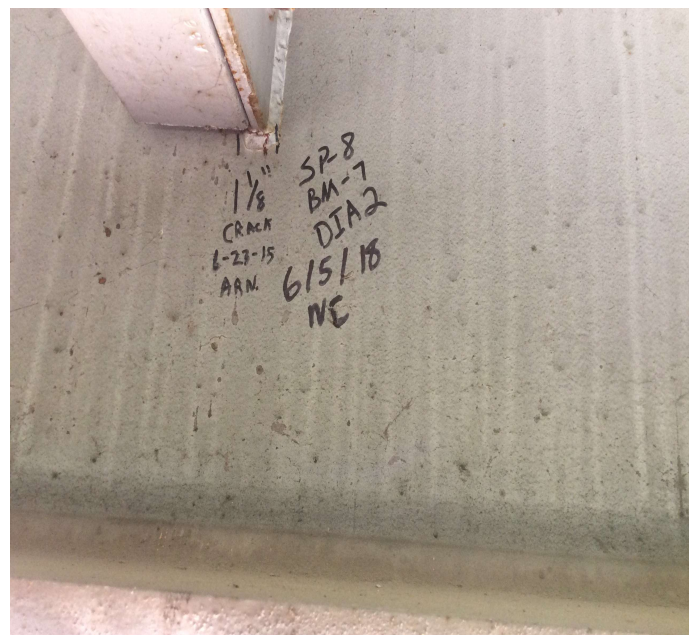
PHOTO 5 Description Span 8 beam 7 diaphragm 2 crack in toe of weld.

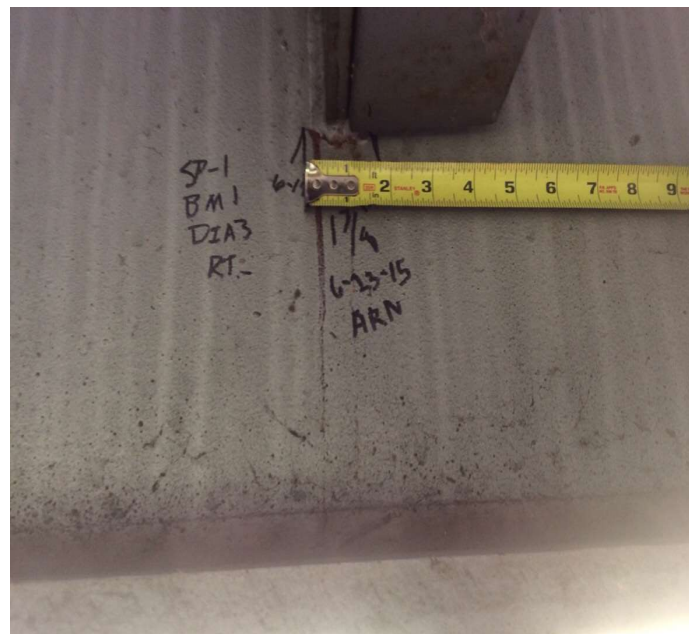
PHOTO 6 Description Span 1 beam 1 diaphragm 3 has 1 5/8 inch crack in the web

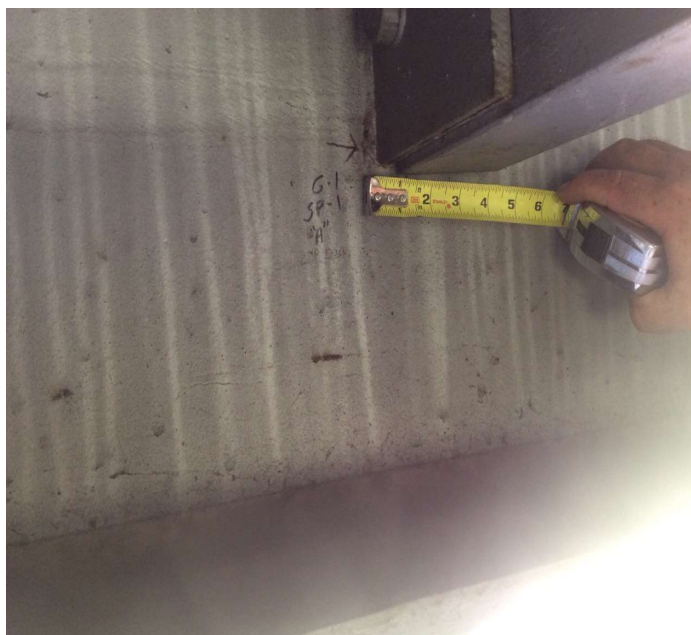
PHOTO 7      Description      Girder 1 span 1 diaphragm 2 has a 1 inch crack in the web

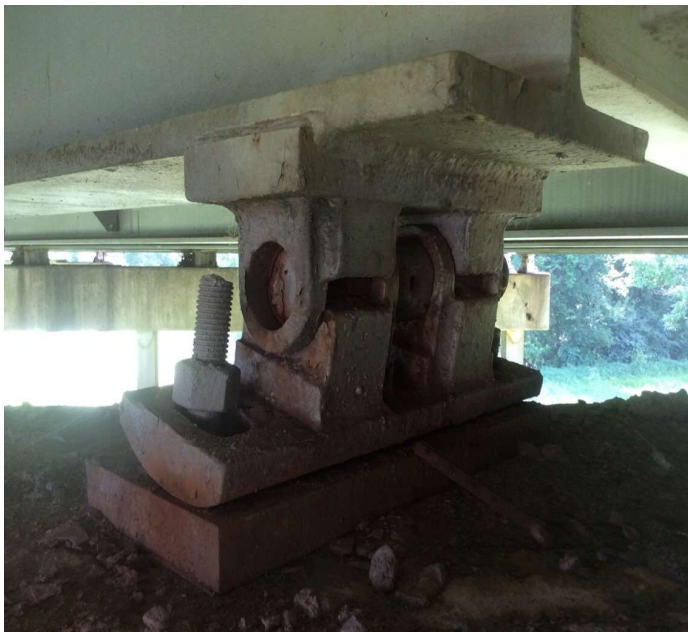
Bent 5 span 5 moveable bearing 2 the bearing pin has worked out of bearing 1 ¼"

The movement is caused by the pin being worn making it loose. Similar condition at girder 5

PHOTO 1      Description      Bearing pin working out.

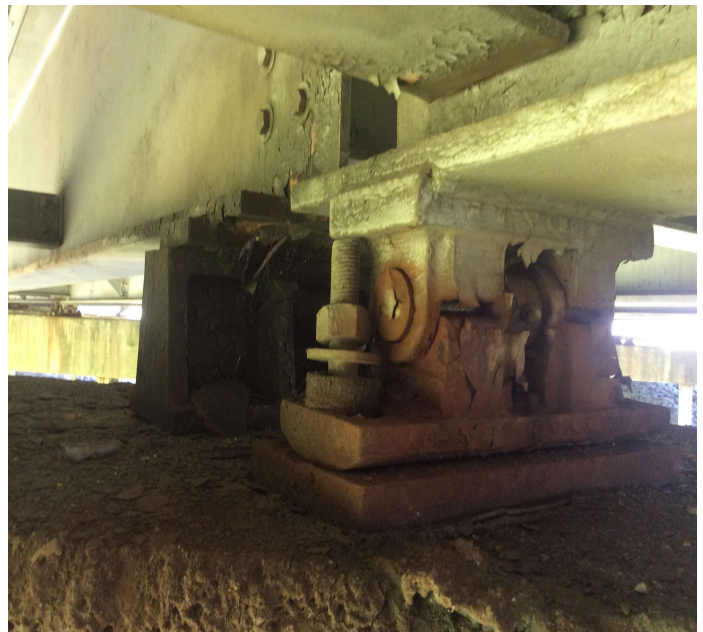
Bent 7 span 7 moveable bearing 4 has a gap between bearing and sole plate causing traffic impact to bearing.

PHOTO 2      Description      Bent 4 moveable bearing 4 has movement under traffic impact.

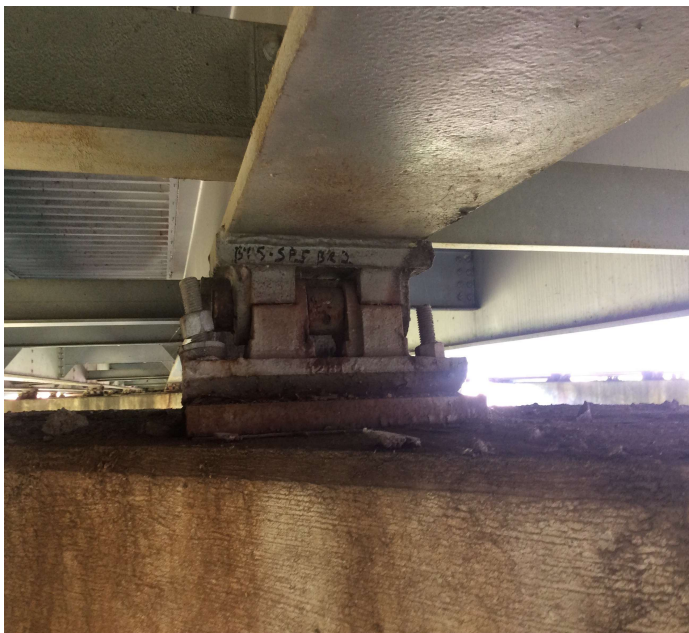
PHOTO 3      Description      Bent 5 moveable bearing 3 pin is working out.

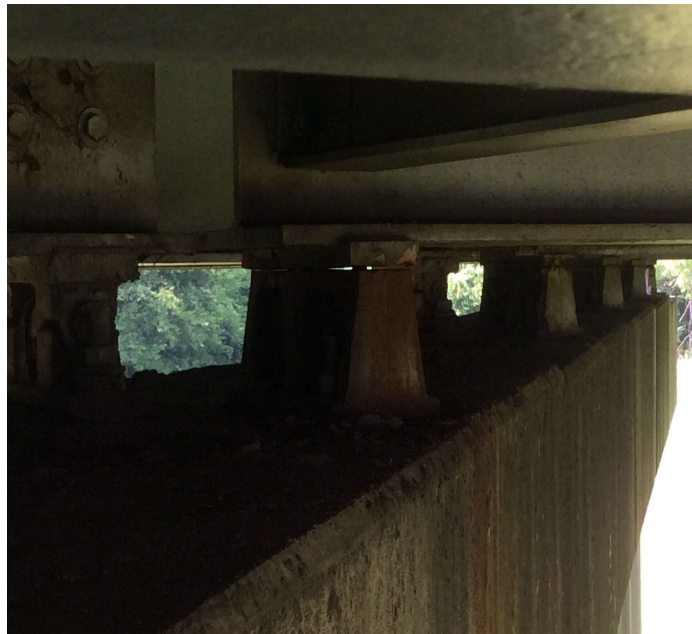
Bent 5 span 4 fixed bearing 4 has a gap between bearing and sole plate.

PHOTO 1      Description      Gap between bearing and sole plate.

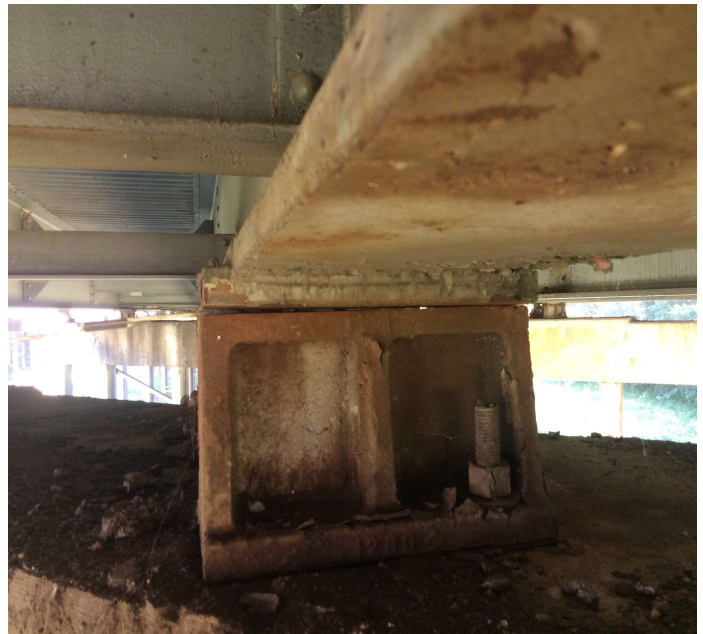
Added 6/5/2018 Bent 5 fixed bearing 3 has a gap between bearing and sole plate.

PHOTO 2      Description      Bent 5 fixed bearing 3 has up to 3/8" gap between the bearing and sole plate. bearing 4 has a gap also.

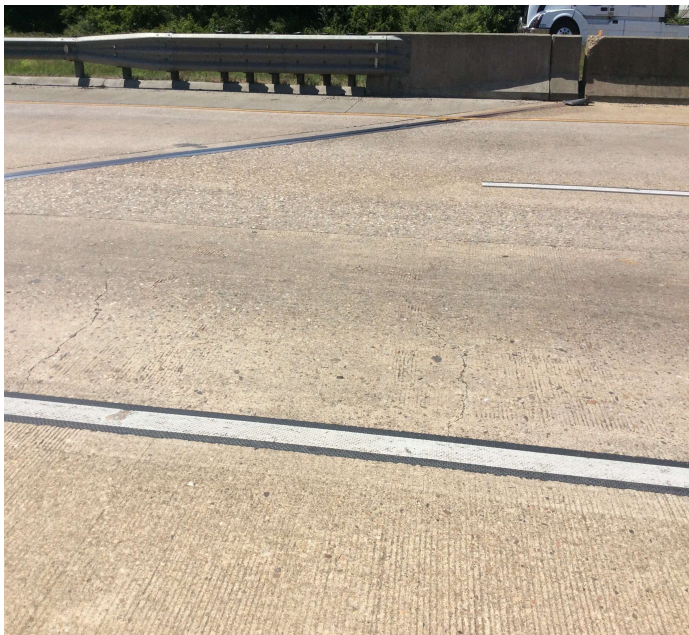
Deck on all spans have large unsealed cracks and bent 1 and 7 have a large pothole in roadway.

PHOTO 1      Description      Large transverse cracks in right lane.

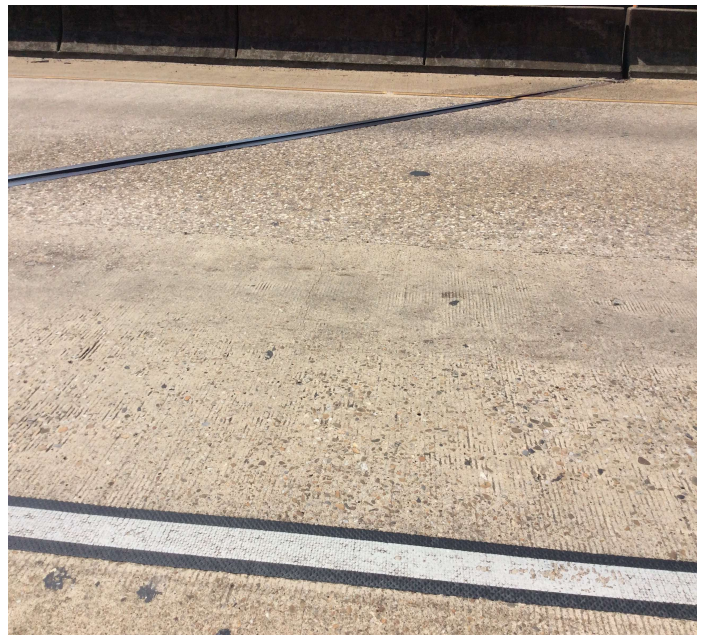
PHOTO 2      Description      Large transverse cracks in right lane.

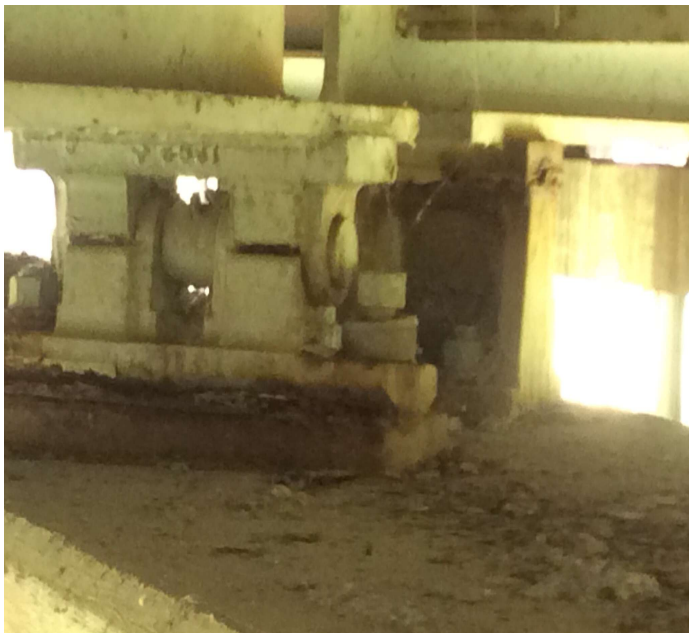
Bearings at all bents have active laminating rust.

PHOTO 1      Description      Most bearings have heavy pack rust build up.

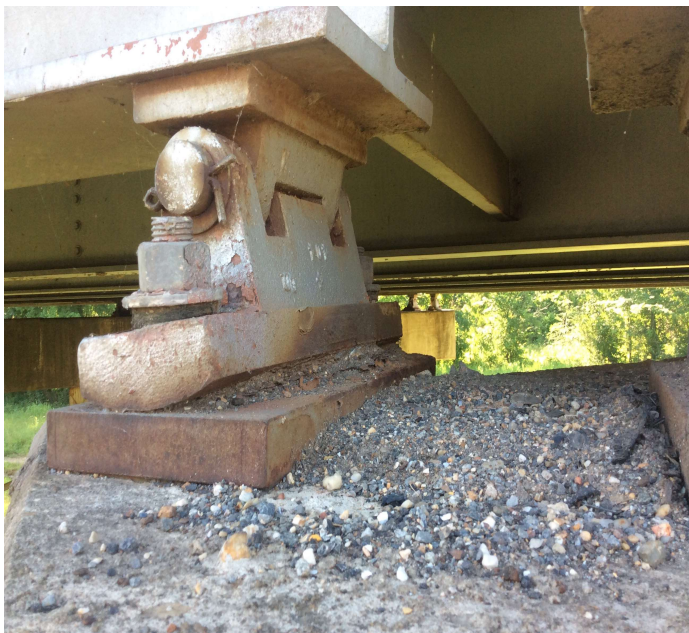
PHOTO 3      Description      Bent 4 bearing 1 ahead side has pack rust. Typical for moveable bearings.

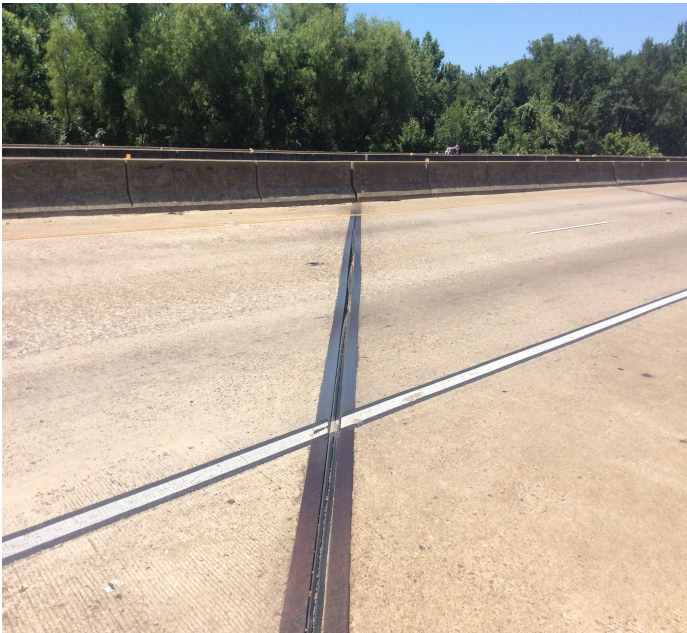
Joint seals at all bents are torn and leaking.

PHOTO 1      Description      Bent 5 joint has lost adhesion in both lanes.
