Bridge Inspection Report

B3093

I-30 WB Log 113.95

SALINE RIVER RELIEF

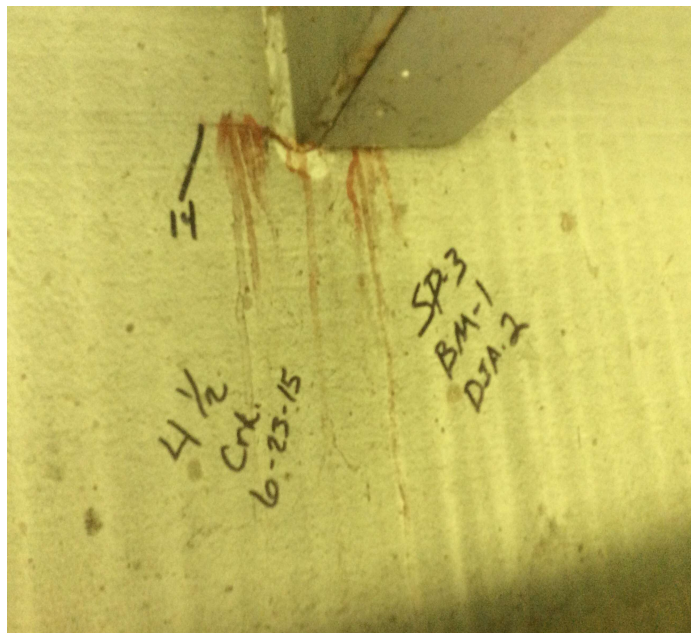
Span 3 beam 1 at diaphragm 2, Span 7 beam 7 at diaphragm 2, Span 10 beam 1 at diaphragm 2, span 10 beam 7 diaphragm 2 & span 8 beam 1 diaphragm 2, have cracks in the webs at bottom welds of diaphragm bracket connections.

PHOTO 1 Description 4 1/2 inch crack span 3 beam 1 dia. 2 at bottom of dia. Bracket.

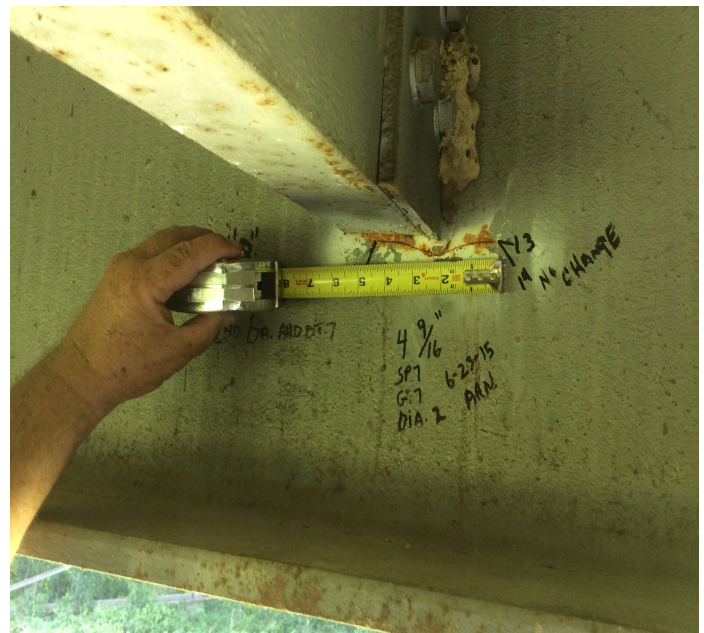
PHOTO 2 Description Span 7 GDR 7 second diaphragm. Has a 4 9/16 inch long crack in web at bottom of diaphragm bracket.

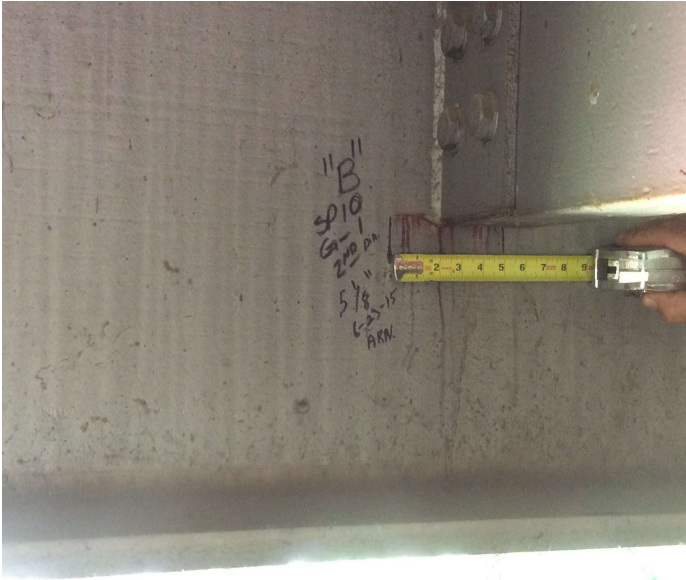
PHOTO 3	Description	Span 10 GDR 1 2nd dia. Has a 5 1/8 inch crack to the web at the bottom of diaphragm.
---------	-------------	--

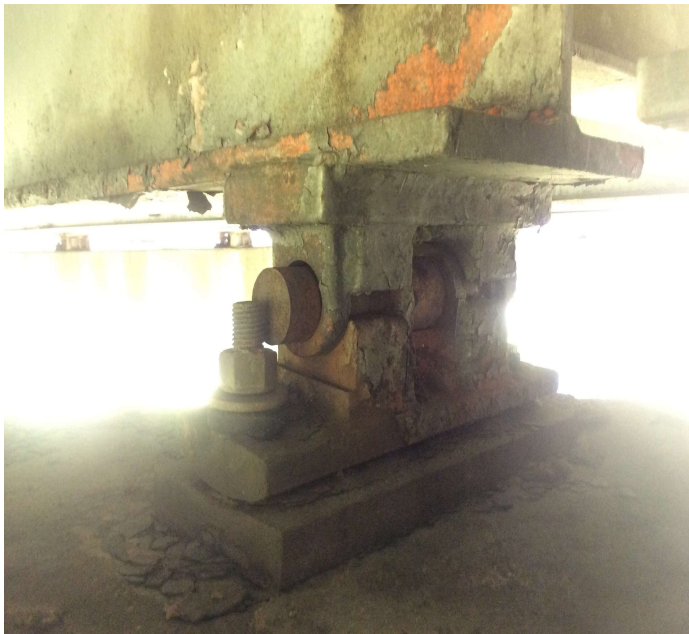
Bent 6 span 6 bearing 3 has a pin working out.

PHOTO 1 Description Bent 6 span 6 beam 3 bearing pin is working out and moving under traffic.

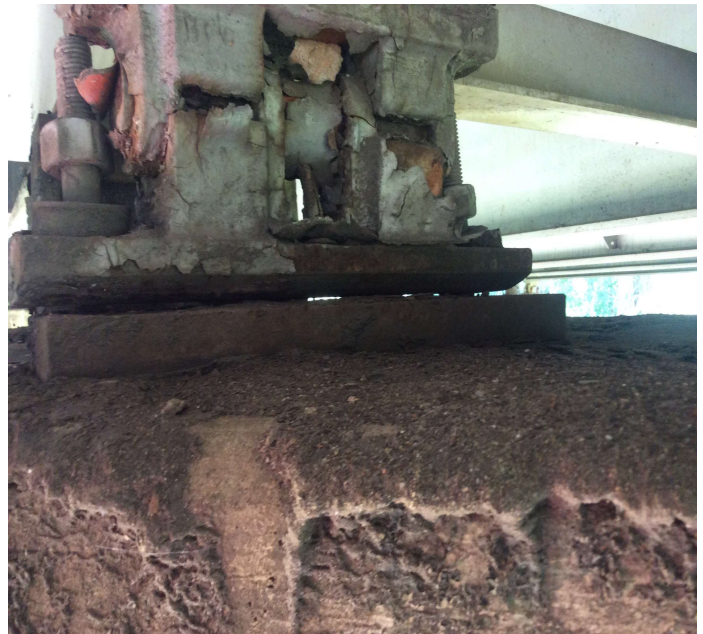
Bent 6 span 6 bearing 5 has 1/4" gap between bottom of bearing and masonry plate causing traffic to impact load the bearing.

PHOTO 2 Description Bent 6 moveable bearings 5 and 6 have up to 3/8" movement when under traffic impact.

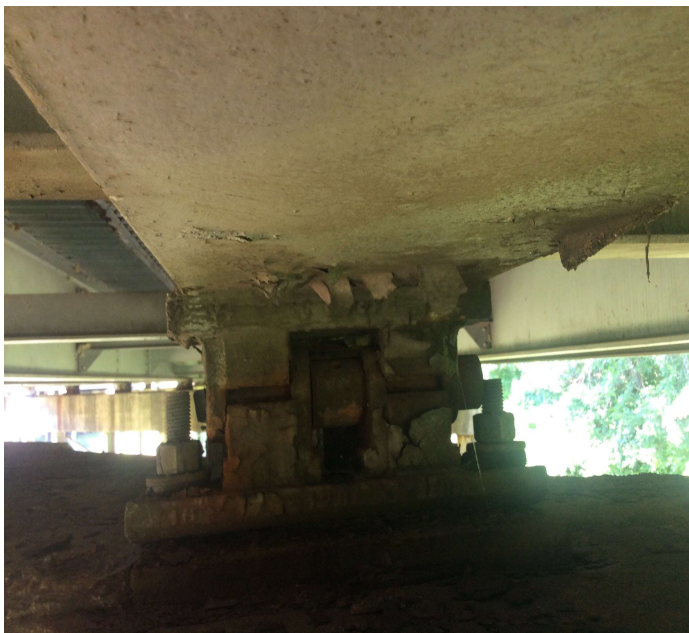
PHOTO 3 Description Bent 6 moveable bearing 3, bearing pin is working out.

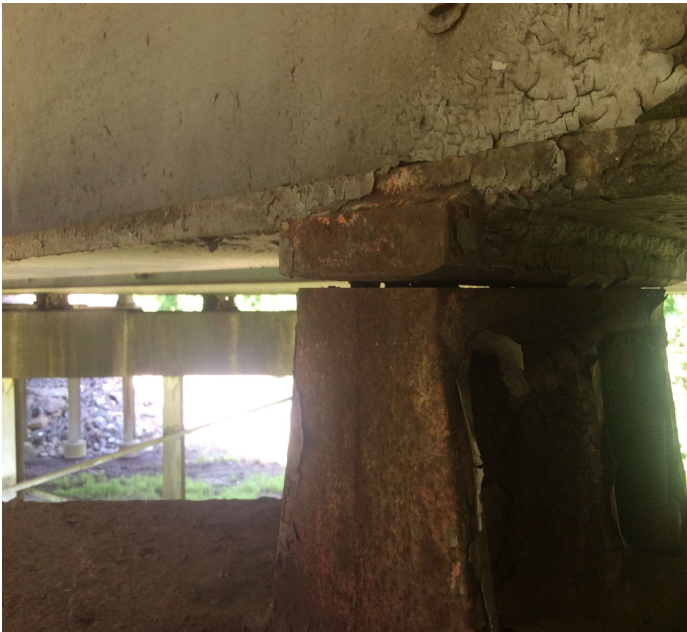
Bent 3 span 2 girder 4: the fixed bearing has a 1/8" gap between the bearing and sole plate causing traffic to impact load the bearing.

PHOTO 1 Description Bent 3 fixed bearing 4 has movement under traffic impact.

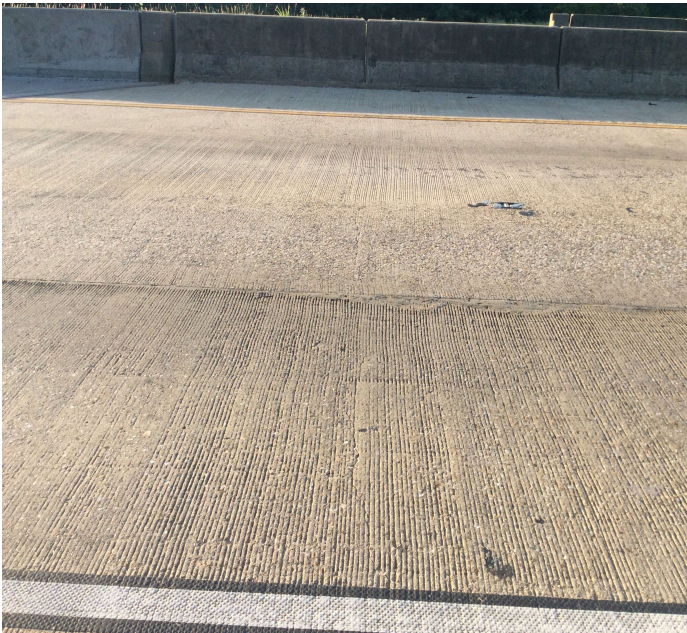
Deck all spans large unsealed cracks.

PHOTO 1 Description Span 10 large transverse cracks.

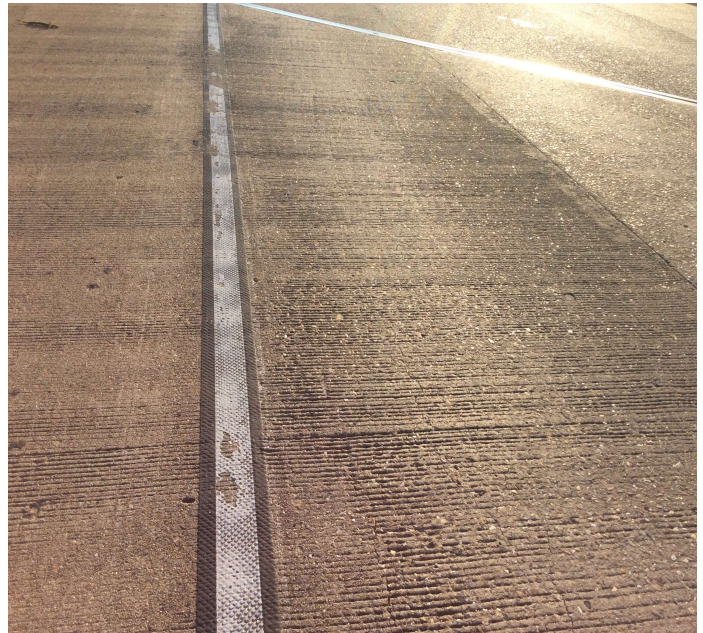
PHOTO 2 Description Span 6 longitudinal cracks.

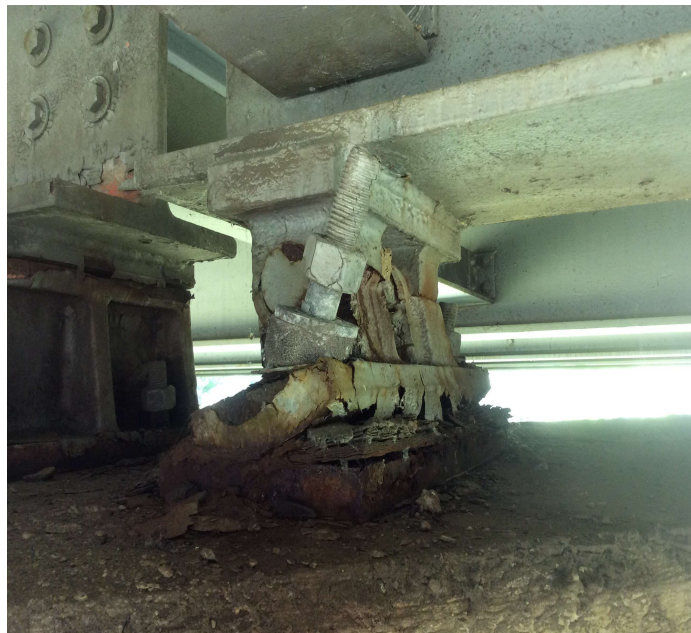
Bearings all bents have laminating rust.

PHOTO 1 Description Most all bearings have pack rust.

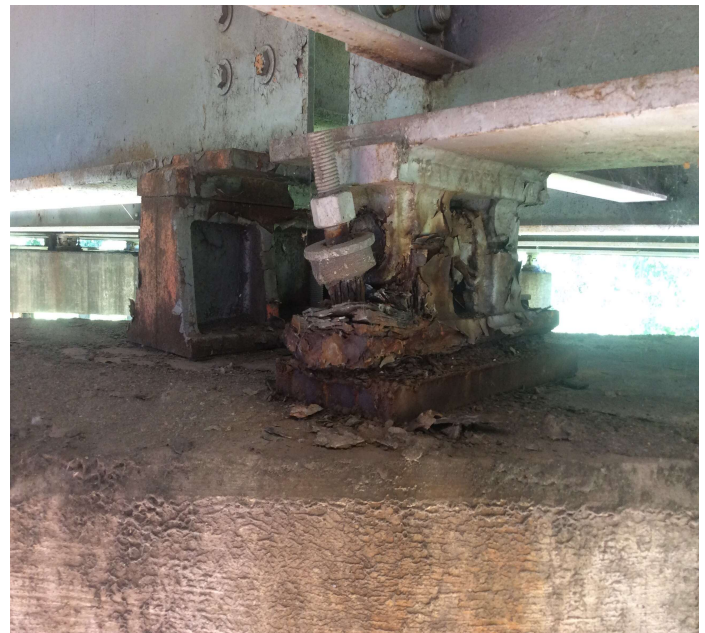
PHOTO 2 Description Bent 8 moveable bearing 6 has pack rust. Typical condition.

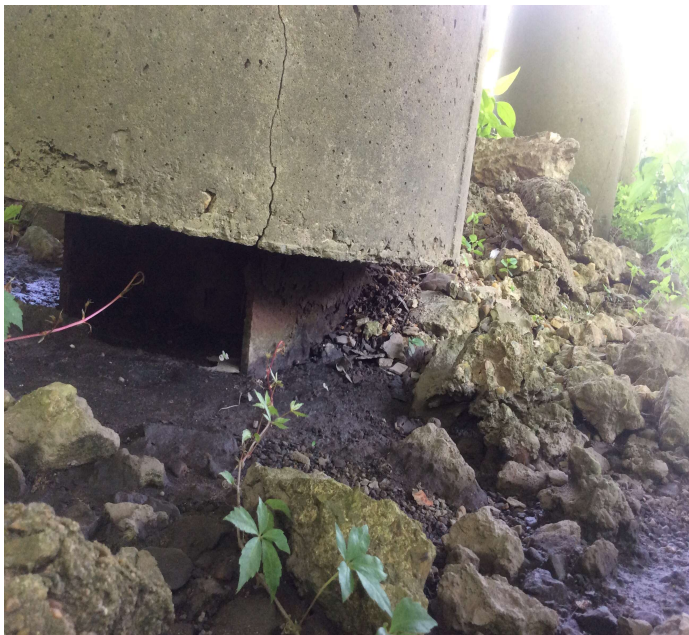
PHOTO 1 Description Erosion or scour has undermined concrete encasement exposing steel piles at ground level.

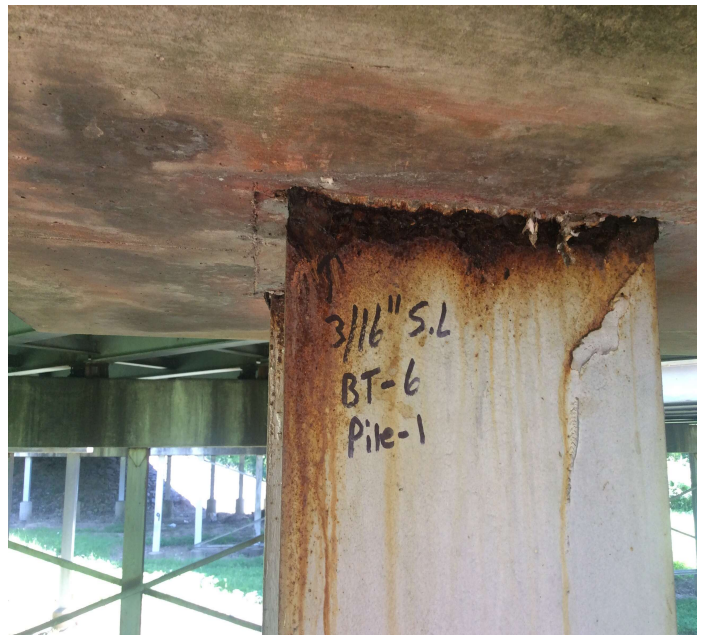
All steel columns have active rust at top of encasements and bottom of caps.

PHOTO 2 Description Bent 6 pile 1 has 3/16\" section loss in top of pile.

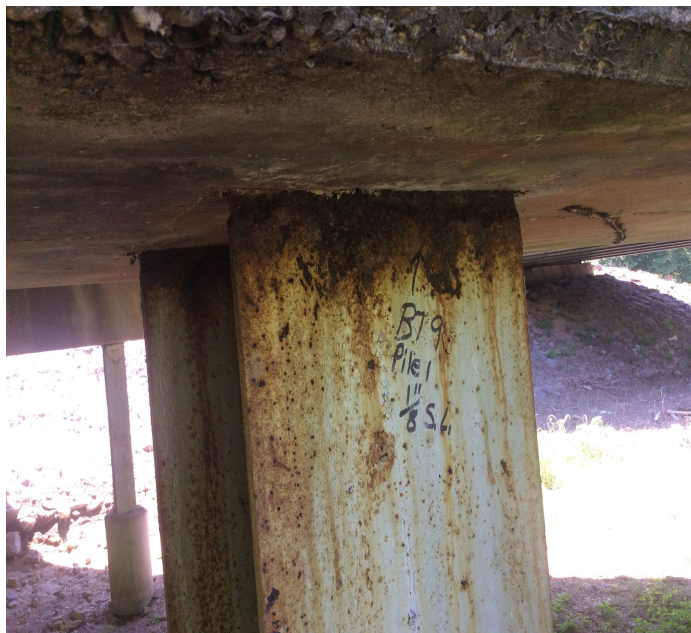
PHOTO 3 Description Bent 9 steel pile 1 has up to 1/8" section loss at the top.

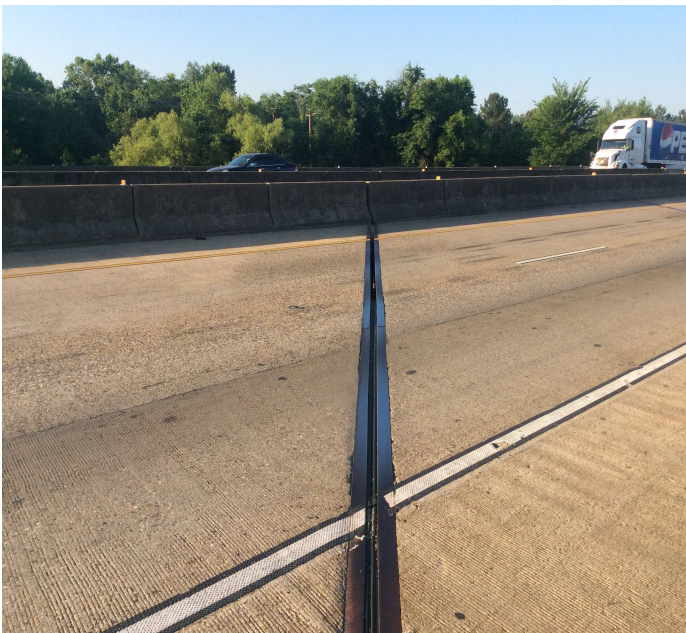
Joint seals at all bents have damage. bent 3 20' of seal has fallen and laying on top of cap

PHOTO 1 Description Bent 3 has 20' joint material that has fallen out.
