Bridge Inspection Report

A3094
I-30 EB Log 114.38
over
SALINE RIVER

Structure Number: A3094

Facility Carried: I-30 EB Log 114.38

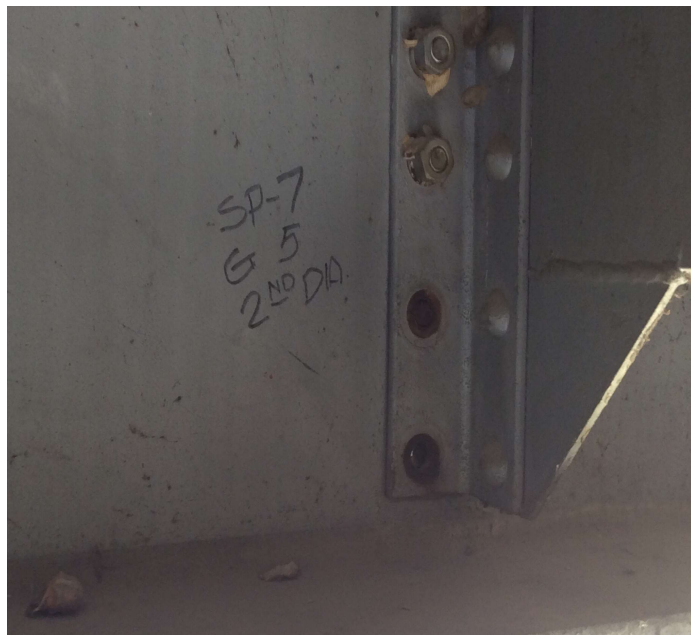
Bolts in the diaphragm connections are missing in spans 5 thru 12.
(42 bolts)

PHOTO 1 Description Span 7 beam 5 diaphragm 2 missing and broken bolt.

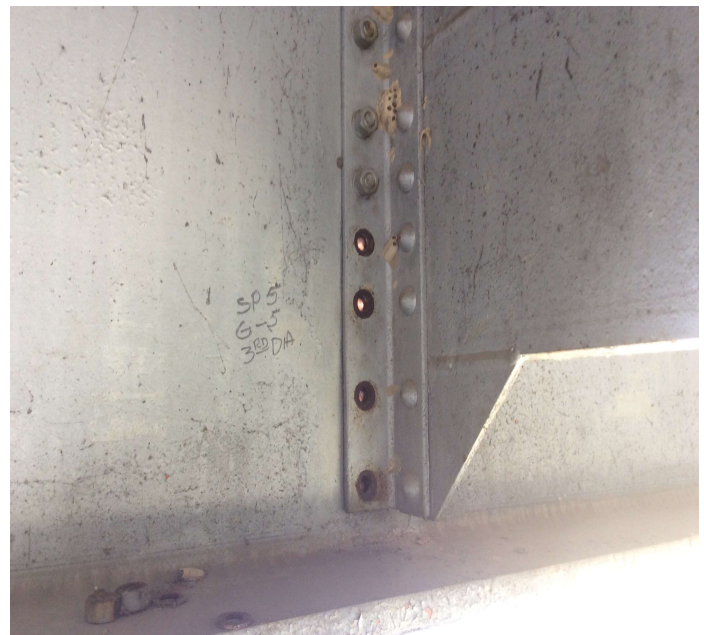
PHOTO 2 Description Span 5 beam 5 diaphragm 3 has four missing bolts.

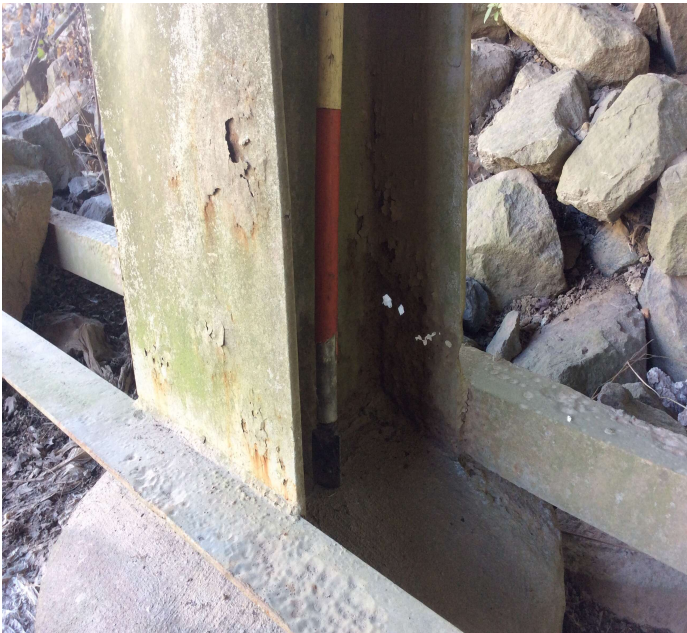
PHOTO 1 Description

Bent 4, piles 4 and 5 have holes rusted through the flanges at the bottom.

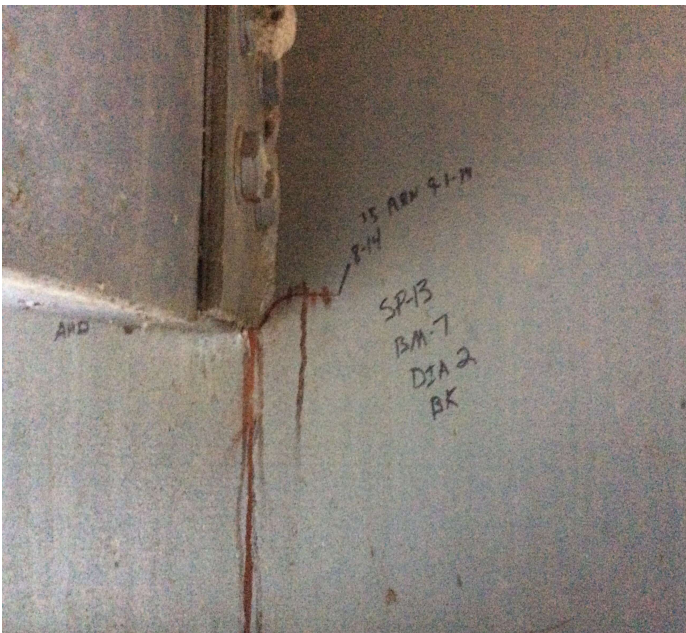
Span 13 girder 7 at second diaphragm has a 3 inch crack on each side of diaphragm. (total 6 inches)

PHOTO 1 Description Span 13 beam 7 diaphragm 2 crack in the web.

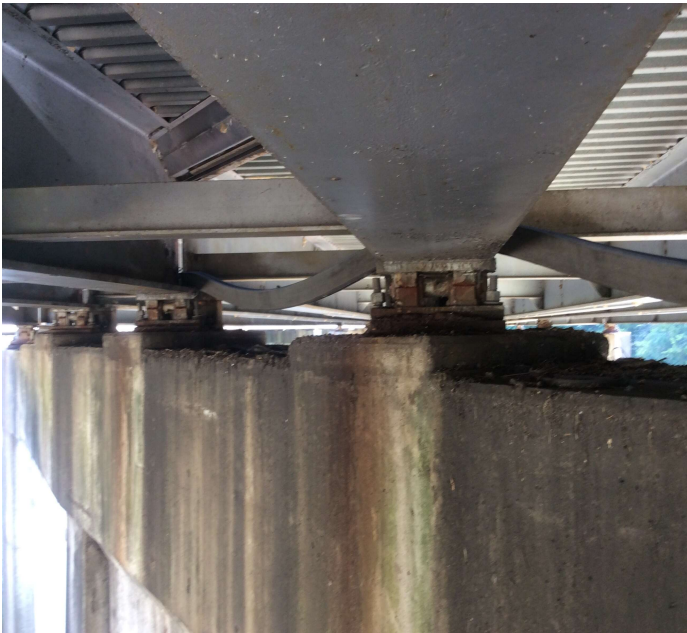
Bearing all bents have laminating rust between bearing and sole plates and masonry plates.

PHOTO 1 Description Bent 7 bearings have corrosion due to leaking joint seals. Common all bents.
