Bridge Inspection Report

B3094
I-30 WB Log 114.38
over
SALINE RIVER

Structure Number: B3094

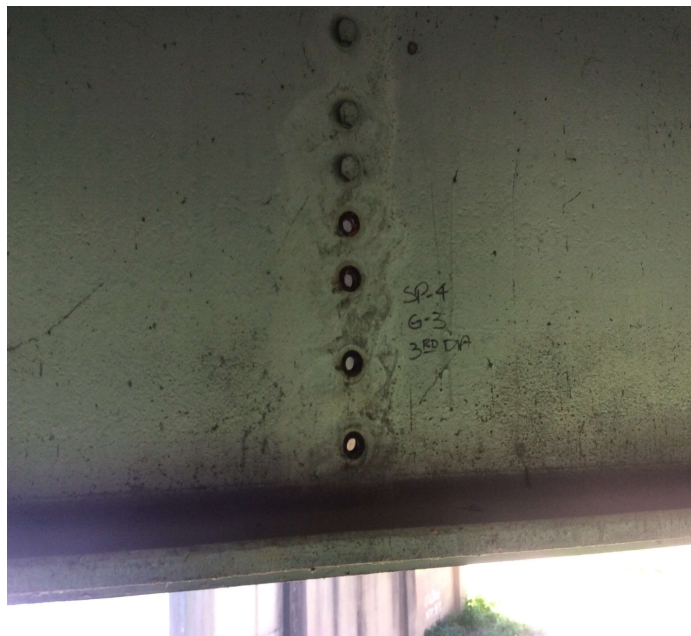
Bolts in the diaphragm connections are missing in spans 3 thru 12.
(81 bolts)

PHOTO 1 Description Span 4 beam 3 diaphragm 3 four missing bolts.

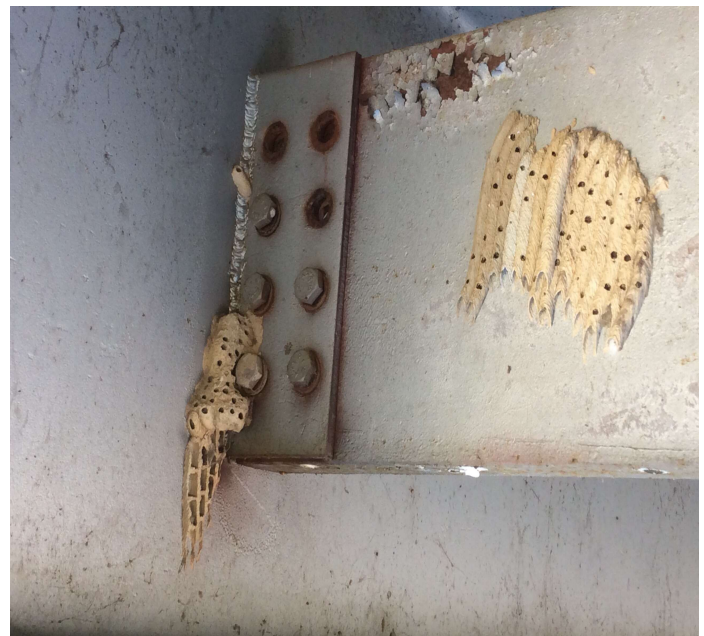
PHOTO 2 Description Span 5 beam 6 diaphragm 5 has missing and loose bolts.

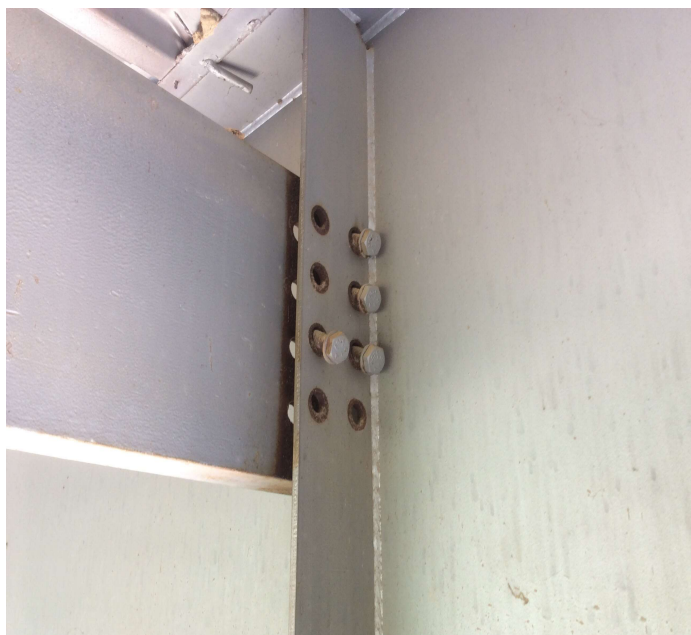
PHOTO 3 Description Span 10 beam 7 diaphragm 5 has missing and loose bolts.

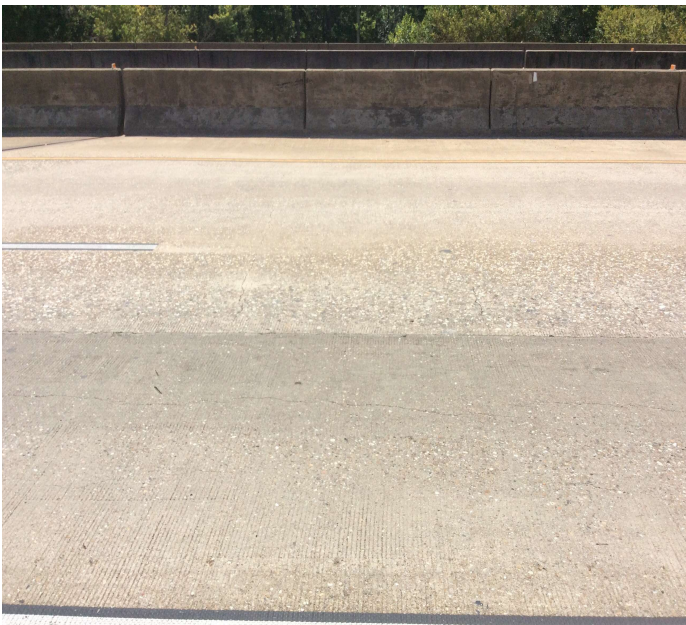
The deck has several transverse and longitudinal unsealed cracks. See photo.

PHOTO 1 Description Span 8 deck has unsealed cracks.

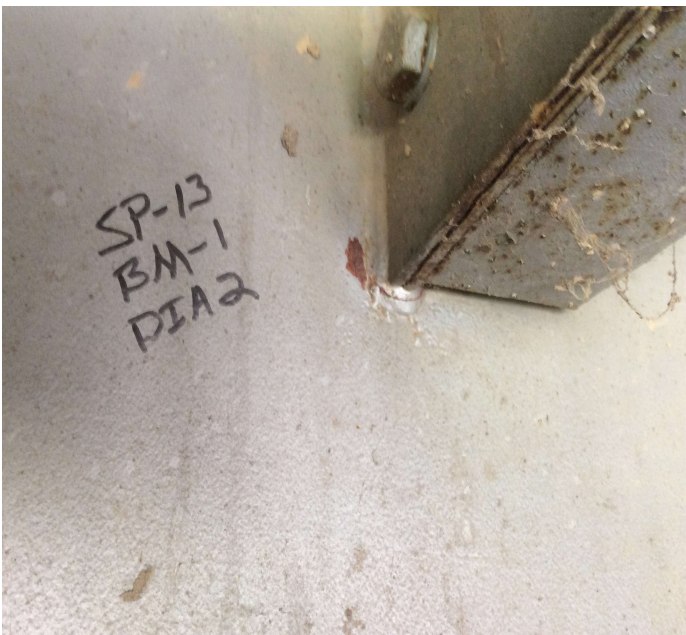
Span 13 beam 1 diaphragm 2 crack in the bottom diaphragm bracket weld.

PHOTO 1 Description Span 13 beam 1 diaphragm 2 crack in the bottom weld.

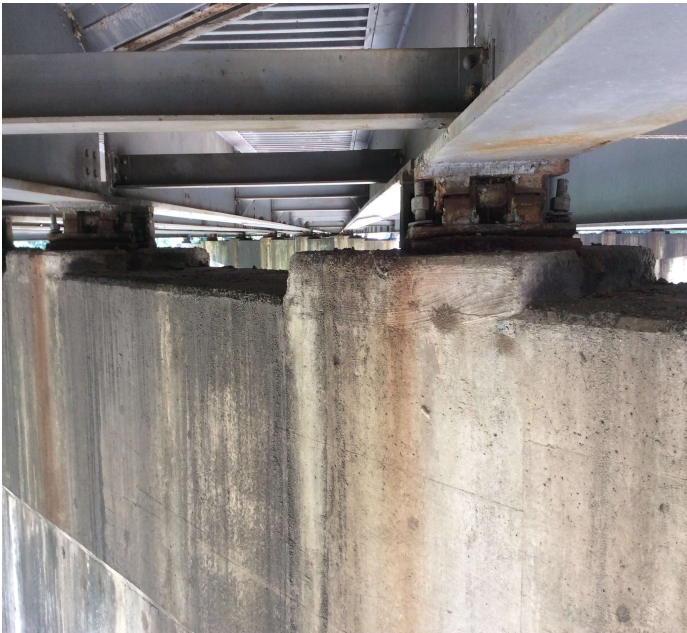
Bearing all bents laminating rust on bearing between sole plates and masonry plates

PHOTO 1 Description Bent 9 bearing have corrosion due to leaking joint seals. Common all bents.
