Bridge #03079(Routine)

JAMES STREET over US 67-SEC 10 LOG 9.81

Team Lead: Keith Harris Inspection Date: March 21, 2022

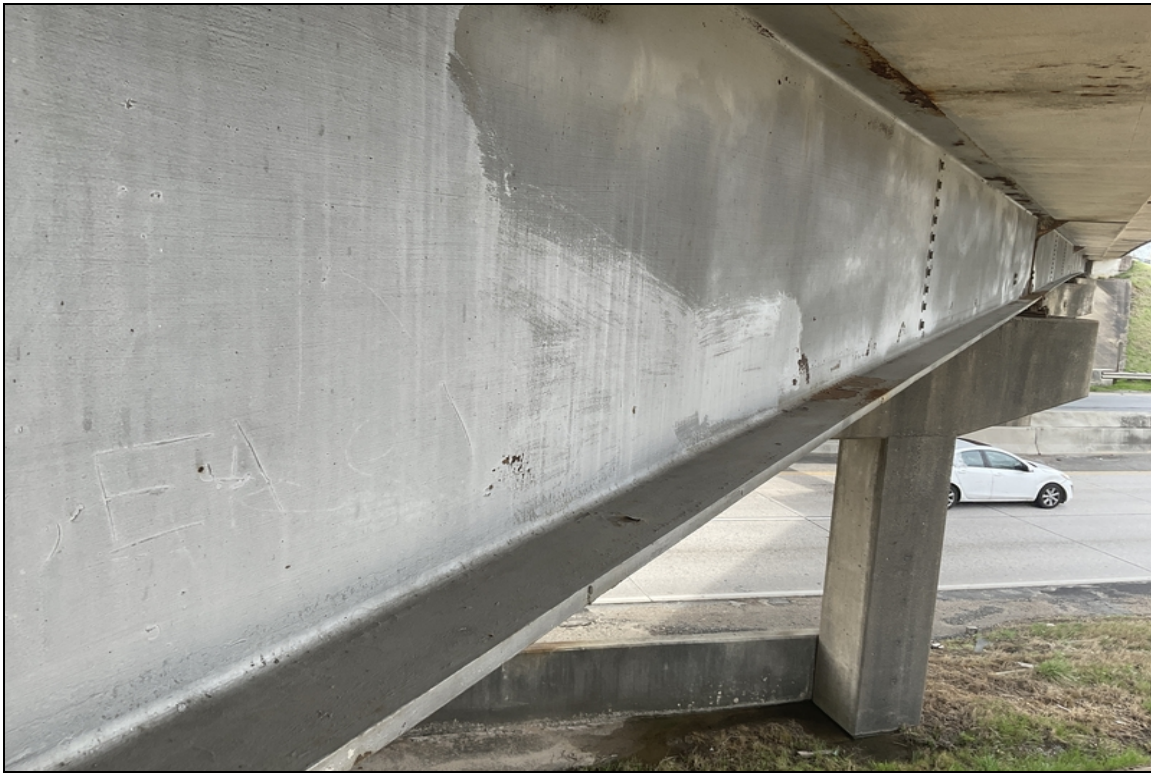
Typical paint condition

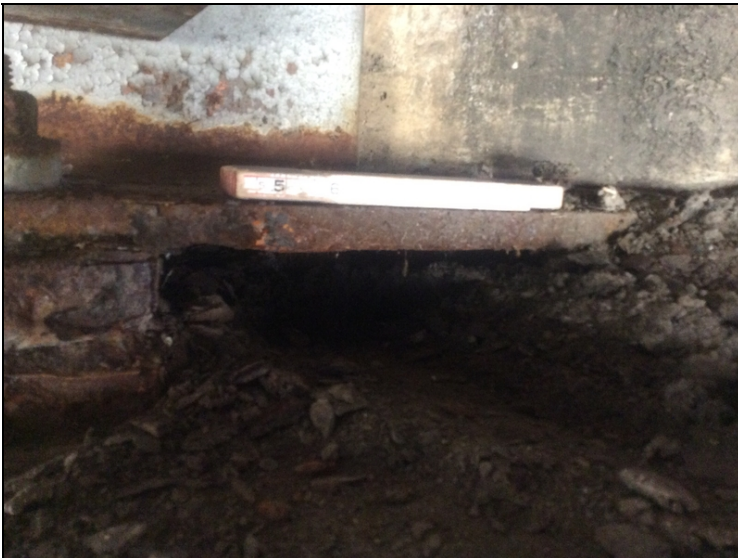
(107)	All of the beams ends have active corrosion with pitting to 1/8 to 3/16 inch deep on the bottom of the bottom flanges and lower webs. Traffic impact to beams 3,4 & 5. Minor scrapes to bottom flange of beams 3 & 4. Beam 5 has gouge and miss alignment up to 1" to bottom flange. 3/4/2020 CDDC497 Span 3, girder 5: traffic impact has caused the bottom flange and cover plate to crack almost completely through and the crack has propagated to the web approximately 8" in length. Girders 3 and 4 have been impacted but no real distortion. Repairs were made 6/18/2020. (Worst case)Span 3, girder 3: large area of measurable section loss to the bottom flange and lower web and at the haunch						
205	Reinforced Concrete Column	EA	6	5	1	0	0
1080	Delamination/Spall/Patched Area	EA	1	0	1	0	0

All of the beams ends have active corrosion with pitting to 1/8 to 3/16 inch deep on the bottom of the bottom flanges and lower webs.

Bent1 beam 4 up to 3/16" pitting to bottom flange at bearing area.

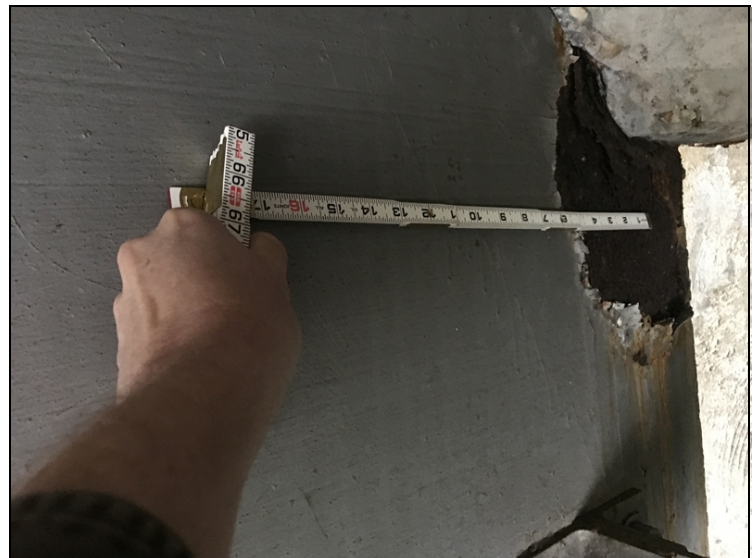
Span 4, girder 1 at bent 5: laminating rust to haunch area.

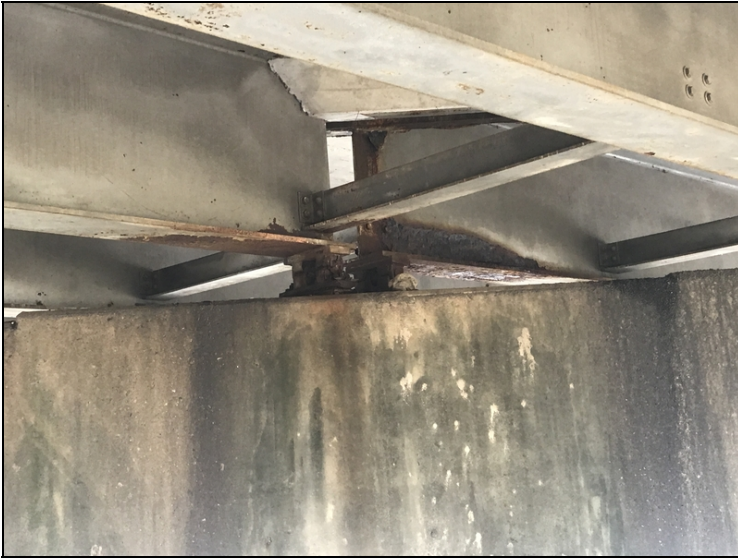
(Worst case)Span 3, girder 3: large area of measurable section loss to the bottom flange and lower web and at the haunch.

Span 3, girder 3: large area of measurable section loss to the bottom flange and lower web and at the haunch

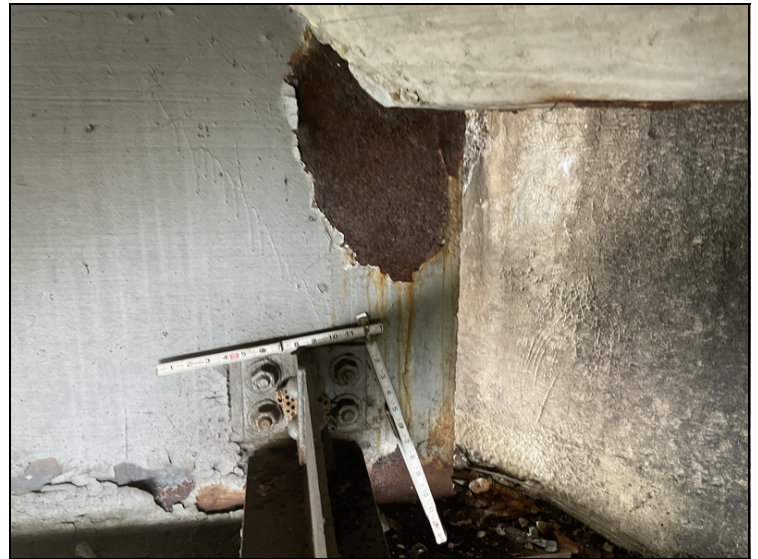
Bent 5 beam corrosion in haunch area with pitting up to 3/16"

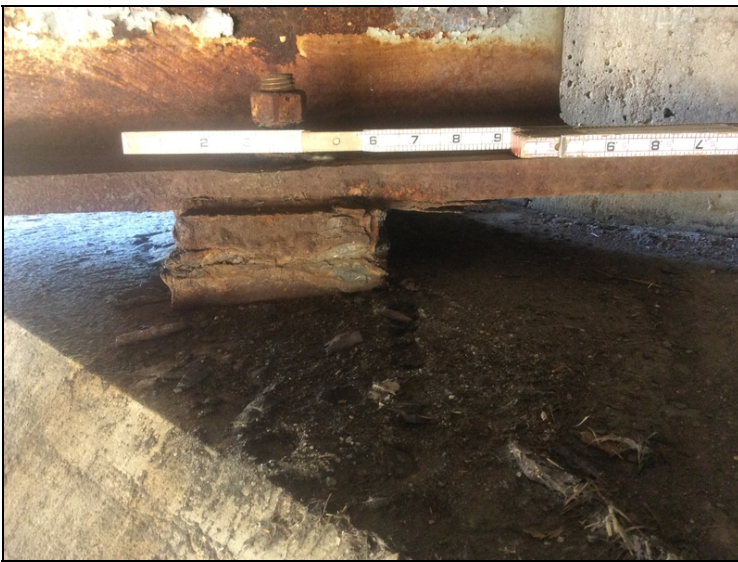
Bearings at Bents 1 & 5 heavy to severe corrosion. All bearings have moderate to heavy corrosion.

Bent 1 beam 5 bearing has corrosion.

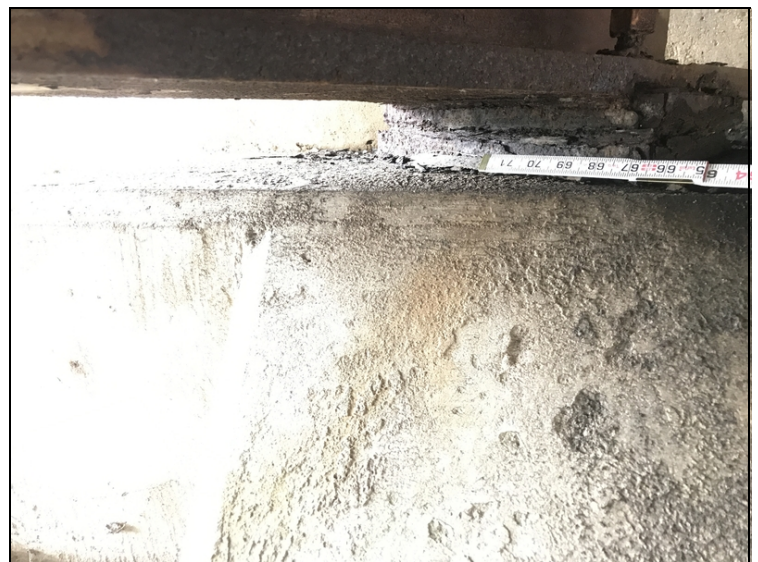
Bent 1, girder 5 bearing with extensive corrosion.
Common to all bearings on this bridge.

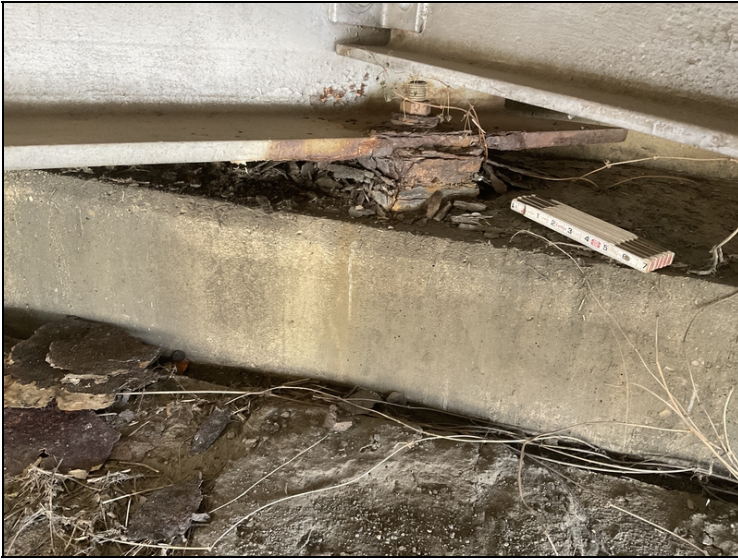
Bent 5 bearing 4 corrosion

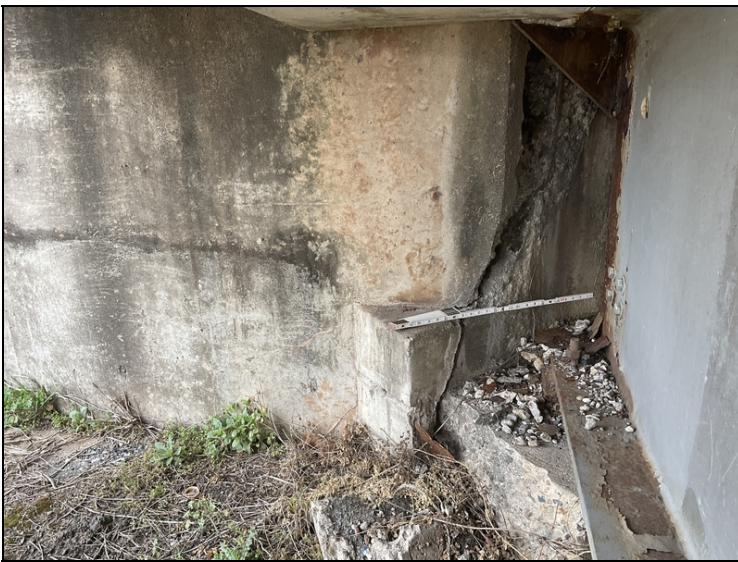
(215)	Bent 1 has a horizontal crack at centerline over the center pile. Bent 5 left side has spall on left end of abutment and spall with exposed rebar in back back wall.						
234	Reinforced Concrete Pier Cap	LF	123	115	1	7	0
1080	Delamination/Spall/Patched Area	LF	1	0	0	1	0

Bent 5 left side spall at left end of abutment, 1" crack & spall exposed rebar in back wall.

Left side of bent 5 has 1" crack and large spall with exposed rebar

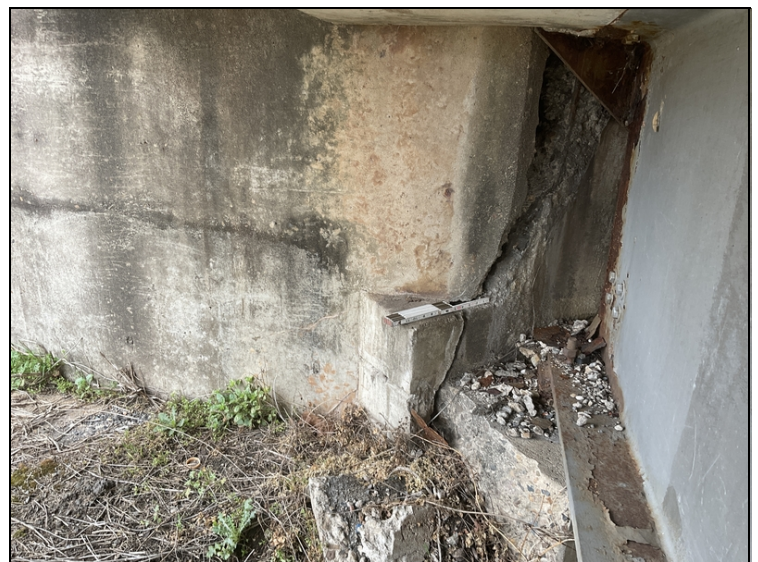
Bent 5 left side spall at left end of abutment, 1" crack & spall exposed rebar in back wall.

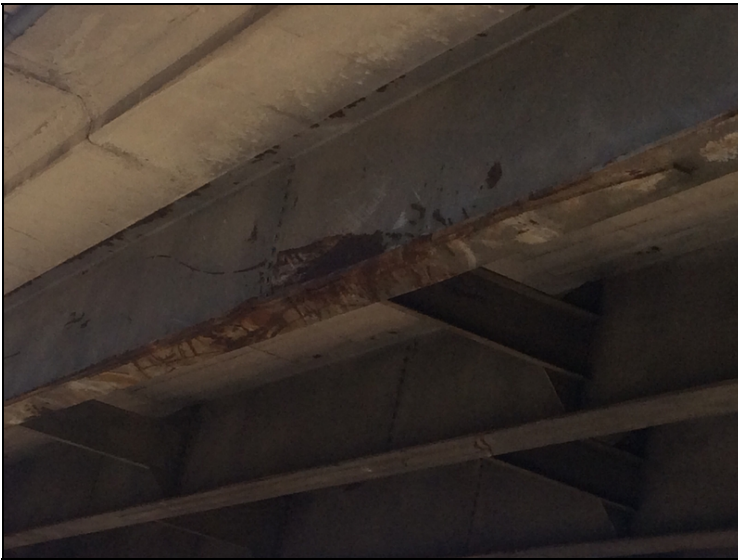
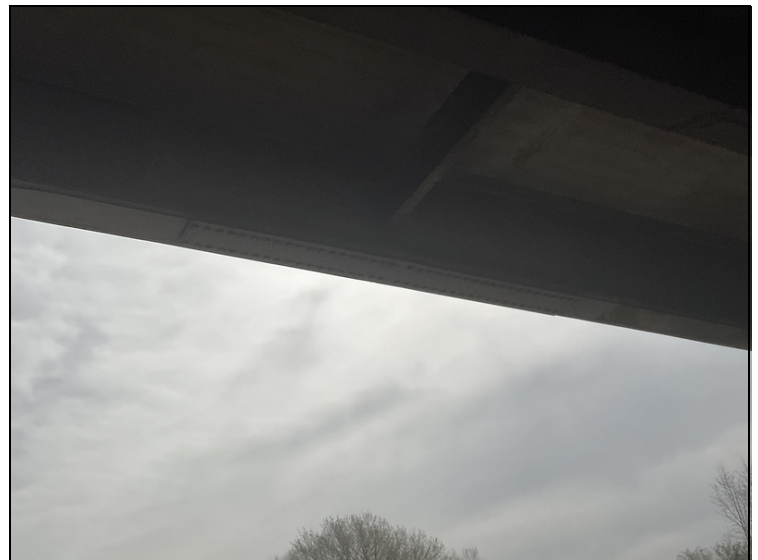
Span 3 beam 5 has traffic impact damage to lower flange and web. See photo

Span 3 beam 5 has been repaired

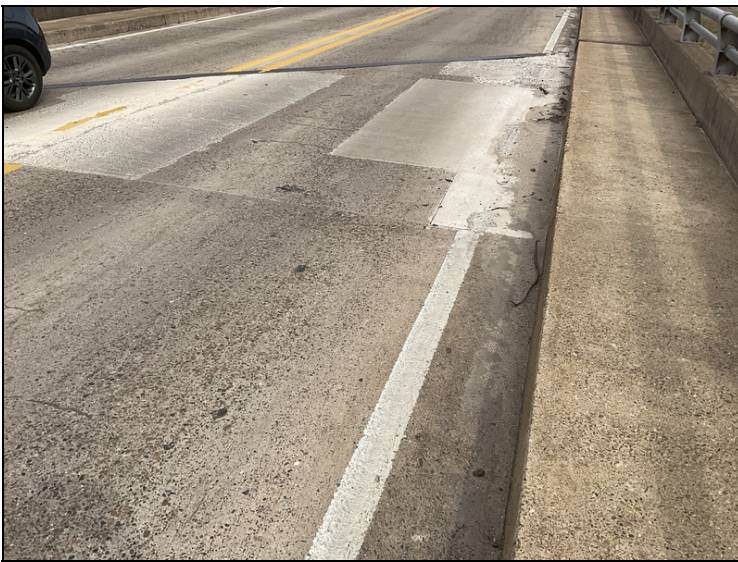
All spans have spalls in driving surface

Span 2 has been patched.

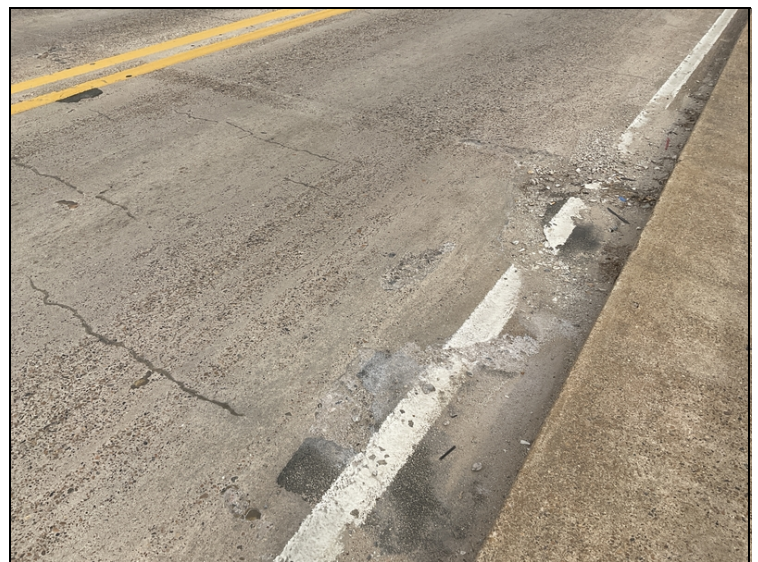
Span 3 spalls in deck

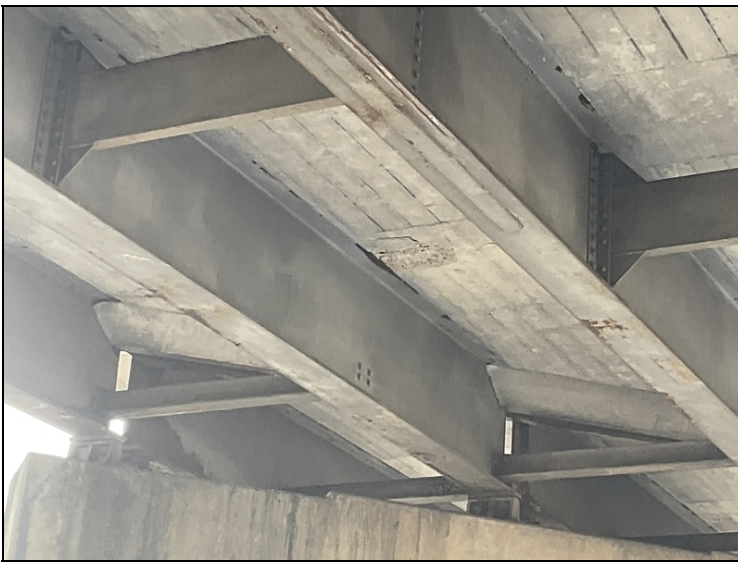
Span 3 delam between beams 3&4 over shoulder and yellow line.

Span 3 delam between beams 3&4 over shoulder
and yellow line.

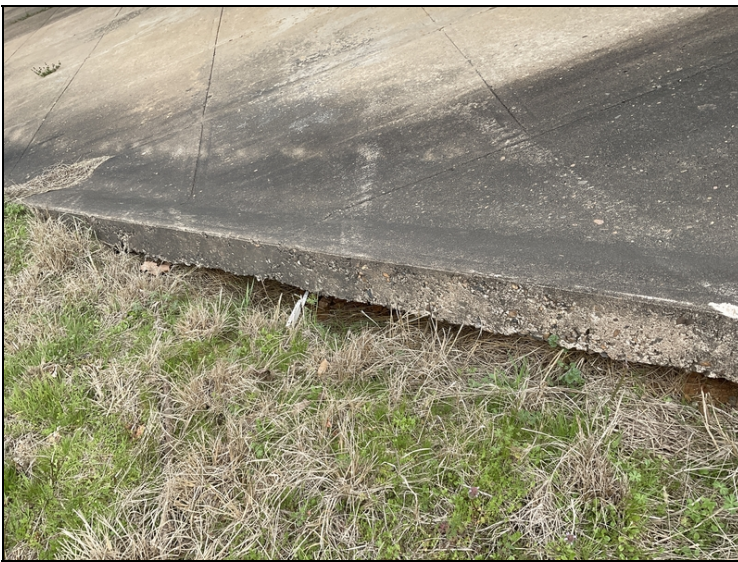
Erosion has undermined the left side of slope paving at bent 1.

Erosion has undermined the left side of slope
paving at bent 1.
