Bridge #A3080(Routine)

US 67 NB Log 10.89 over SH 161

Location: LRAF BASE EXIT

Team Lead: Keith Harris Inspection Date: March 03, 2021

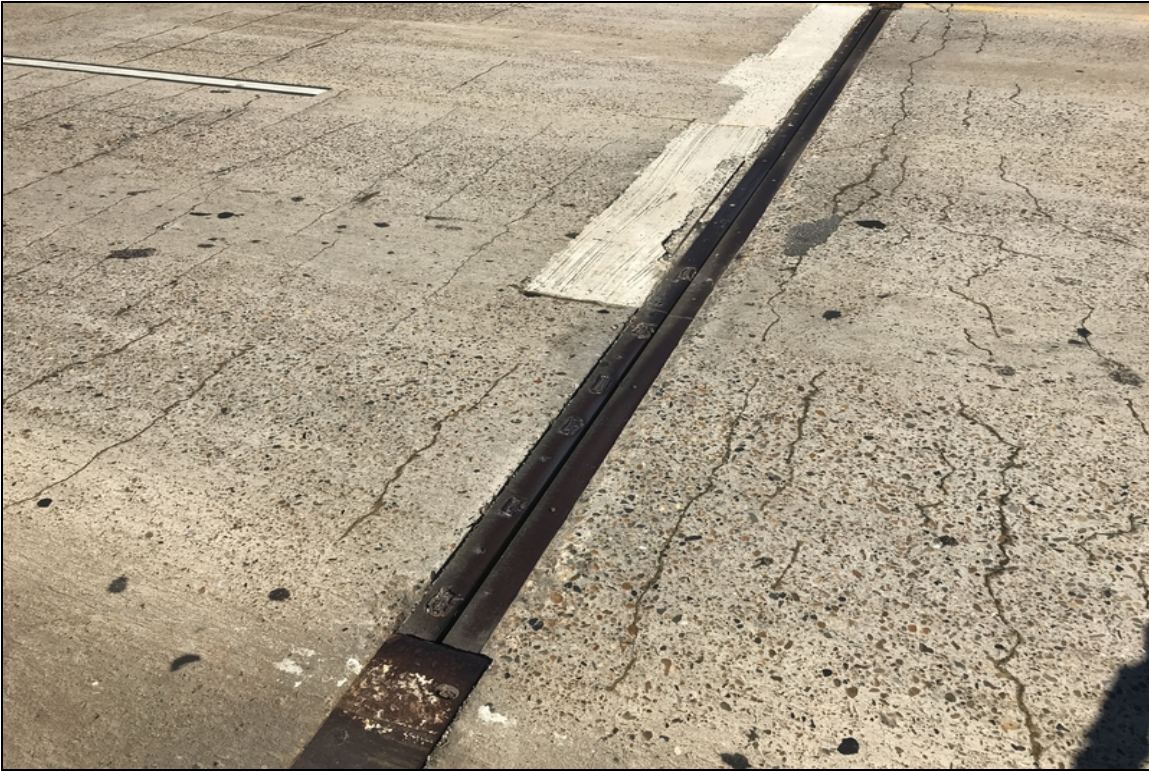
ELEM	DESCRIPTION	UNITS	TOTAL	CS1	CS2	CS3	CS4
2360	Adjacent Deck or Header	LF	82	0	82	0	0
(303)	Along all joints the adjacent header is cracked and spalled. Bent 3 deck plate is missing.						
311	Movable Bearing	EA	15	0	5	10	0
1000	Corrosion	EA	5	0	5	0	0
2220	Alignment	EA	10	0	0	10	0

Span 3 deck plate is missing

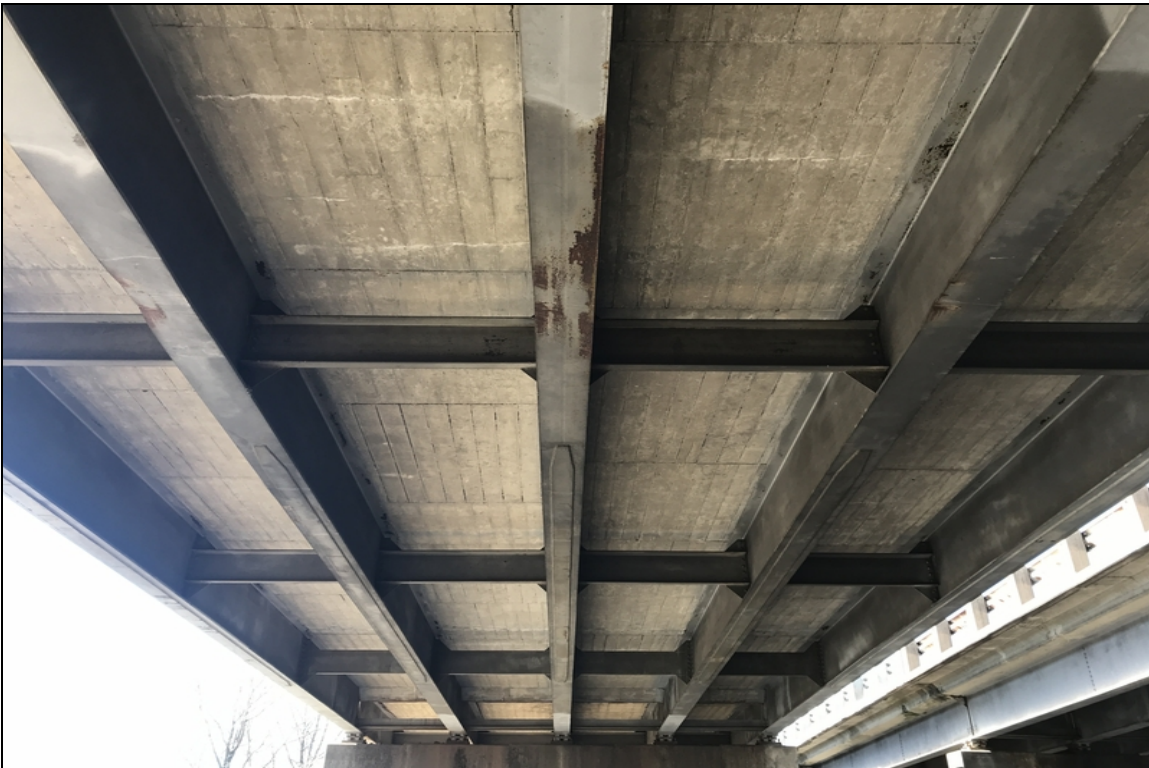
Span 2 under view

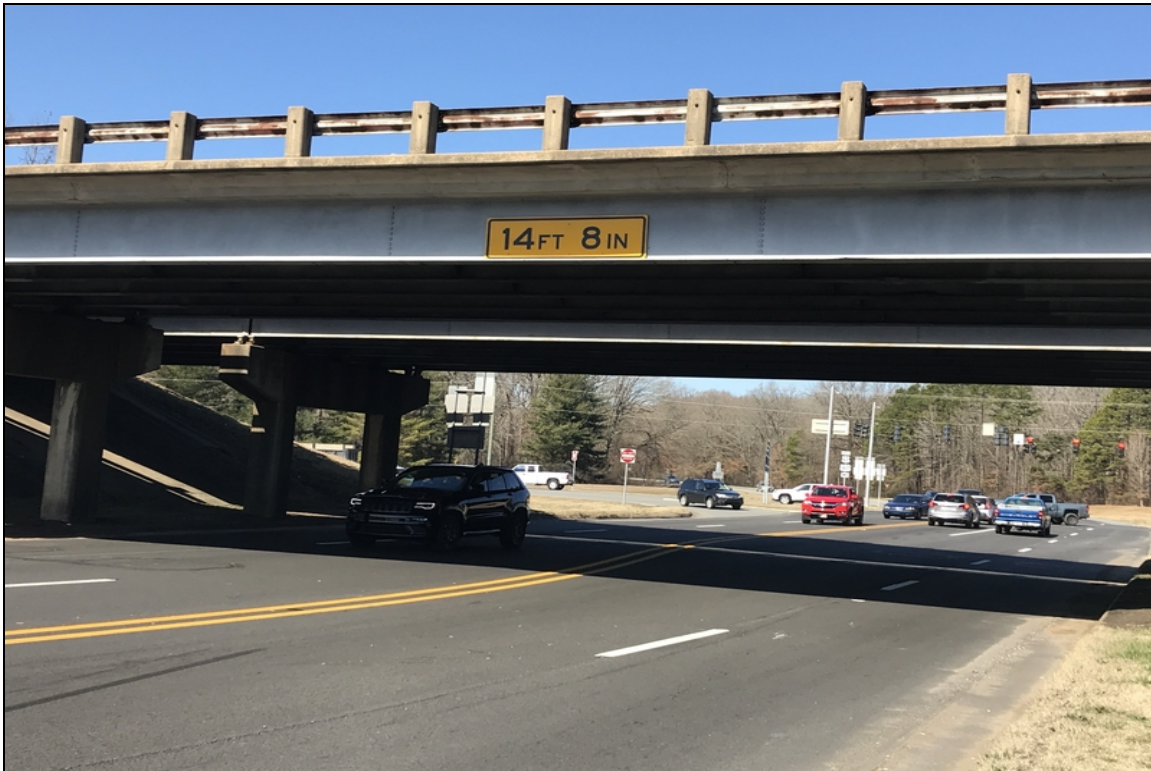
Low clearance sign east side of bridge

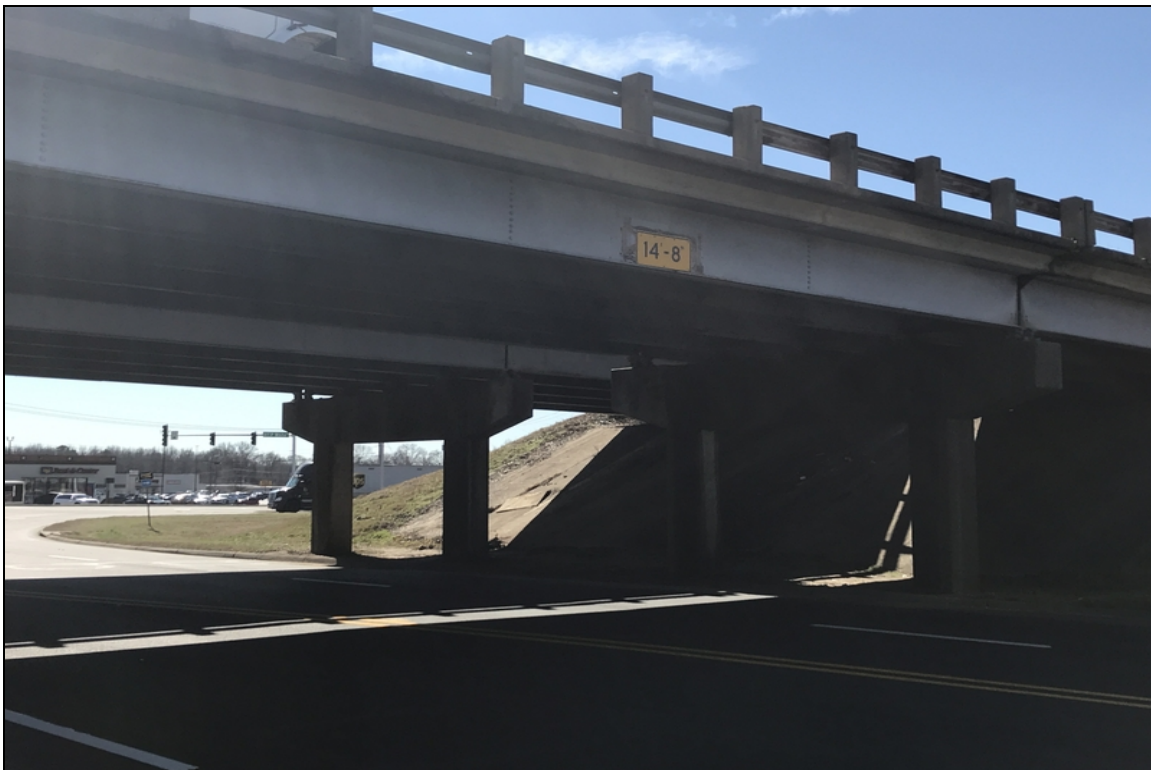
Low clearance sign west side of bridge

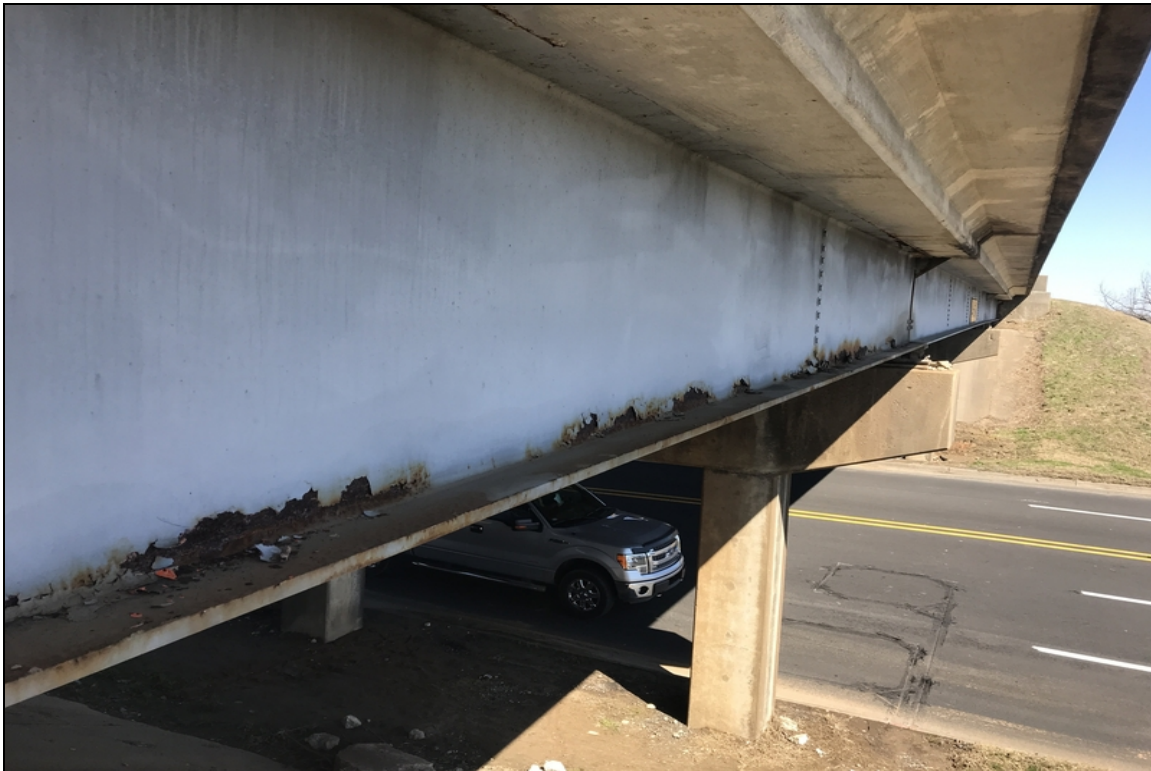
(107)	Active rust in the beam ends near the deck haunches. All beams have freckled rust and peeling paint. Impact damage to beams 4 and 5 in span 2, minor scrapes. The beams ends at bent 4 have laminating rust with pitting up to 1/8" deep.						
205	Reinforced Concrete Column	EA	4	4	0	0	0

Typical paint condition

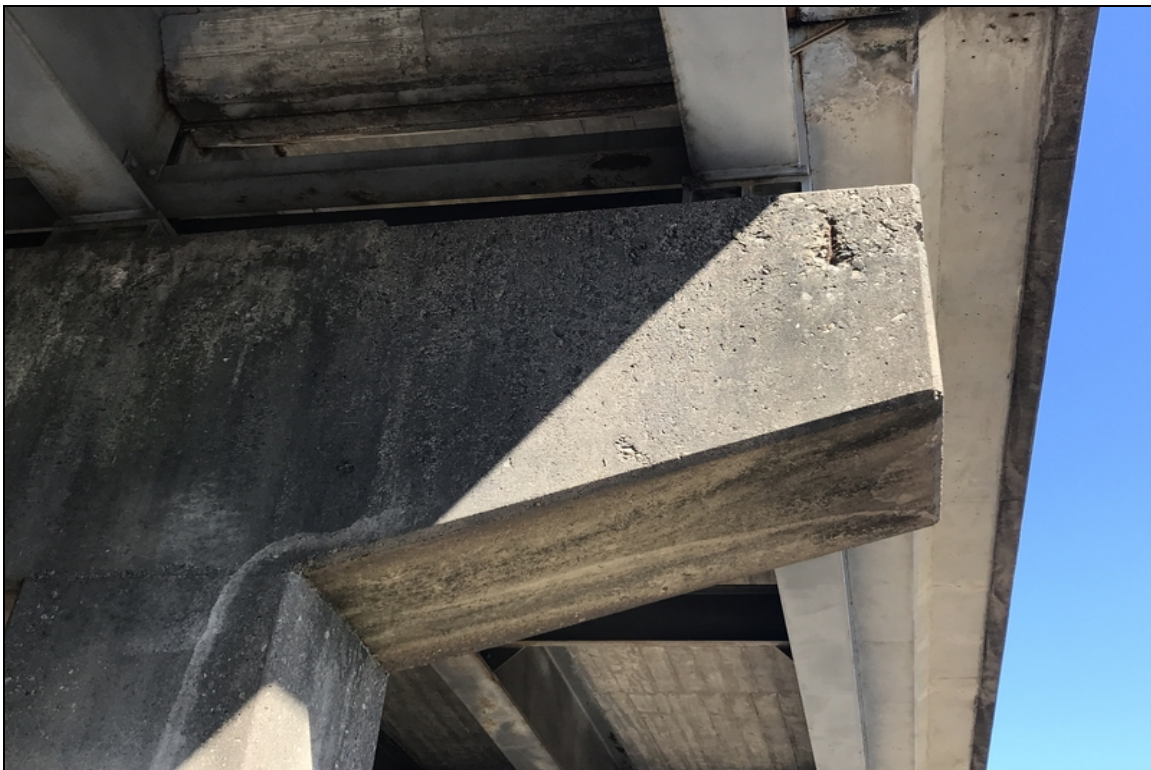
(234)	Bent 3 cap has small spalls and a small spall with rebar back right of column 2.						
303	Assembly Joint with Seal	LF	112	0	82	30	0
2330	Seal Damage	LF	30	0	0	30	0

Bent 3 cap spall with exposed rebar

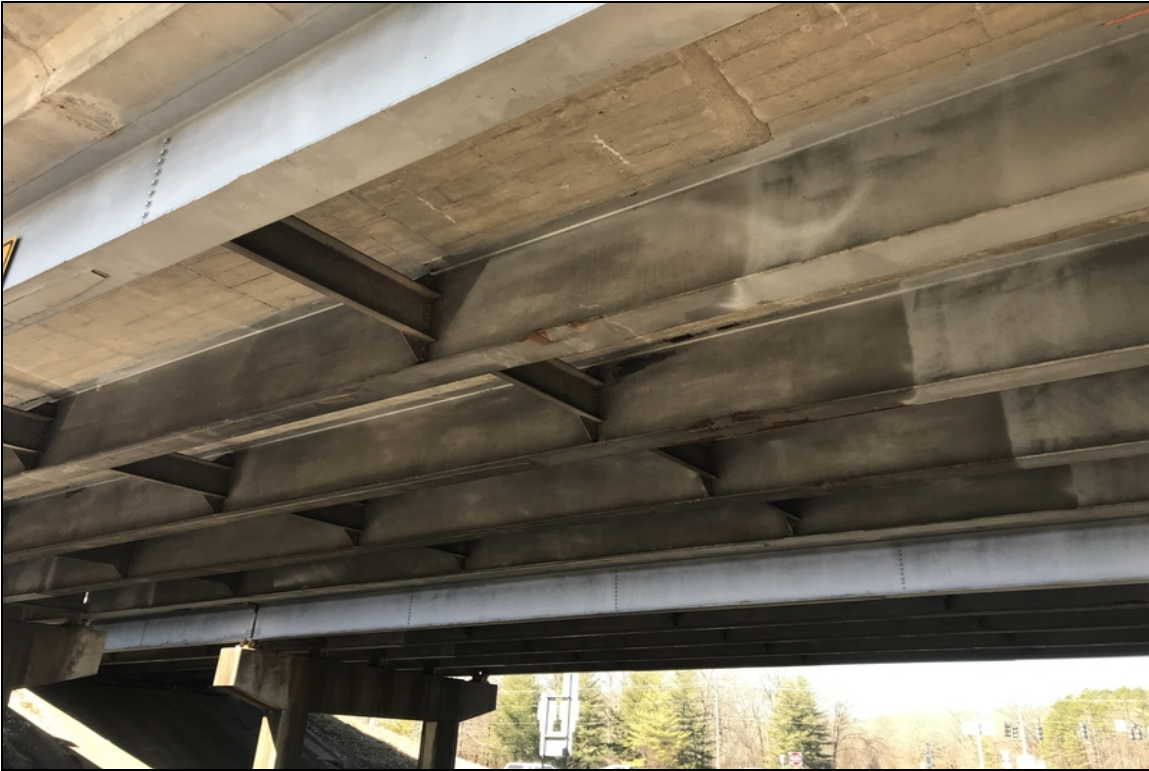
Span 2 minor damage to beams from traffic impact

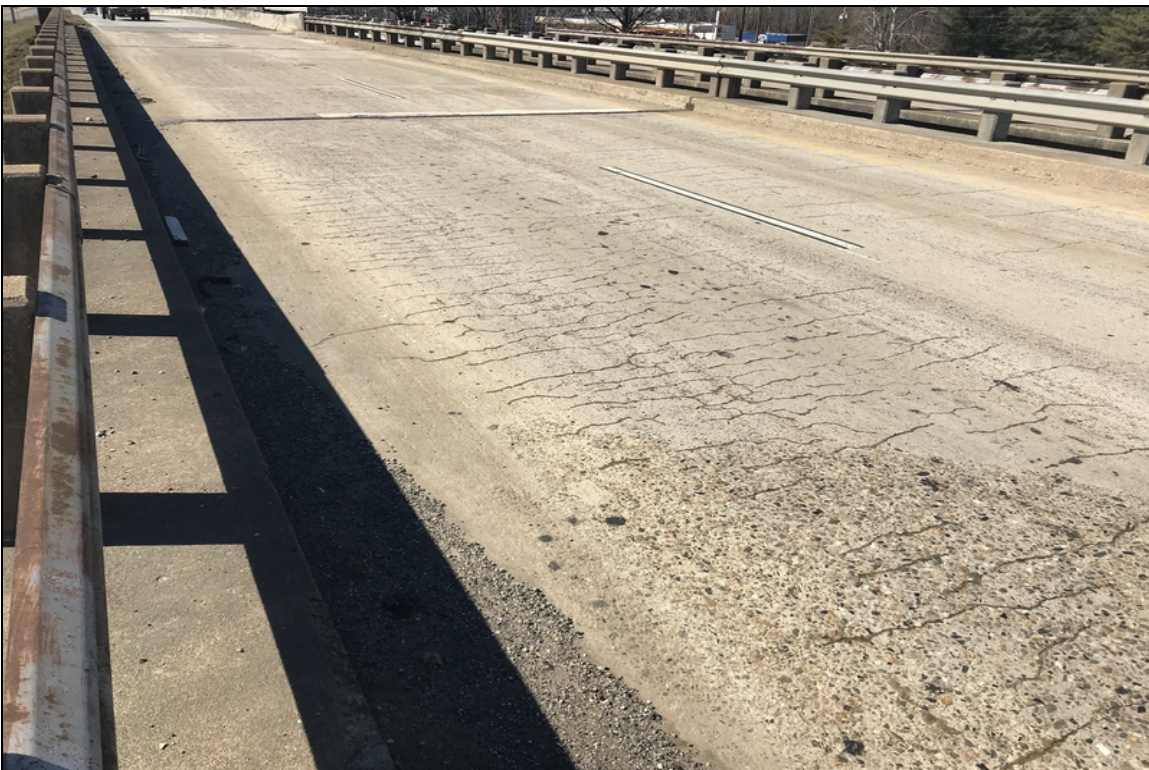
(12)	All spans have large cracks that the majority have been sealed. All spans have concrete patched areas, Spalls filled with asphalt and open spalls with exposed rebar.						
107	Steel Open Girder/Beam	LF	750	265	430	55	0
1000	Corrosion	LF	480	0	425	55	0
7000	Damage	LF	5	0	5	0	0
515	Steel Protective Coating	SF	6593	0	1500	1226	3867
3410	Chalking (Steel Protective Coatings)	SF	5093	0	0	1226	3867
3420	Peeling/Bubbling/Cracking	SF	1500	0	1500	0	0

Deck overview

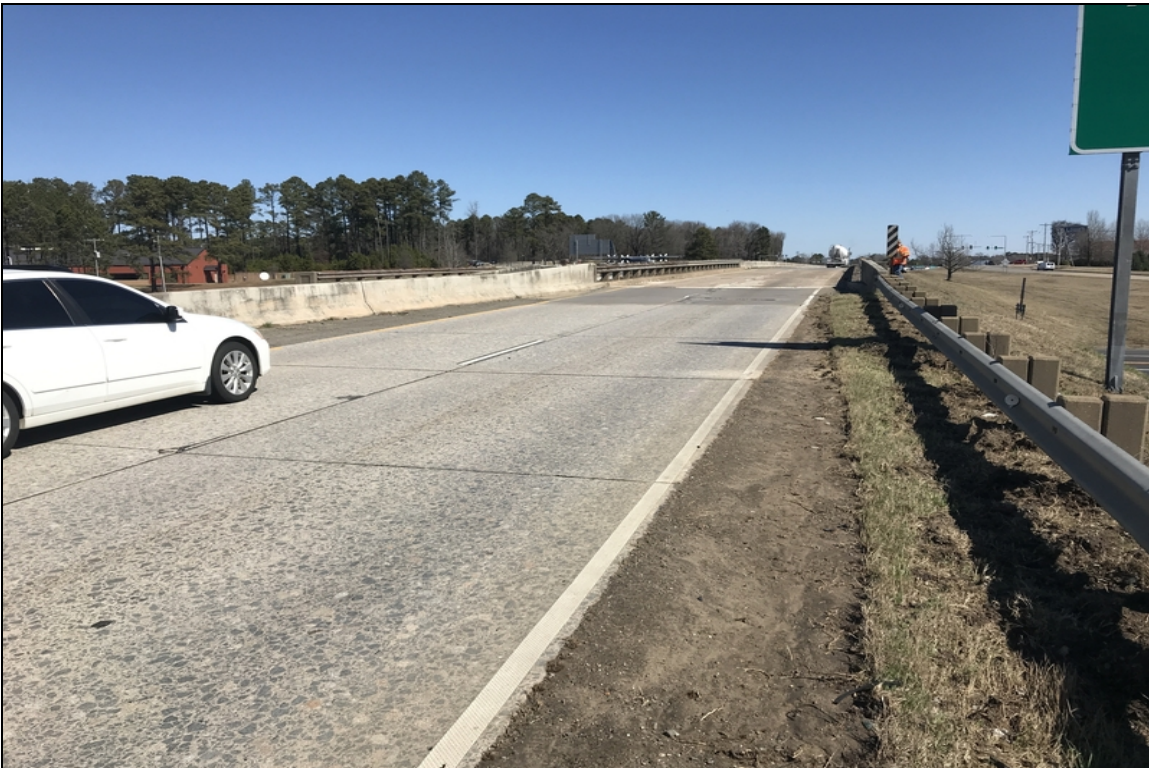
Approach looking north

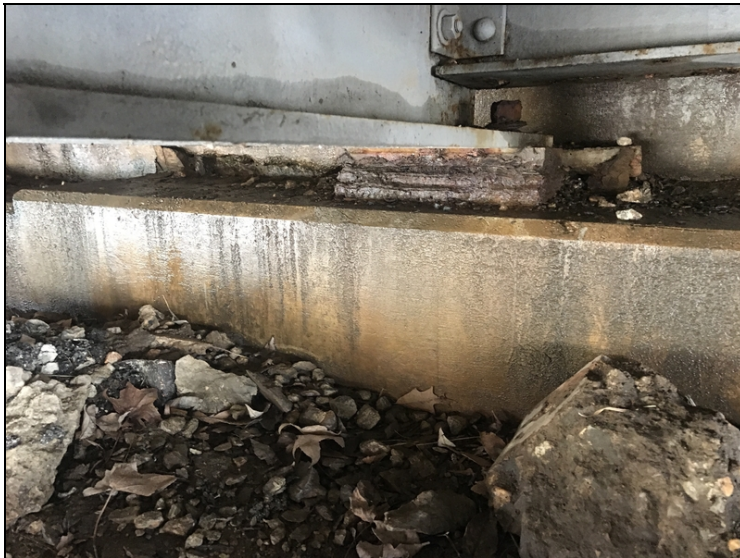
Bearings at bent 1 and 4 abutments have heavy laminating rust between bearing and masonry plate. Bearings at bents 2 and 3 are fully rotated.

Bent 1, girder 2: bearing has active corrosion with section loss to it. This is condition is similar to the other bearings at this bent.

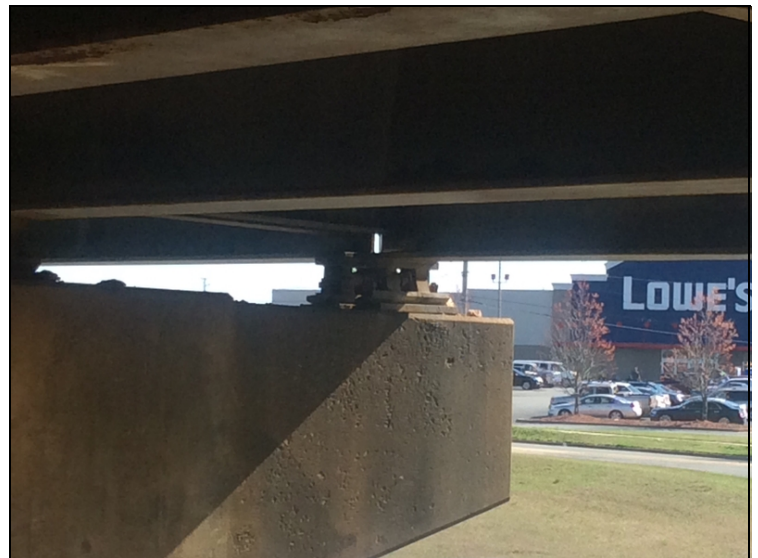
Bent 2 beam 5 bearing is fully rotated

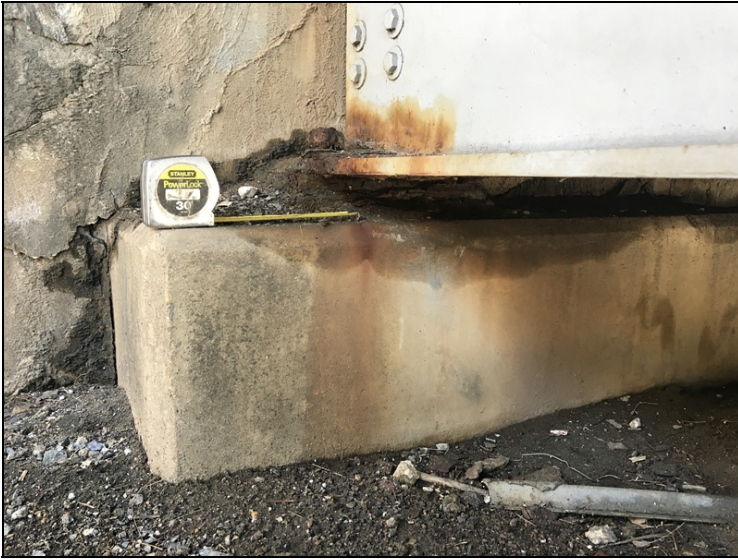
Bent 1 bearing 1 corrosion

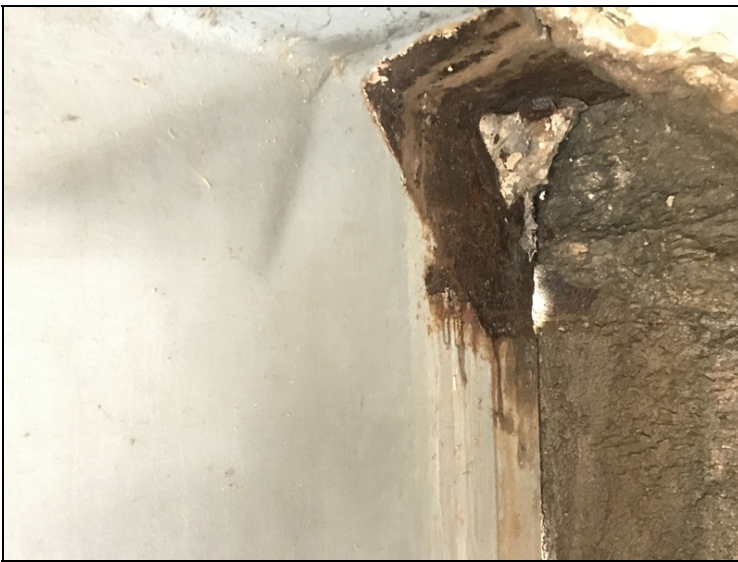
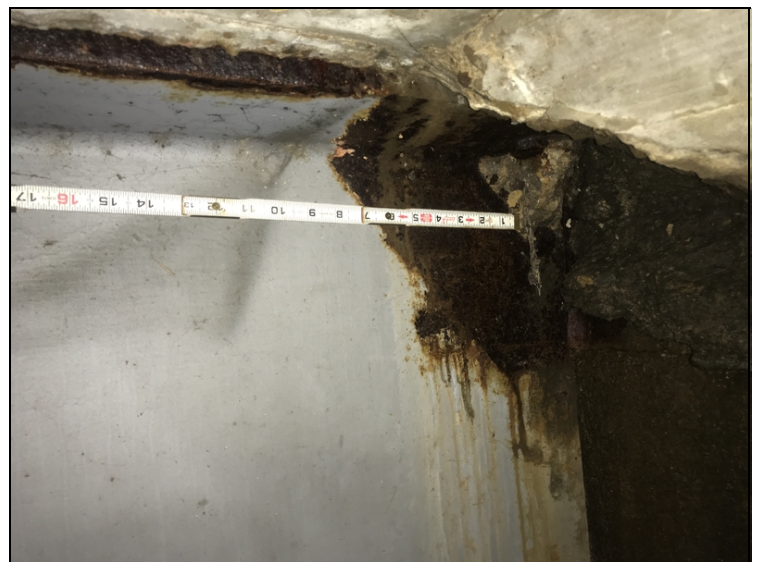
Beam ends at haunch are have active rust with minor section loss.  
Span 3 beam 3 has a 1" hole in web at haunch area.

Span 1, girder 2: the haunch has pitting

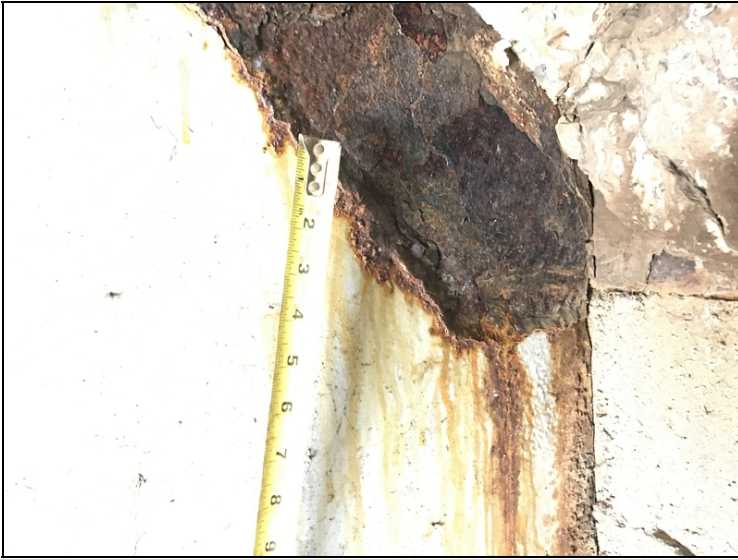
Span 3 Beam 3 at bent 4 has a 1" hole in web and active corrosion to haunch.

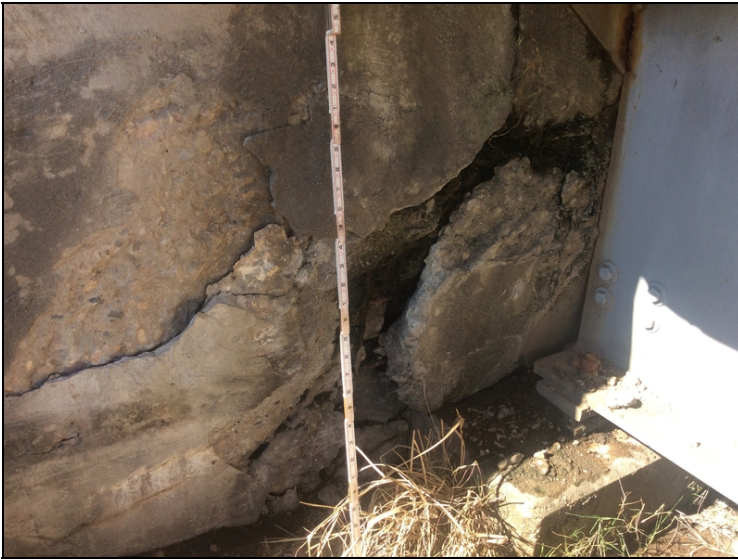
Bent 1 and 4 abutments the back walls are sheared and leaning against bridge deck closing all deck joints not allowing the bridge to expand and causing hard impact to span 1.

Bent 1 abutment the back walls are sheared and leaning against bridge deck closing all deck joints and causing hard impact to span 1.

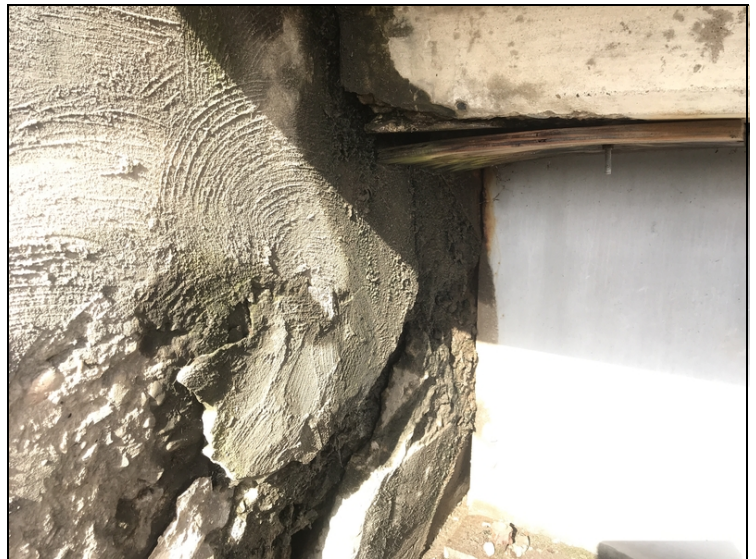
Bent 1: the back wall is broke and is leaning against the girders. The back wall has spalled in numerous places and exposing rebar

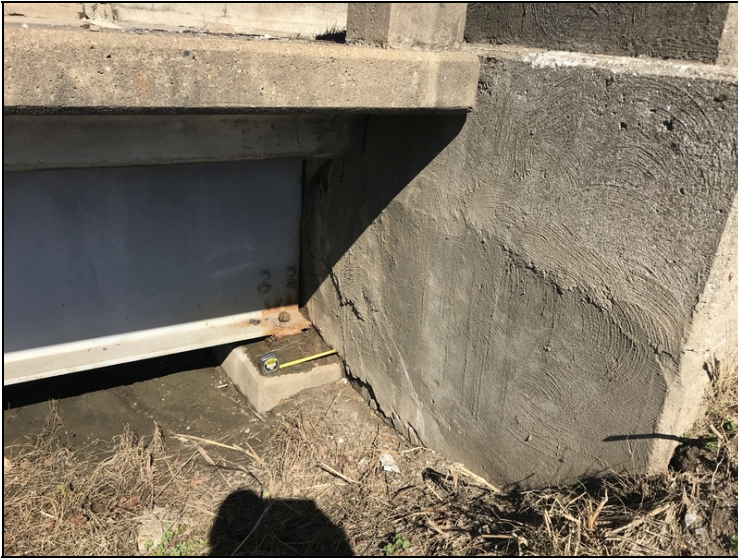
Bent 4 abutment the back wall is sheared and leaning against bridge deck closing deck joint.

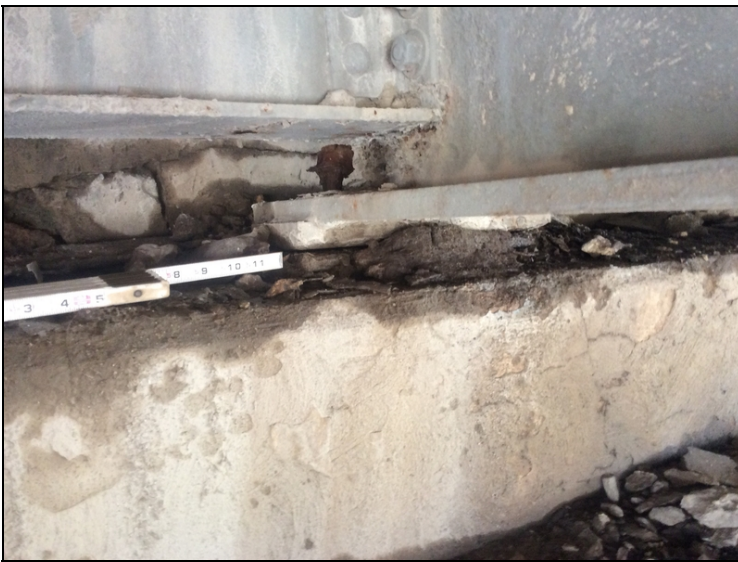
Bearings at bent 1 abutment have a gap between sole plate and bearing causing span 1 to work up and down. Photo

Bearings at bent 1 abutment have a gap between sole plate and bearing causing span 1 to work up and down.

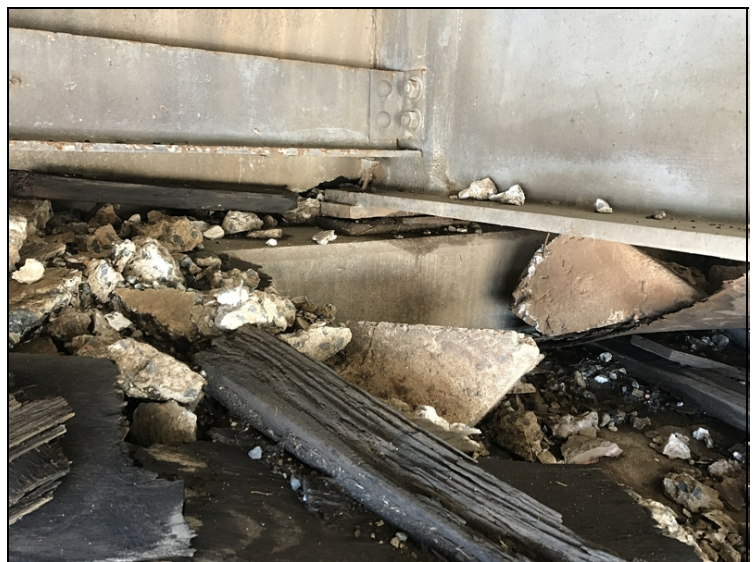
Bearings at bent 1 abutment have a gap between sole plate and bearing causing span 1 to work up and down.

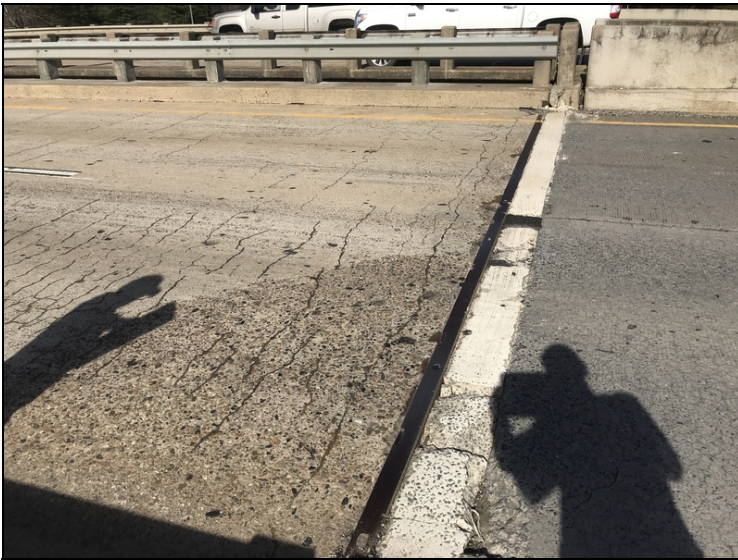
Bent 4: joint material is missing and the joint has completely closed. Similar condition is at bent 1 and 3.

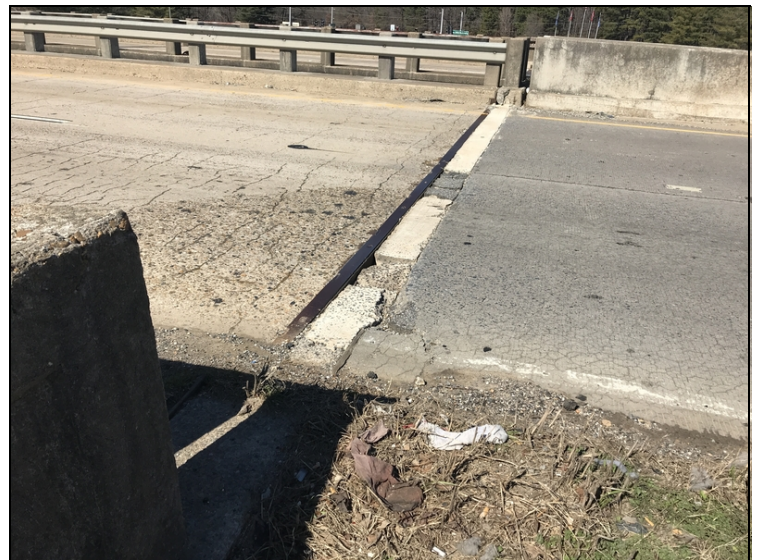
Tops of bent 1 and 4 abutments have deep spalls and spalls filled with asphalt.

Bent 4 top of back wall has large spalls and spalls filled with asphalt

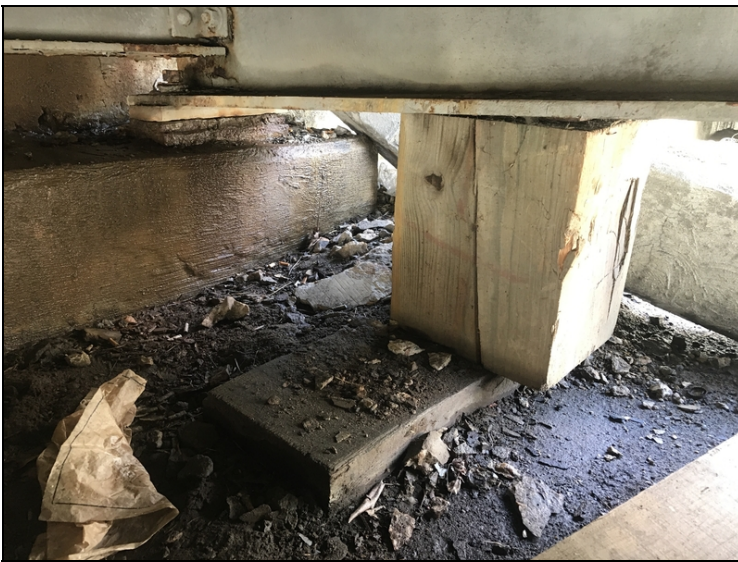
Span 1, girder 1, ahead of bent 1: blocking is in place from previous maintenance work pressing against the girder. Also, there is false work that is laying around under the bridge near bent 1.

Span 1, girder 1, ahead of bent 1: blocking is in place from previous maintenance work at this bridge.

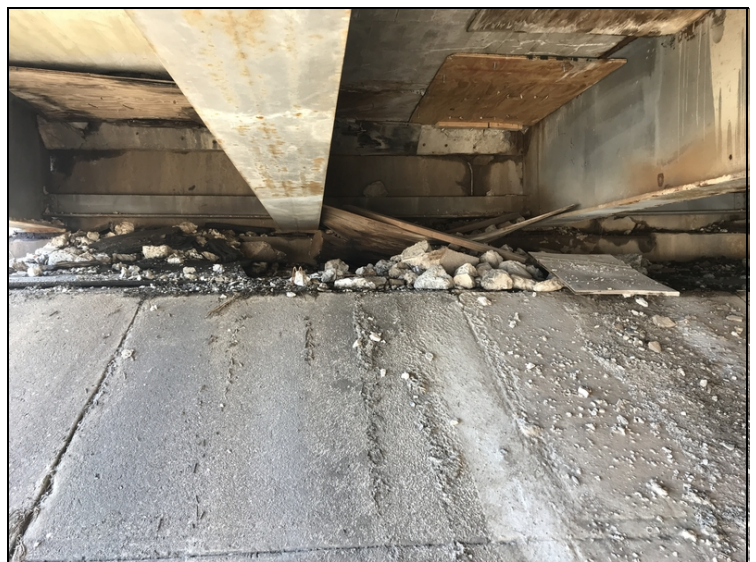
there is false work and busted concrete laying around under the bridge near bent 1.

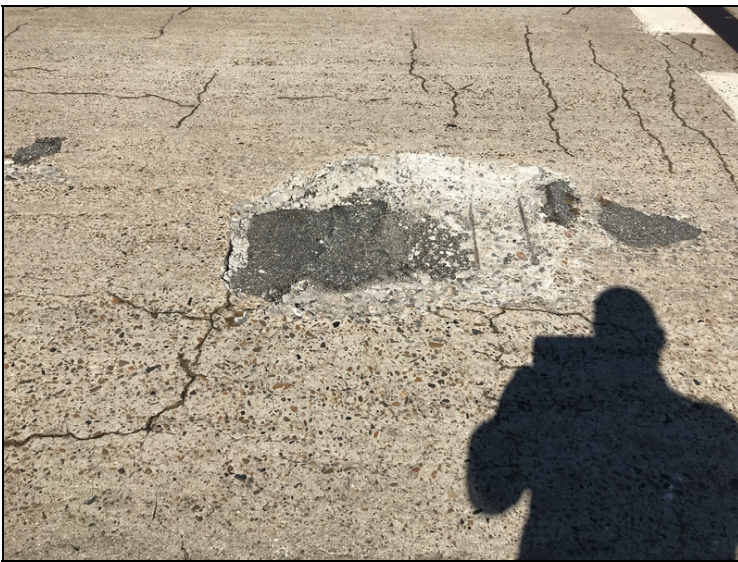
Span 1 Previous patch is failing. Daylight can be seen through patch.  
Numerous large spalls with exposed rebar in deck.

Span 1 large spall with exposed rebar at centerline

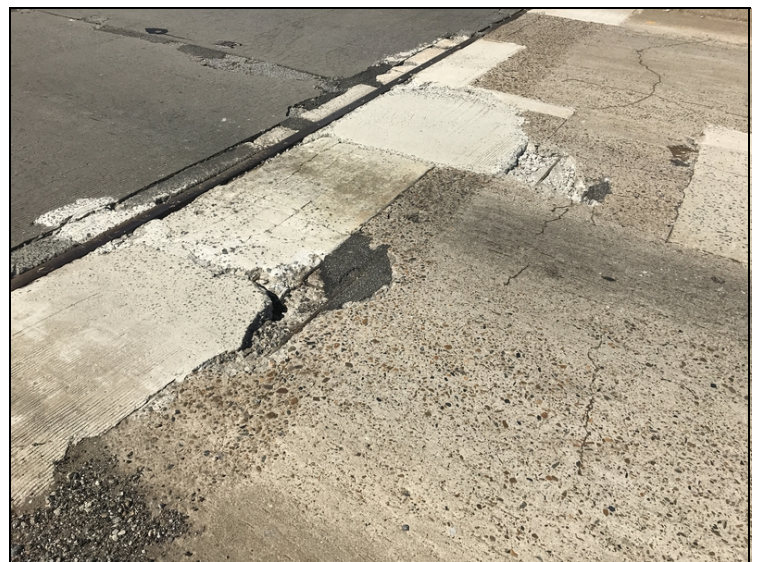
Large spalls with exposed rebar and spalls filled with asphalt in span 1.

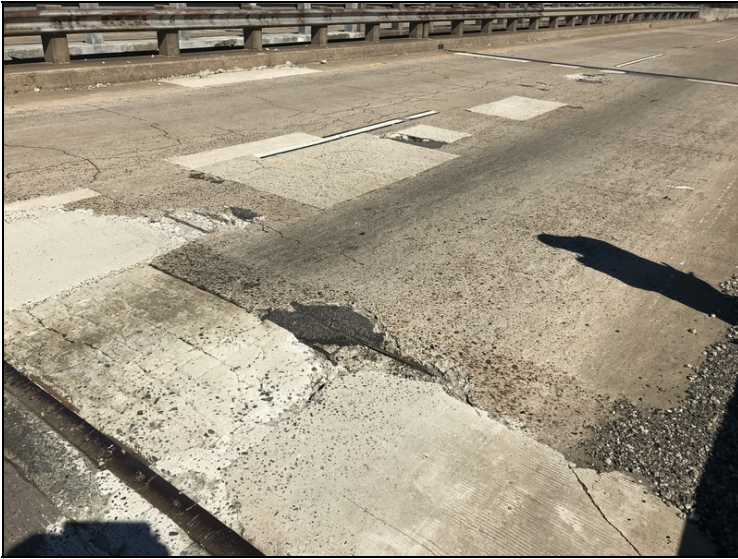
Span 1 overview

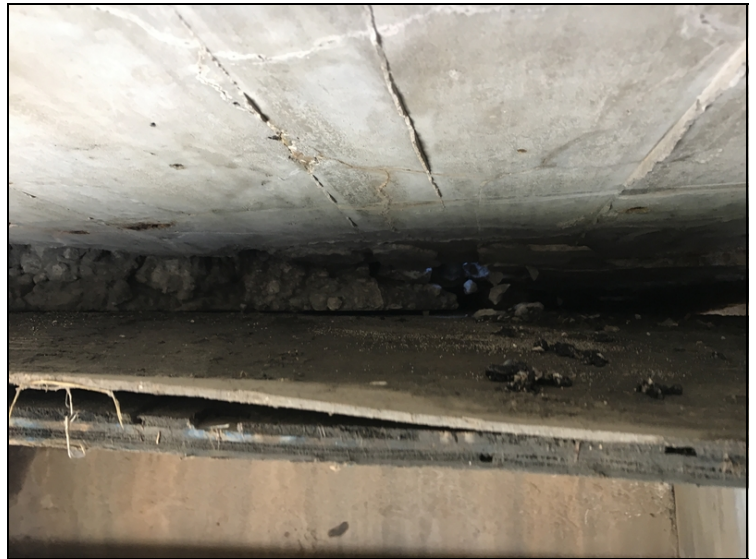
Span 1 Previous patch is failing. Daylight can be seen through patch.

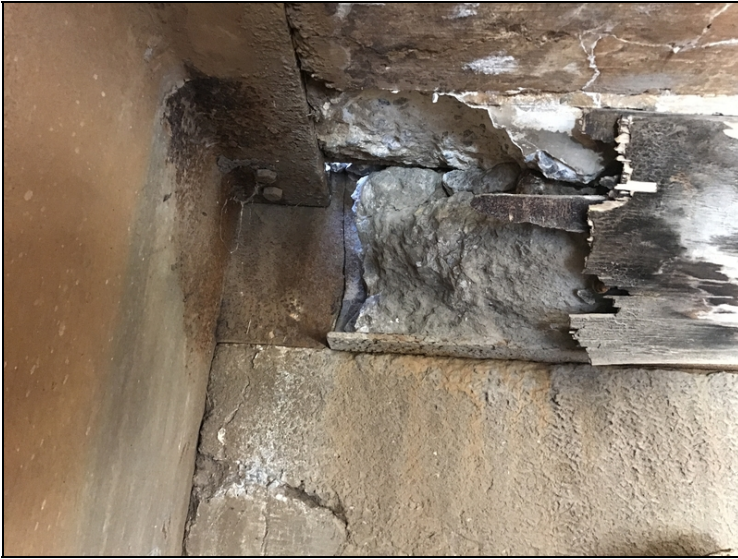
Span 1 Previous patch is failing. Daylight can be seen through patch.
