Bridge Inspection Report

B5582
I-630 EB Log 5.80
over
ROCK CREEK

Structure Number: B5582

Facility Carried: I-630 EB Log 5.80

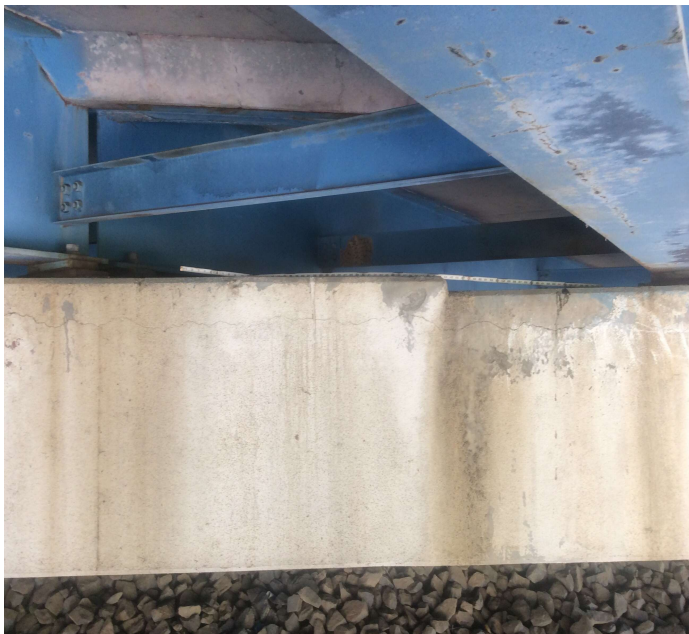
PHOTO 1 Description Bent 2 cap ahead under beams 6 & 7. The cap has a horizontal crack 13 foot long and up to 0.025" wide.

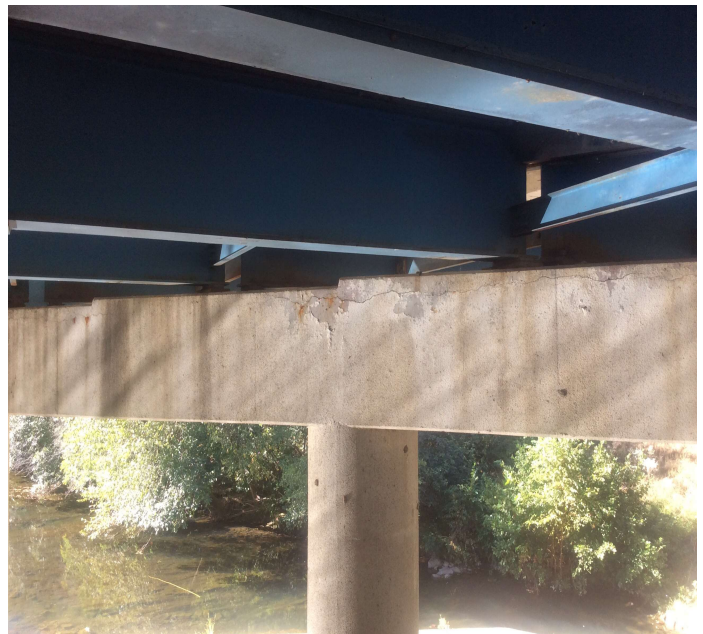
PHOTO 2 Description Bent 3 cap back . Horizontal crack up to 0.035 wide with rust stains. in the cap under beams 2,3 & 4

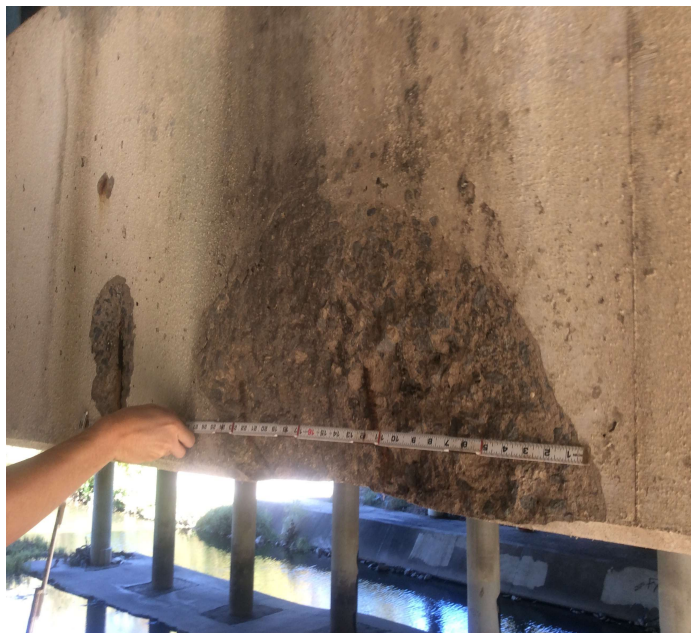
PHOTO 3 Description Bent 4 cap ahead between column 2 & 3 spalls with exposed rebar.

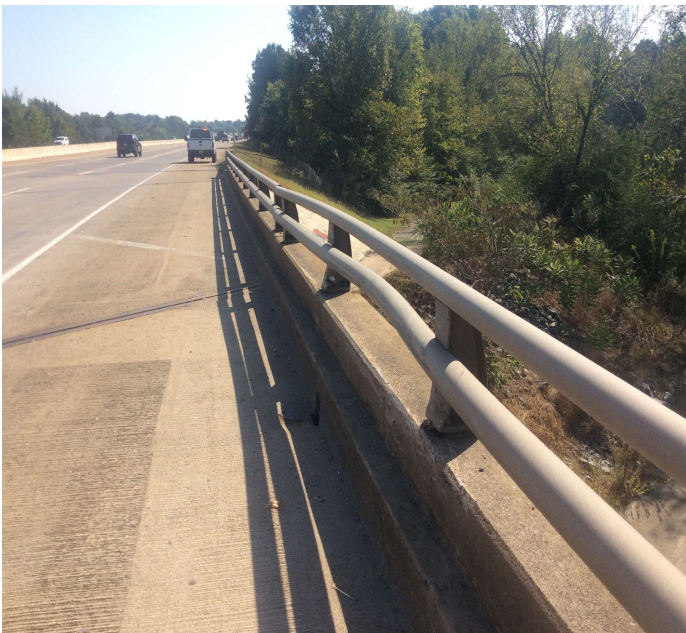
PHOTO 1 Description

Bent 2 span 2 left side, guardrail damage.

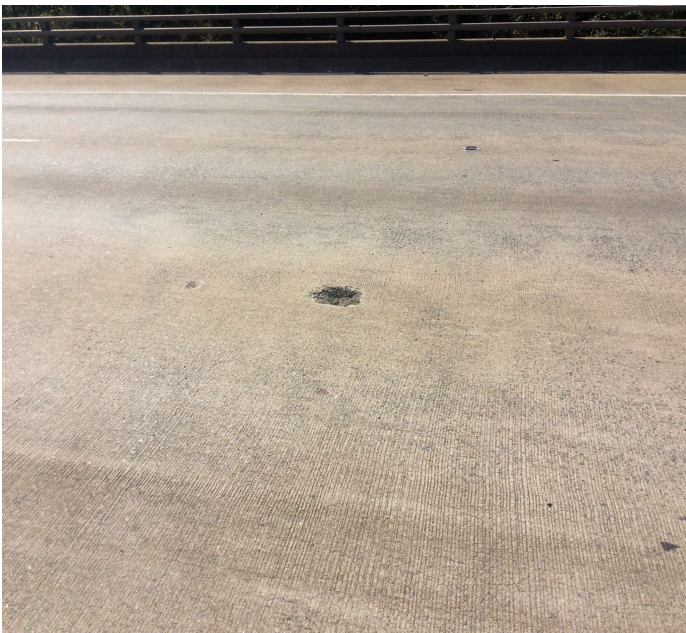
PHOTO 1 Description

Spall in span 4, middle lane.
