# Bridge Inspection Report

**A5583**

**I-630 WB Log 5.48**

**MISS AVE, RUSHING CREEK**

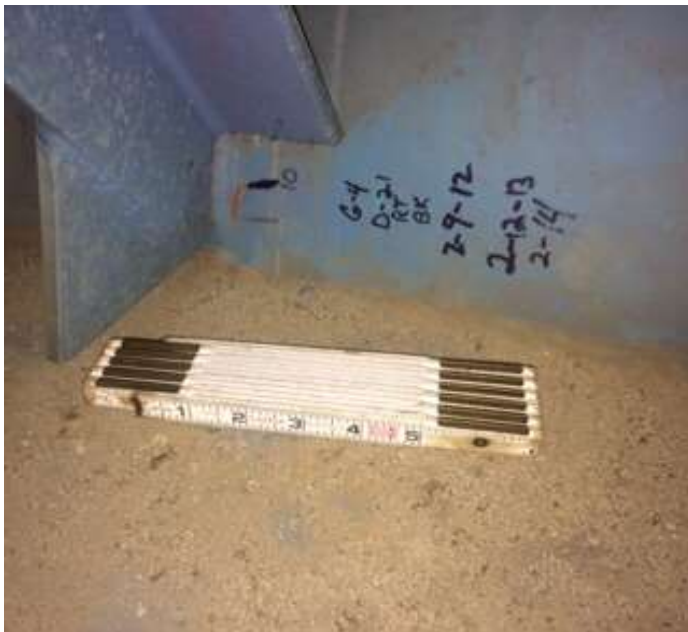
Fatigue cracks are present in the sides of the box girders and at the welded connections of the cross brace diaphragm on Girder 1 left side diaphragms 1, 2, 3, 4, 10, 14, 21 and 22, Girder 1 right side diaphragms 1, 2 and 11, Girder 2 left side diaphragms 2, 3, 4, 10, 14, 15, 21 and 22, Girder 2 right side diaphragms 2, 3, 4, 7, 10, 11, 15, 21 and 22, Girder 3 left side diaphragms 2, 3, 4, 14, 15, 21 and 22, Girder 3 right side diaphragms 1, 2, 3, 4, 10, 11, 14, 15, 19, 21 and 22, Girder 4 left side diaphragms 1, 2, 3, 4 and 21, Girder 4 right side diaphragms 1, 2, 3, 4, 10, 14, 15, 19, 21 and 22. See photos

PHOTO 1 Description Girder 4 diaphragm 21 back crack in the web. No change.

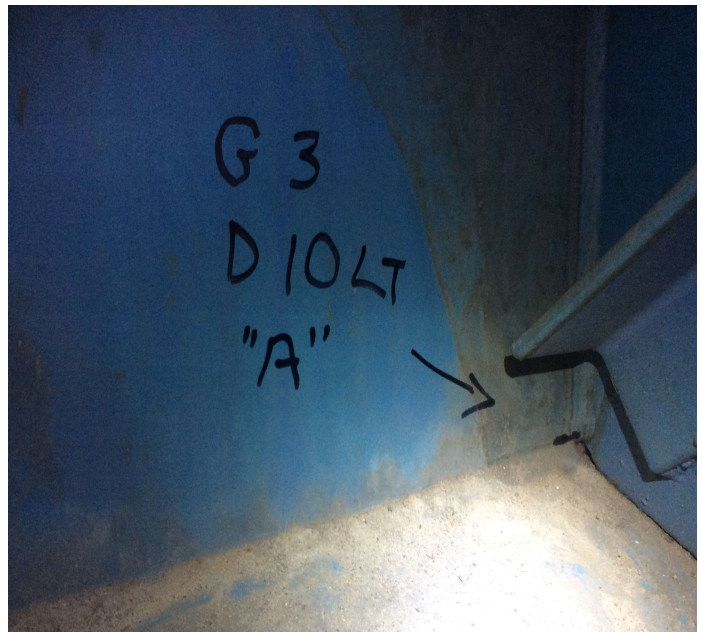
New fatigue cracks were found during this inspection. Girder 3: dia. 1 lt., dia. 7 rt., dia. 8 rt. and lt., dia. 9 rt. dia. 10 rt. and lt. Also, at bulk head 1 a crack was located at the top right welded connection. New photos linked.

PHOTO 2 Description girder 3 diaphragm 10

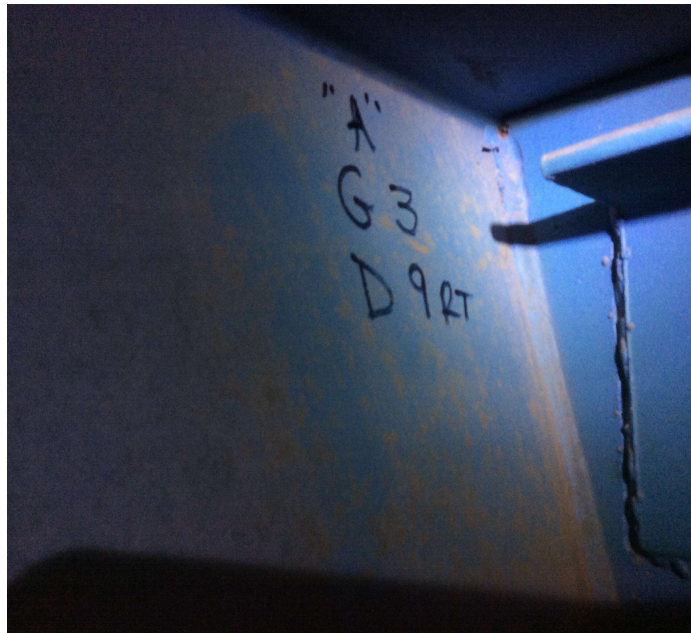
PHOTO 3 Description girder 3 diaphragm 9

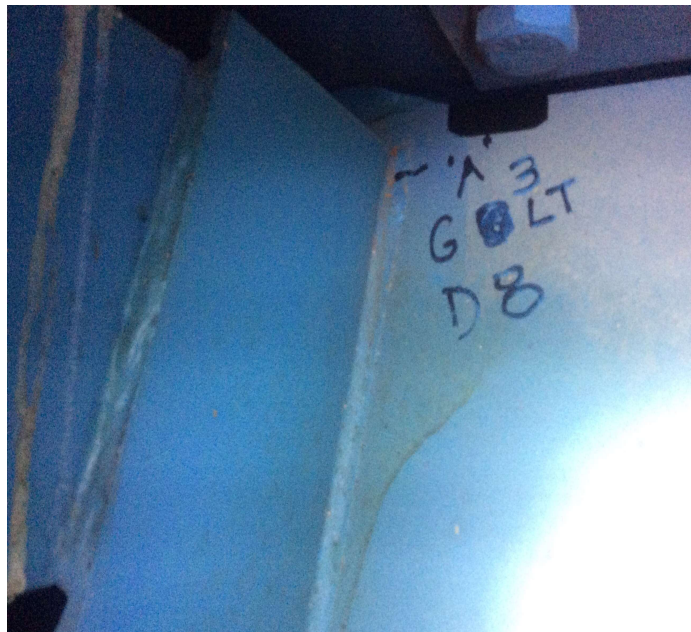
PHOTO 4 Description girder 3 diaphragm 8

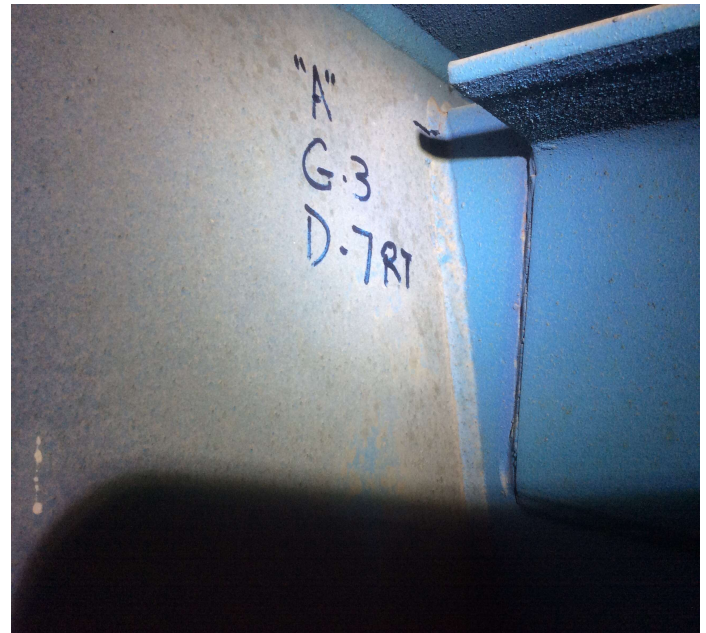
PHOTO 5 Description girder 3 dia 7

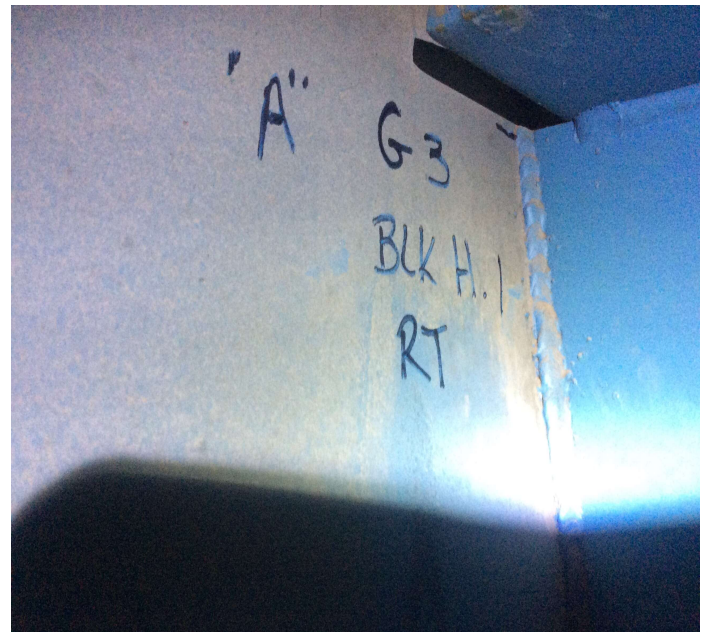
PHOTO 6 Description girder 3

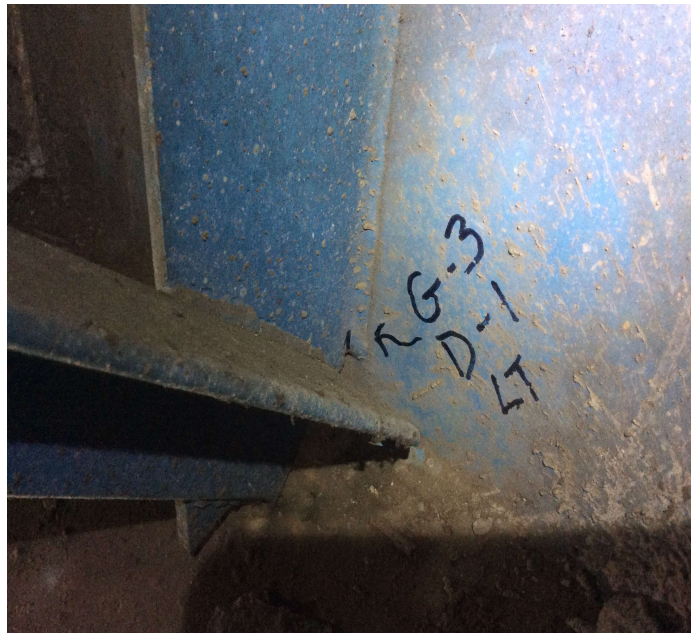
PHOTO 7 Description New crack located

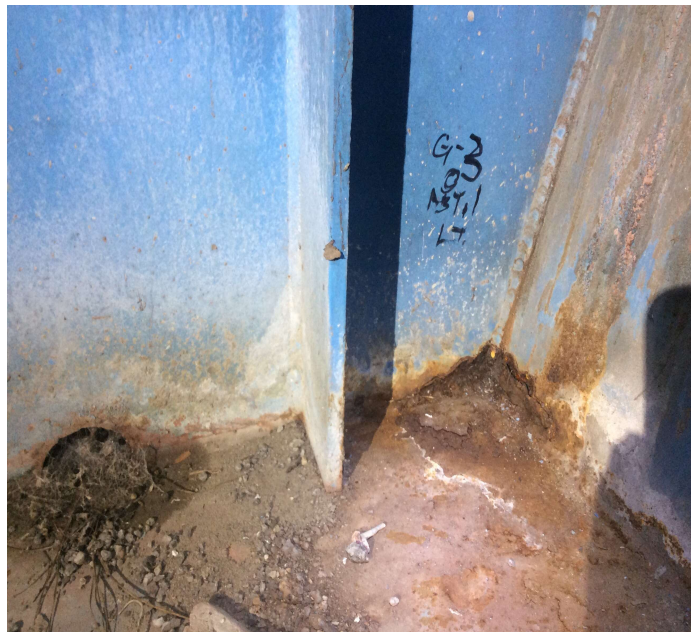
PHOTO 8 Description girder 2

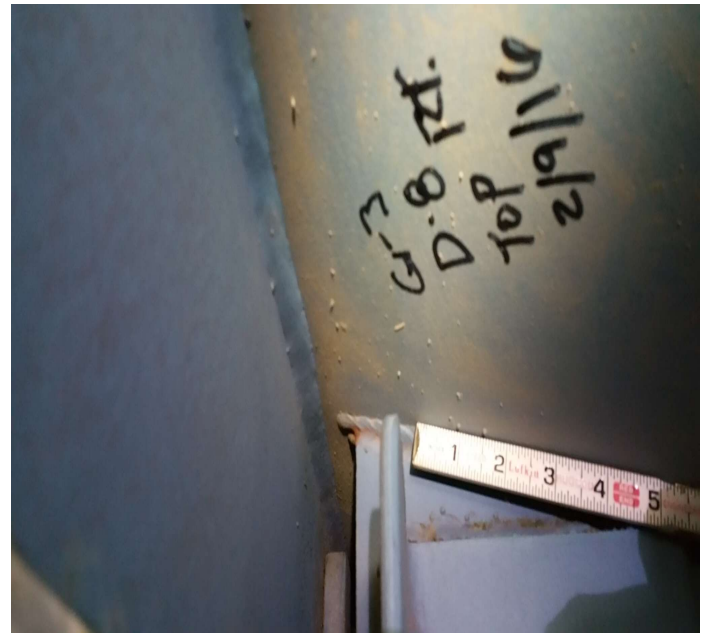
PHOTO 9 Description Girder 3 diaphragm 8 back right side. New crack in the weld at upper diaphragm.

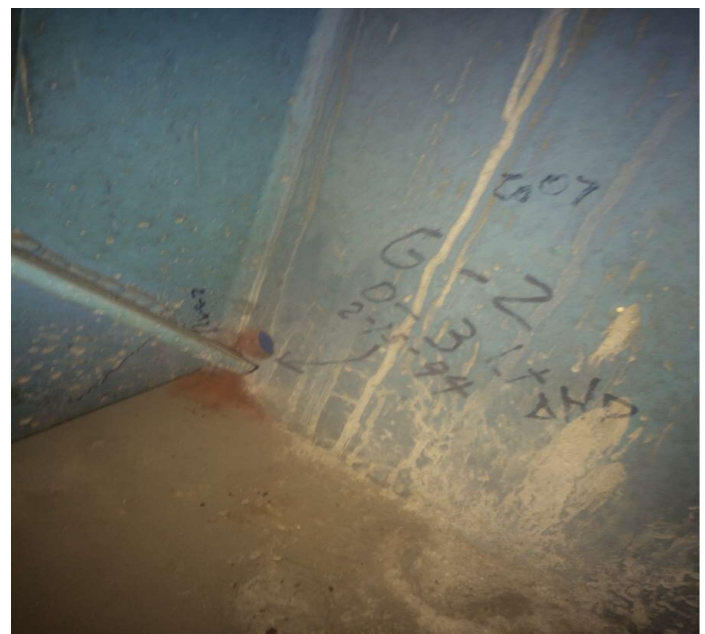
PHOTO 10 Description Girder 2 diaphragm 3 crack in the weld. No change.

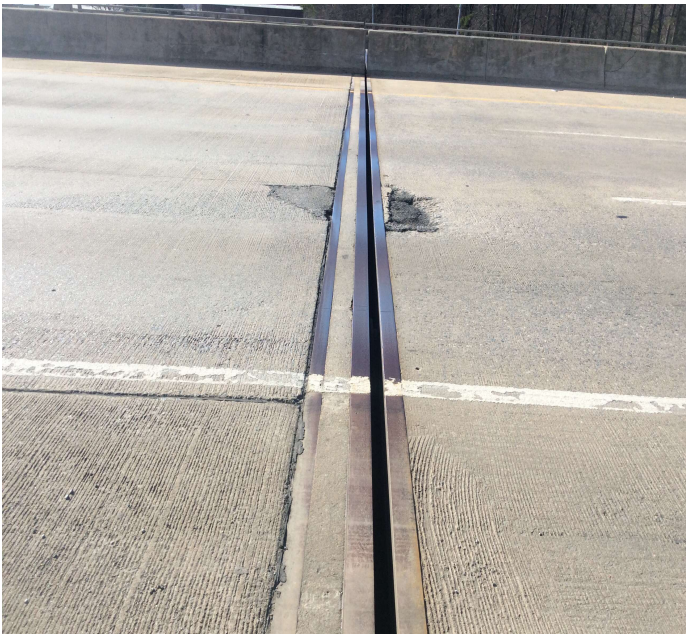
Joint seals at both abutments.

The joint seals at both abutments are missing allowing moisture and debris to build-up around bearings and enter the steel box girders. Spalls on top of abutment 2

PHOTO 1      Description      Bent 1 joint seal missing. Common bent 5.

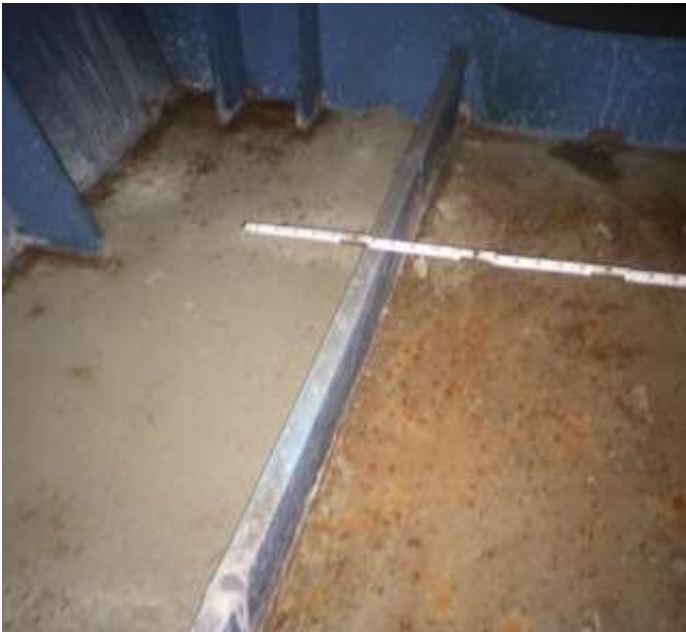
Girder 4 span 1 back of bulk head 1.

Active rust to bottom of box girder, bottom of web stiffeners and bottom of bulk head.

PHOTO 1      Description      Girder 4 at first bulkhead back active rust with moderate pitting to bottom flange and lower web.
