Bridge Inspection Report

B5583

I 630 EB Log 5.48

MISS AVE, RUSHING CREEK

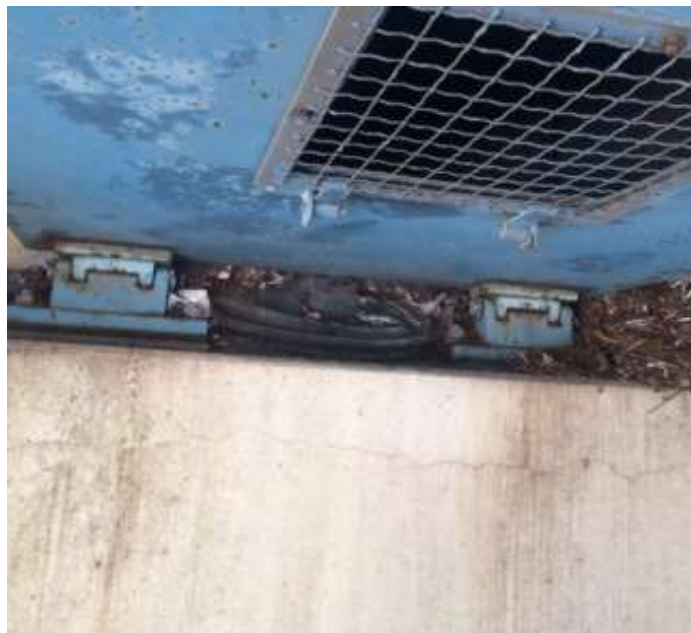
Top of abutment 1 has large cracks and abutment joint armor is popping under traffic. Joint seals are missing at both abutments causing debris to build-up around bearings.

PHOTO 1 Description West abutment girder 4. Debris has accumulated on girder end and bearing due to joint seals laying on abutment.

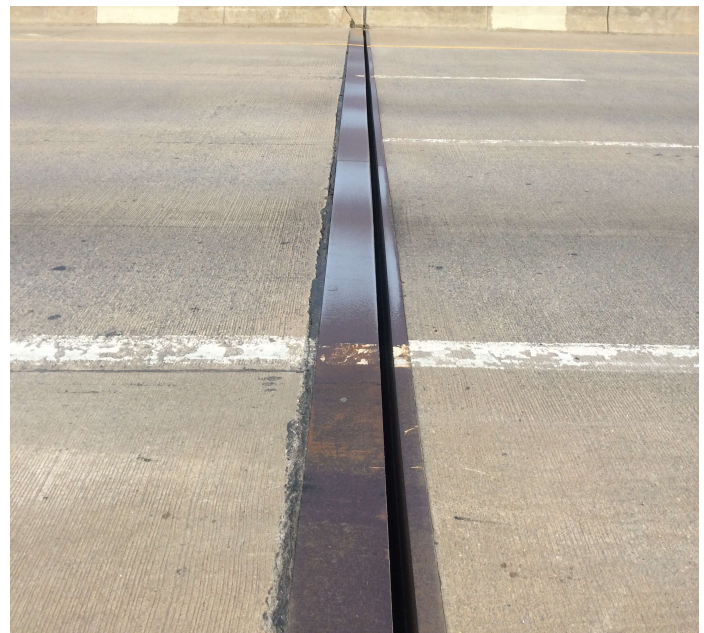
PHOTO 2 Description Bent 5 joint seal missing. Common bent .

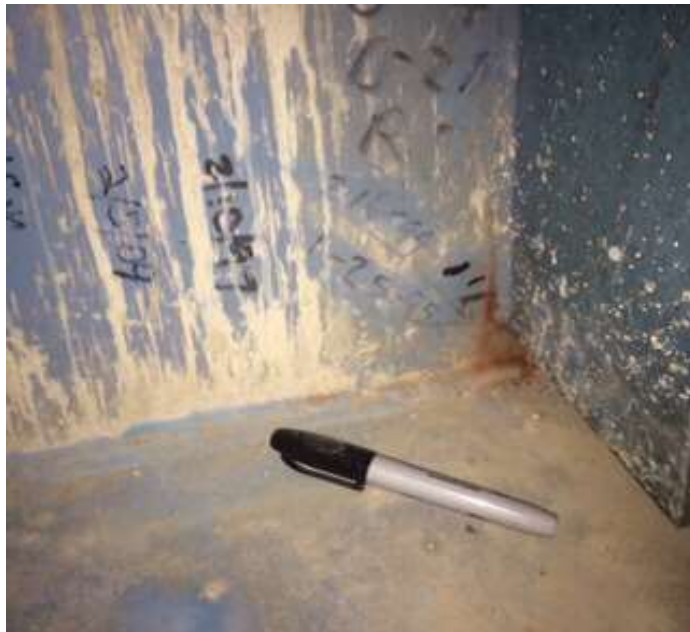
Fatigue cracks are present in the sides of the box girders and at the welded connections of the cross brace diaphragm on Girder 1 left side diaphragms 1, 2, 3, 4, 10, 14, 15, 21, 22 and bulkhead 3, Girder 1 right side diaphragms 1, 2, 14, 15, 22 and bulkhead 3, Girder 2 left side diaphragms 2, 3, 4, 10, 14, 15, 21 and 22, Girder 2 right side diaphragms 3, 4, 10, 14, 15, 21 and 22, Girder 3 left side diaphragms 1, 2, 3, 4, 11, 15, 21 and 22, Girder 3 right side diaphragms 3, 14, 21 and 22, Girder 4 left side diaphragm 10, Girder 4 right side diaphragms 1, 2, 3, 4, 10, 14, 21 and 22, Girder 4 right side 4th stiffener between diaphragms 7 and 8. Photos attached.

PHOTO 1 Description Girder 4 diaphragm 21 ahead crack in the web. No change.

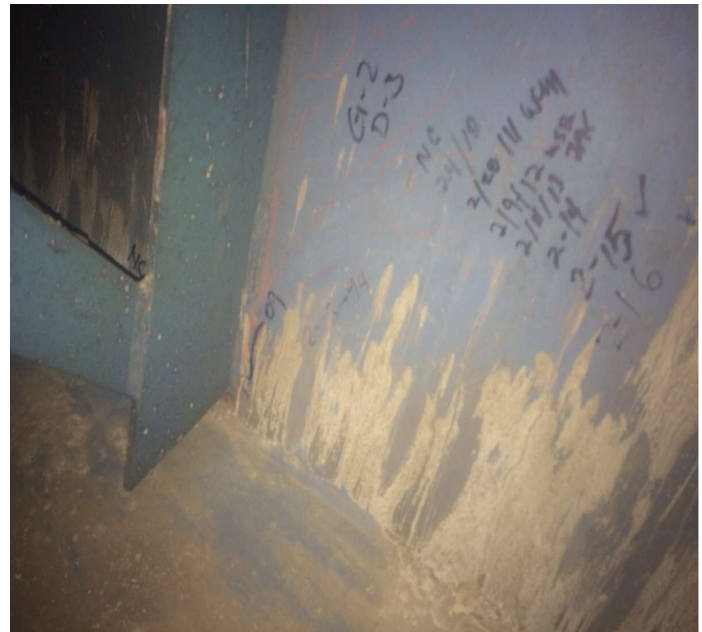
PHOTO 2 Description Girder 2 diaphragm 3 back crack in the weld. No change.

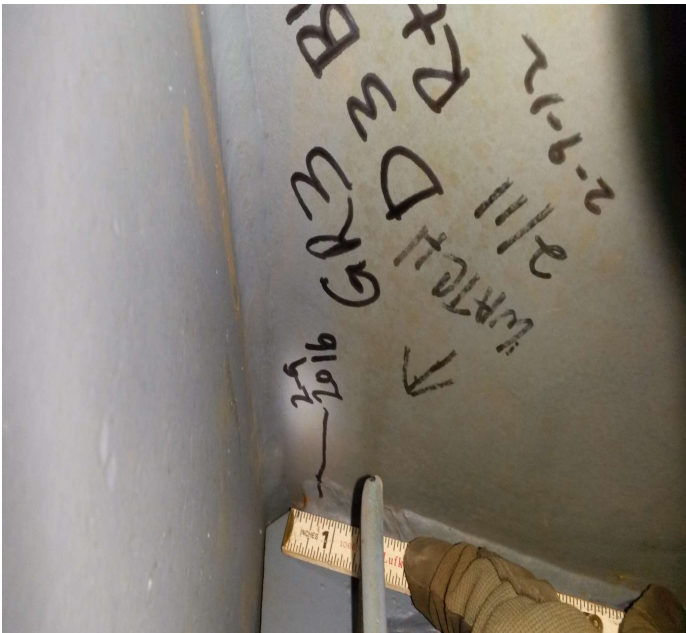
PHOTO 3 Description Girder 3 diaphragm 3 back crack in the top weld. New crack.

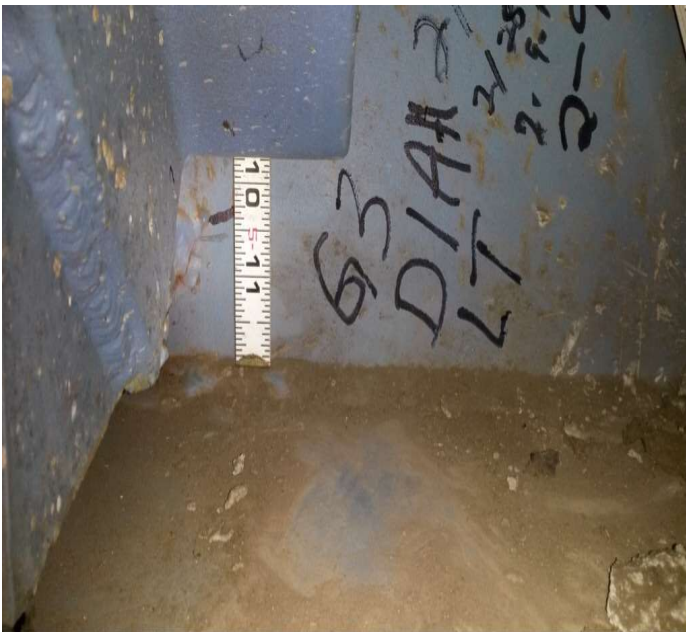
PHOTO 4 Description Girder 3 diaphragm 1 left bottom crack has propagated 1/4".

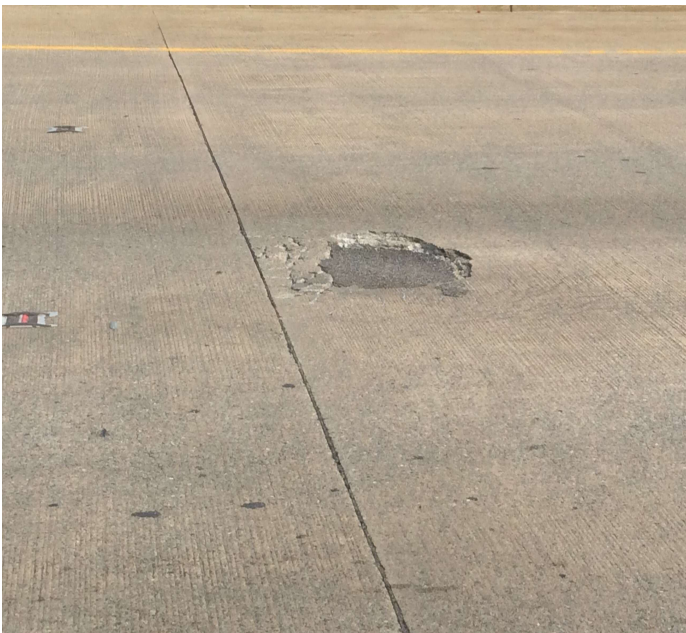
Deck has spalls and spalls filled with asphalt and a deep spall at joint of abutment 1.

PHOTO 1 Description Span 4 spall filled with asphalt
