Bridge Inspection Report

03638
US167 S-4 LM17.76
over
US 79-SEC 5

Structure Number: 03638

Facility Carried: US167 S-4 LM17.76

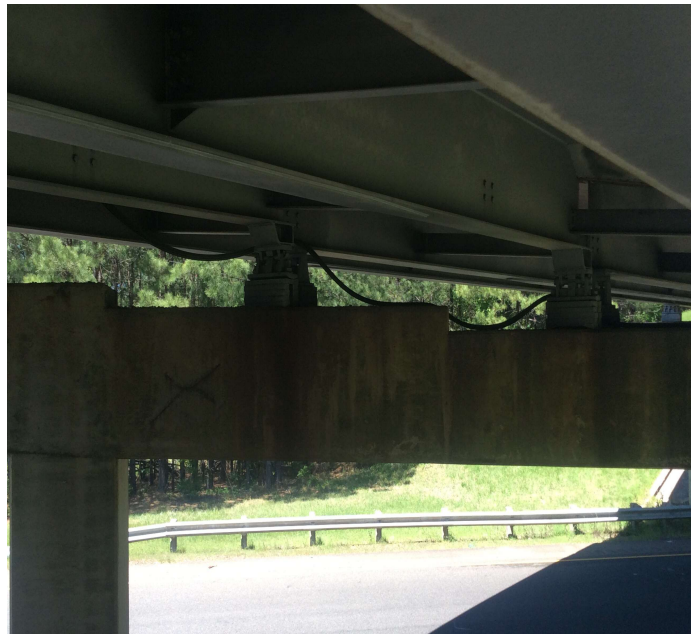
Deck has numerous spalls especially spans one and three. Deck joints bents two and three strip seal has failed on right ends allowing water and roadway salts to drain onto bearings and steel beam ends.

PHOTO 1 Description Bent 2 joint seal missing

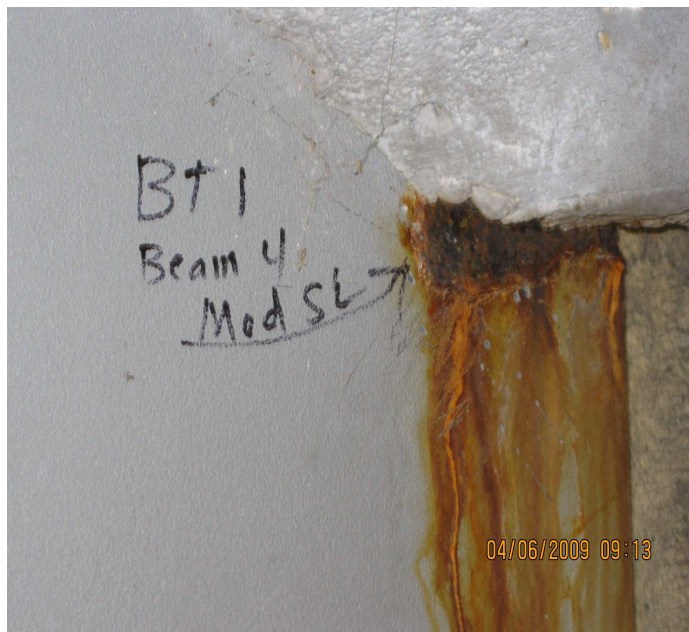
Bent one beam four has moderate section loss at haunch. Bent two beams two and three have moderate section loss at haunch. Bent three beam three has moderate section loss at haunch. Bent four cap spalled with exposed steel. Bent two bearing four has packrust and one anchor nut is deteriorated.

PHOTO 1 Description Bt. 1 Beam 4

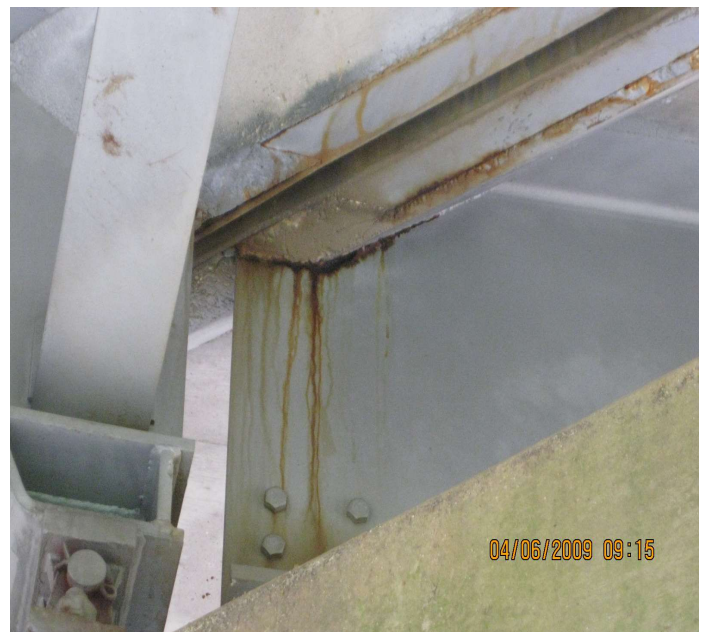
PHOTO 2 Description Bt2, beam 2 & 3.

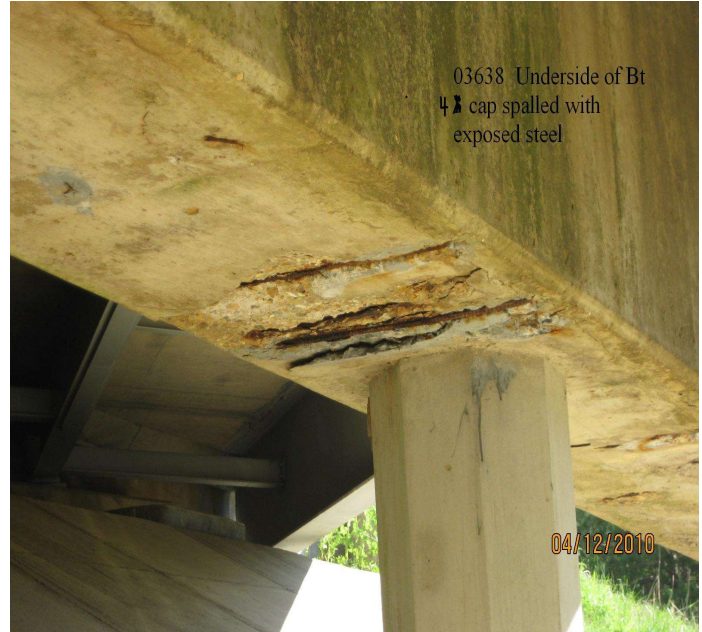
234 - Reinforced Concrete Pier Cap	1- Ben.	93	ft.	67	26	0	0
	Bent 2 cap ahead, spall with exposed rebar. Bent 3 back, has horizontal crack. Bent 4, bottom of cap has spalls with exposed rebar.						
1080 - Delamination/Spall/Patched Area		6			6		
1090 - Exposed Rebar		12			12		
1130 - Cracking (RC and Other)		8			8		
300 - Strip Seal Expansion Joint	1- Ben.	160	ft.	122	0	0	38
	Joint seals at bents 2 and 3 are missing.						
2310 - Leakage		19					19
2330 - Seal Damage		19					19
311 - Movable Bearing	1- Ben.	16	each	16			
313 - Fixed Bearing	1- Ben.	16	each	15	1	0	0
	Abutment 5 beam 5 has initial corrosion.						
1000 - Corrosion		1			1		
321 - Reinforced Concrete Approach Slab	1- Ben.	1750	sq. ft.	1670	80	0	0
1130 - Cracking (RC and Other)		80			80		
330 - Metal Bridge Railing	1- Ben.	396	ft.	396

PHOTO 5 Description Bt. 4 Cap

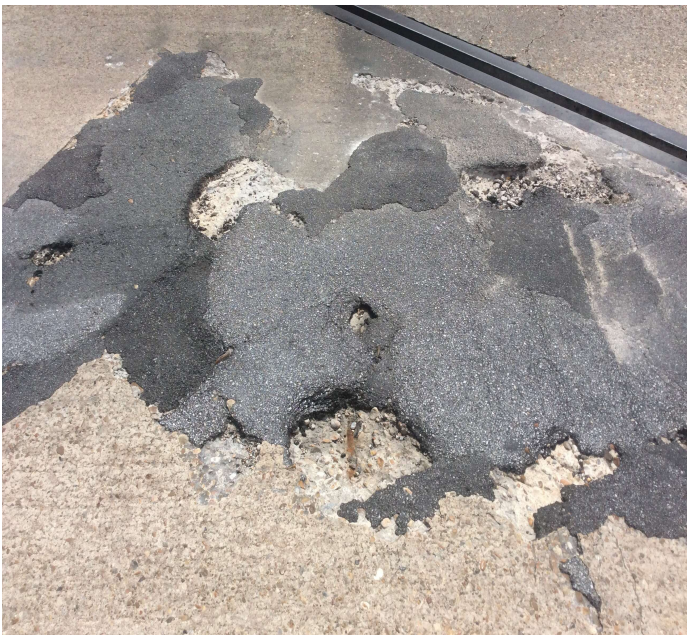
PHOTO 1 Description

Span 3, spall with exposed rebar in deck.

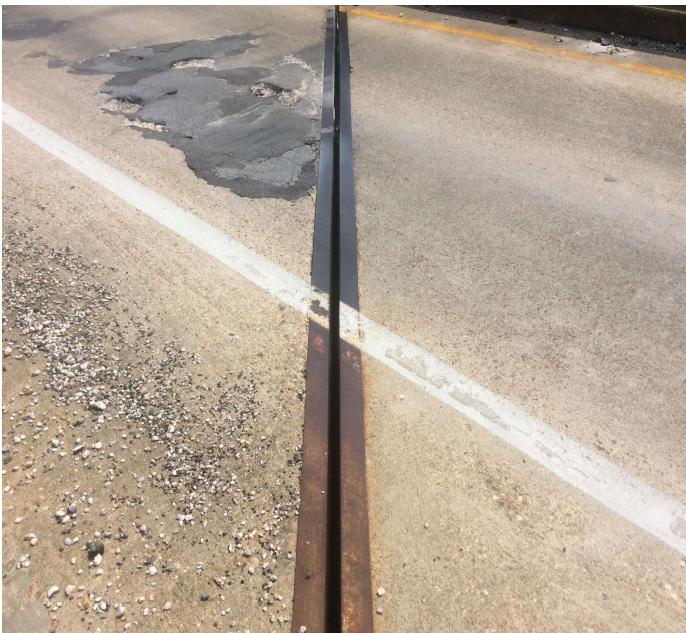
PHOTO 1 Description

Joint seals at bents 2 and 3 are missing.
