Bridge Inspection Report

01913
US 412-08- LM 2.58
over
LATERAL NO 3

Structure Number: 01913

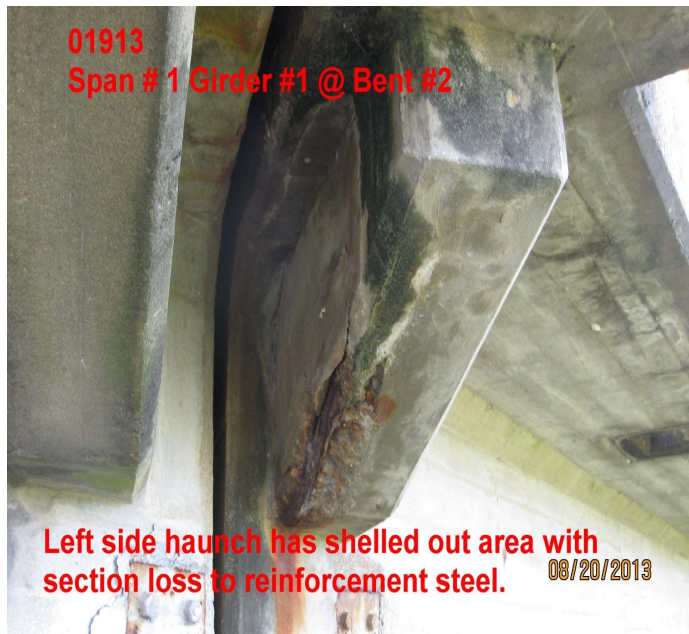
PHOTO 1 Description

Left side of Span 1 Girder 1 over Bent 2 haunch is shelled out with loss of section to rebar due to steel placement, as built condition.

Left side of Span 2 Girder 1 near Bent 3 has a shelled off area with rebar exposed.

Stage: Monitor
